**Case Study Assessment –
Rehabilitation of the
Dona Lake Tailings Area
Pickle Lake, Ontario**

MEND Report 9.2a

FINAL Report

**Prepared by Philippe Poirier, Eng., M.A.Sc.
SNC-LAVALIN ENVIRONMENT INC.**

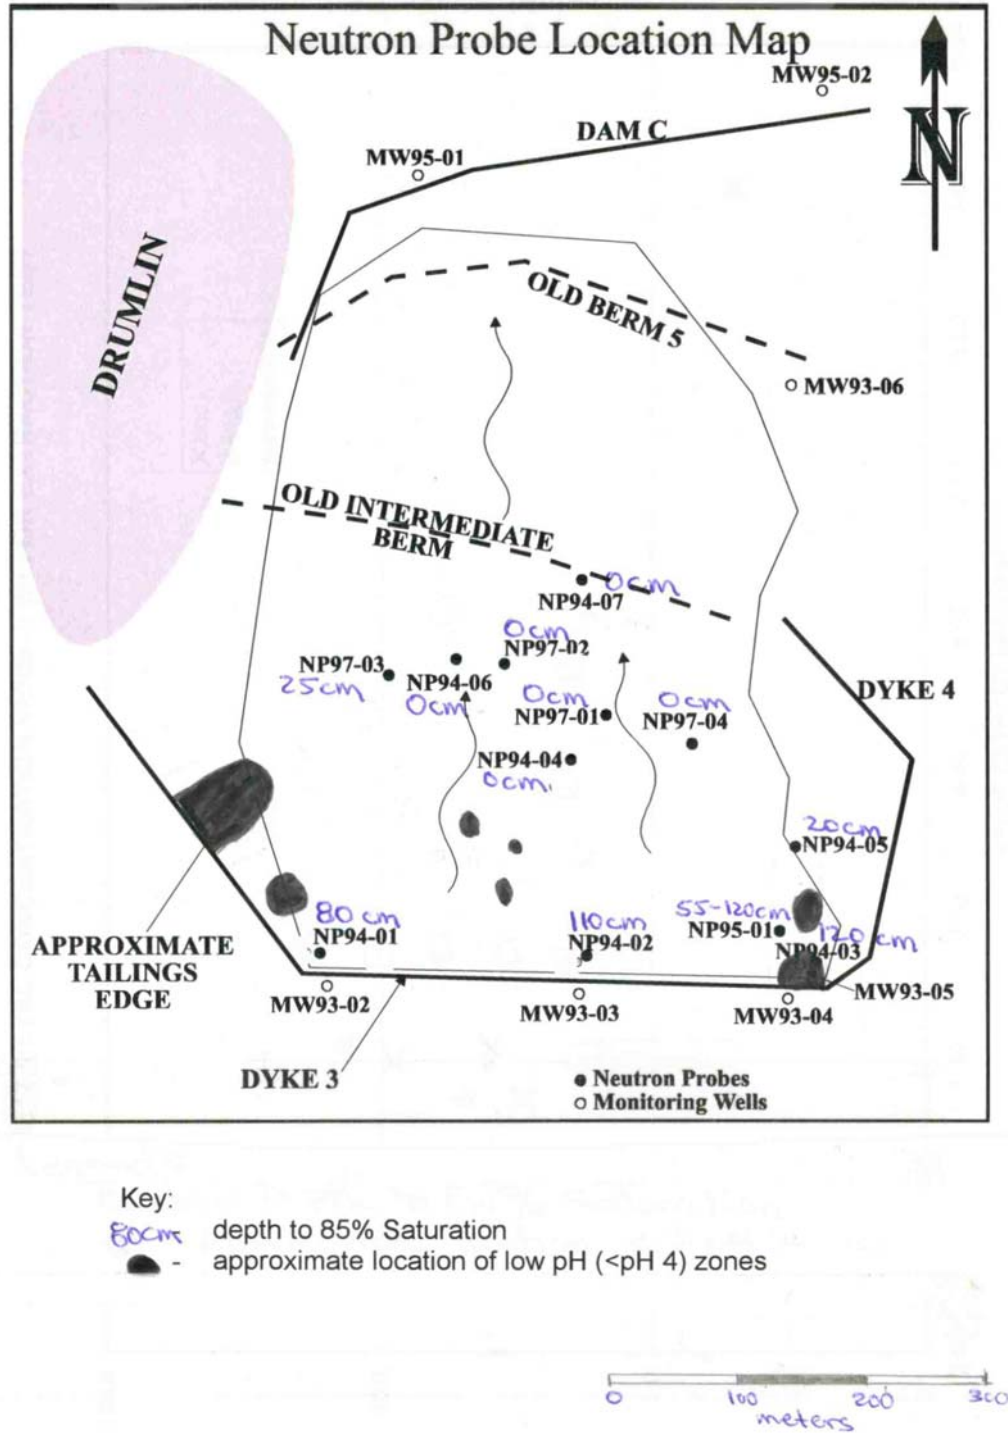
Figure 4.1 – Location of the neutron probes and areas of low pH (Placer Dome, 1999)

- 2 piezometer nests, installed along Dyke 3, and 5 groundwater monitoring wells.
- 8 neutron probe access tubes, to monitor in-situ moisture conditions. The location of the neutron probes, labelled NP94-01 to NP-94-07 and NP-95-01, are shown on Figure 4-1.
- A series of jet-fill tensiometers, at different depths in the tailings along Dyke 3, to measure the negative pore water pressure of the tailings.
- A nest of suction lysimeters installed in the tailings material near Dyke 3.

The water content profiles measured by the neutron probe access tubes were used to validate the results obtained from the infiltration models. In 1995, the phreatic surface measured in NP94-02, located near Dyke 3, was 2.5 m below the tailings surface. Further upstream of Dyke 3, in NP94-07, the water level was 0.5 m below the tailings surface.

In October 1998, University of Saskatchewan monitored 9 neutron probes. Figure 4-1 shows the depth to 85% saturation measurements ([Placer Dome, 1999](#)). Results are consistent with expectations in that neutron probes adjacent to Dyke 3 (NP94-01, 02 and 03) exhibited relatively deep zones (55 to 120 cm) with less than 85% saturation. Neutron probes located approximately 100 m upstream from the exposed beach (NP94-05 to 07) showed saturation values higher than 85% at depths of 0 to 20 cm from the tailings surface. Due to construction work in 1999, most of the neutron probe tubes and piezometers installed in 1994, 1995 and 1997 had to be reinstalled. No monitoring was conducted in 2000 and Placer Dome has not confirmed whether the monitoring program was pursued after 2000.

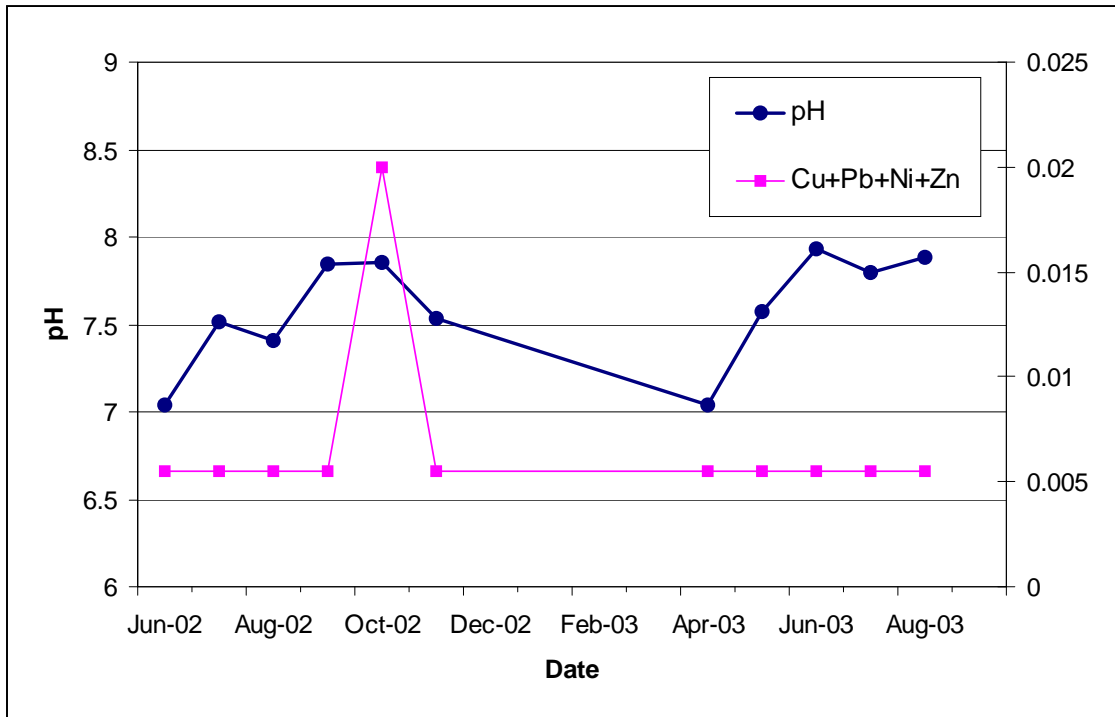
Figure 7.1 – Water quality of the final effluent

The Ontario Ministry of Environment revoked the conditions of the Certificate of Approval (CofA) for the tailings impoundment, as the mine ceased operations in 1994. The surface water monitoring program is therefore governed by the terms of the approved closure plan. Water quality data at the final effluent for 2002 and 2003 is shown in Figure 7-1. The effluent was in compliance for both years, with contaminant levels well below discharge criteria.

Sulphate has been increasing and was elevated significantly in 2000 compared to 1999. However, in 2001 sulphate concentrations were similar to 2000, indicating that the concentrations might have reached a plateau. The sulphate is due to sulphide oxidation and was expected. A mass balance prepared in 1998 predicted that the sulphate concentration might increase to between 292 and 773 mg/L as the pond level increased and submerged previously oxidized tailing ([Placer Dome, 2001](#)). The maximum measured sulphate concentration in 2001 was 234 mg/L, which is still below predicted values as shown on Figure 7-1. Metal concentrations at the final effluent are also well below predicted values.
