**A PRELIMINARY ASSESSMENT  
OF SUBAQUEOUS TAILINGS  
DISPOSAL IN BENSON LAKE,  
BRITISH COLUMBIA**

**MEND Project 2.11.1a-b**

**Rescan Environmental Services Ltd.  
Vancouver, Canada**

**March 1990**

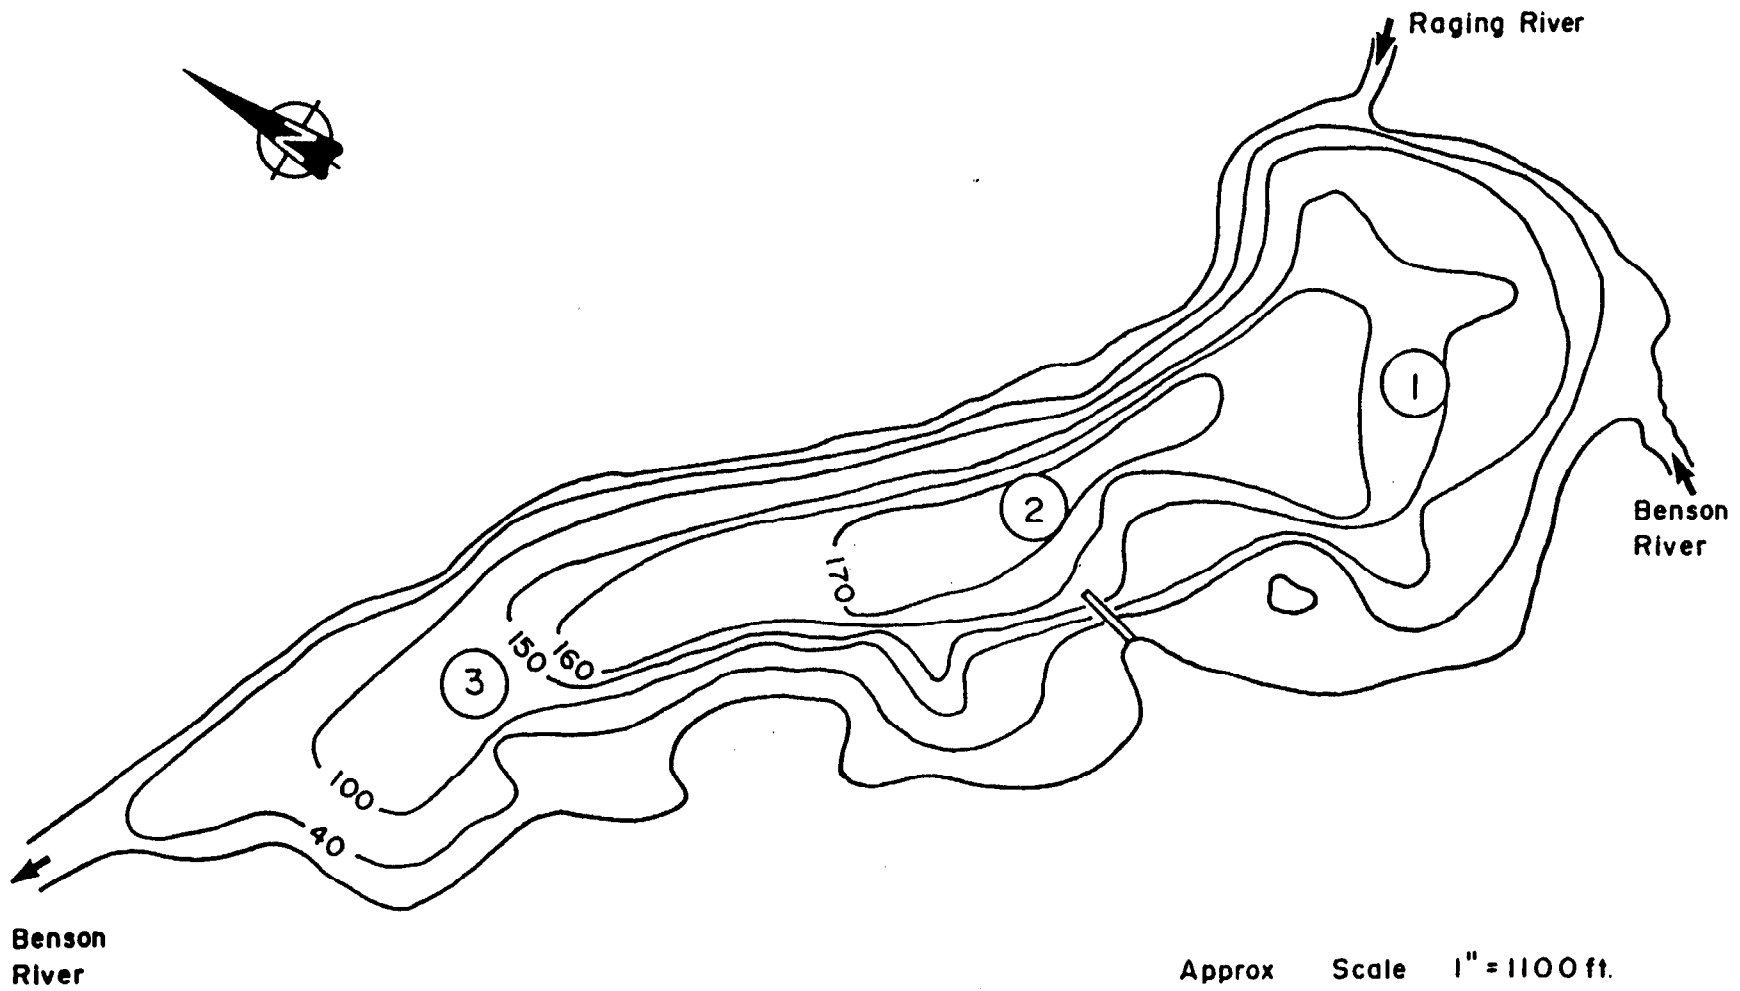
Figure 1-2 Benson Lake Showing Contours, Secchi Disc Stations, and Discharge Location

Lake soundings were completed in March 1970 to determine bathymetry in the region of the outfall (Figure 1-2, Kussat et al. 1972). Relative to 1962 Cominco readings, the lake depth had not been significantly altered.

Although the units and differences between isopleths differ, the present bathymetry of Benson Lake (Figure 3-1) is similar to that observed in 1970 (Figure 1-2). However, the deeper portions of the lake differ slightly. The area within the 50 m isopleth in Figure 3-1 is much smaller than the area within the 170 ft (52 m) isopleth in Figure 1-2.

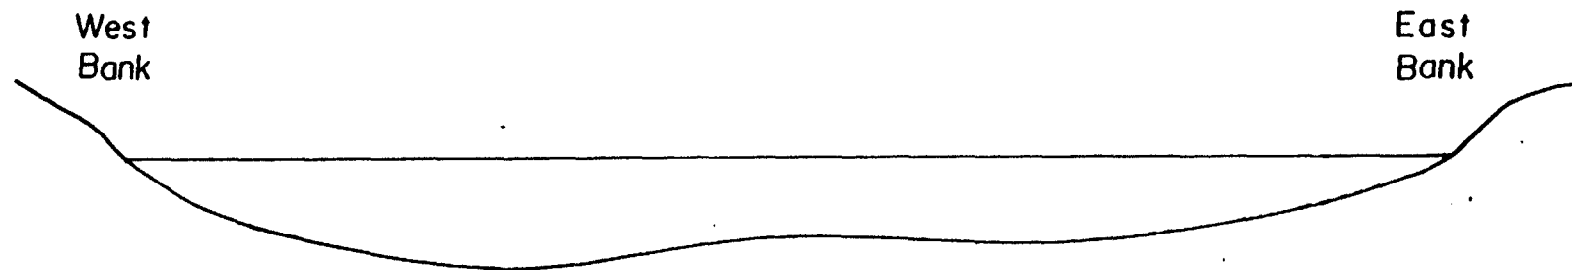
**Figure 3-3: Craft Creek stream profile and current data at a site located 50 m upstream of the main road bridge, November 3, 1989.**

**Profile and Current Data: Stream width = 8.9 m**

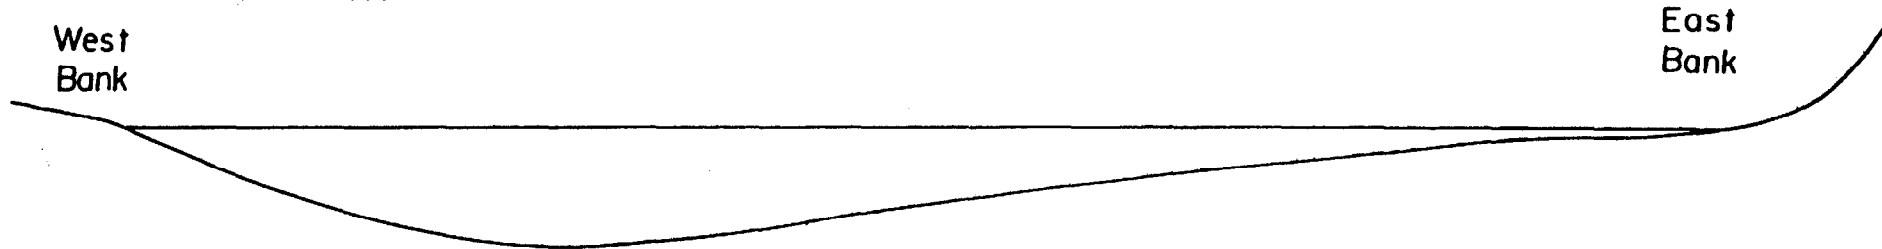
**Figure 3-6: Inlet Benson River stream profile and current data at a site located approximately 10 m downstream of the pump house access road bridge, March 4, 1990.**

**Profile and Current Data: Stream width = 32.8 m**
