**In-Pit Disposal of Reactive
Mine Wastes: Approaches,
Update and Case Study
Results**

MEND Report 2.36.1b

June 2015

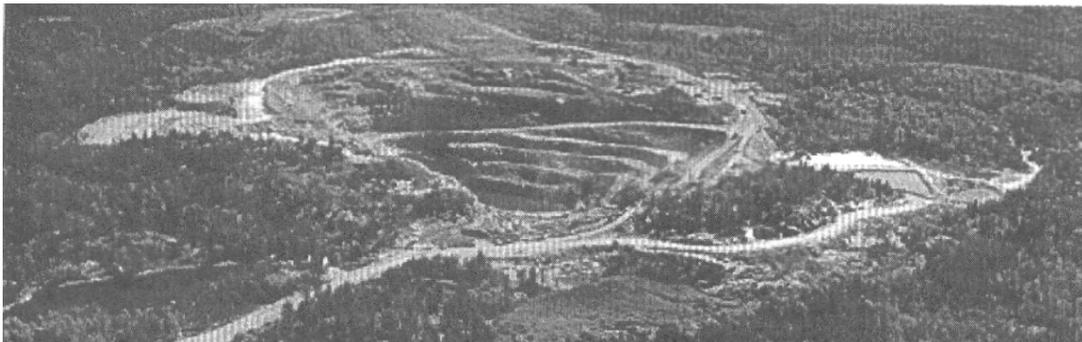
Figure 1-3 NNE Perspective of the Whistle Open Pit [10]

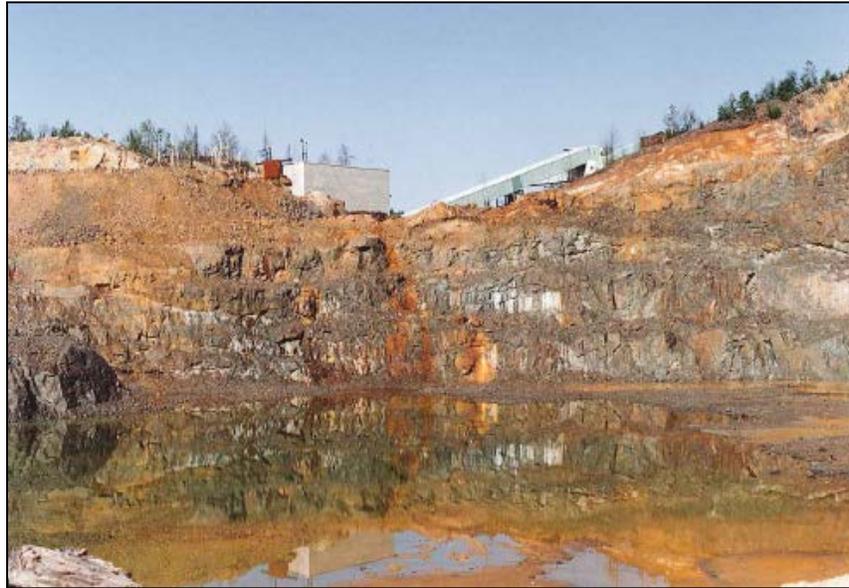
Figure 1-4 Whistle Mine Pit in 1997 ¹¹

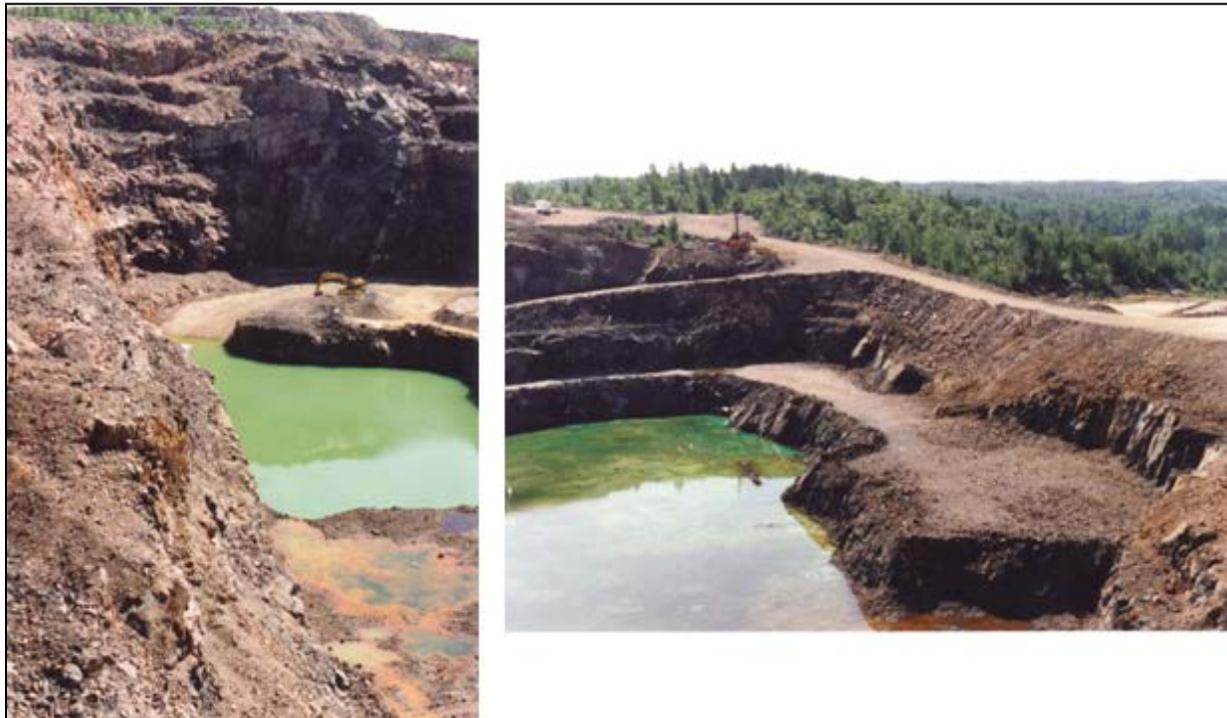
Figure 1-5 Whistle Mine Pit Waters, Green Indicating Nickel Content ¹²

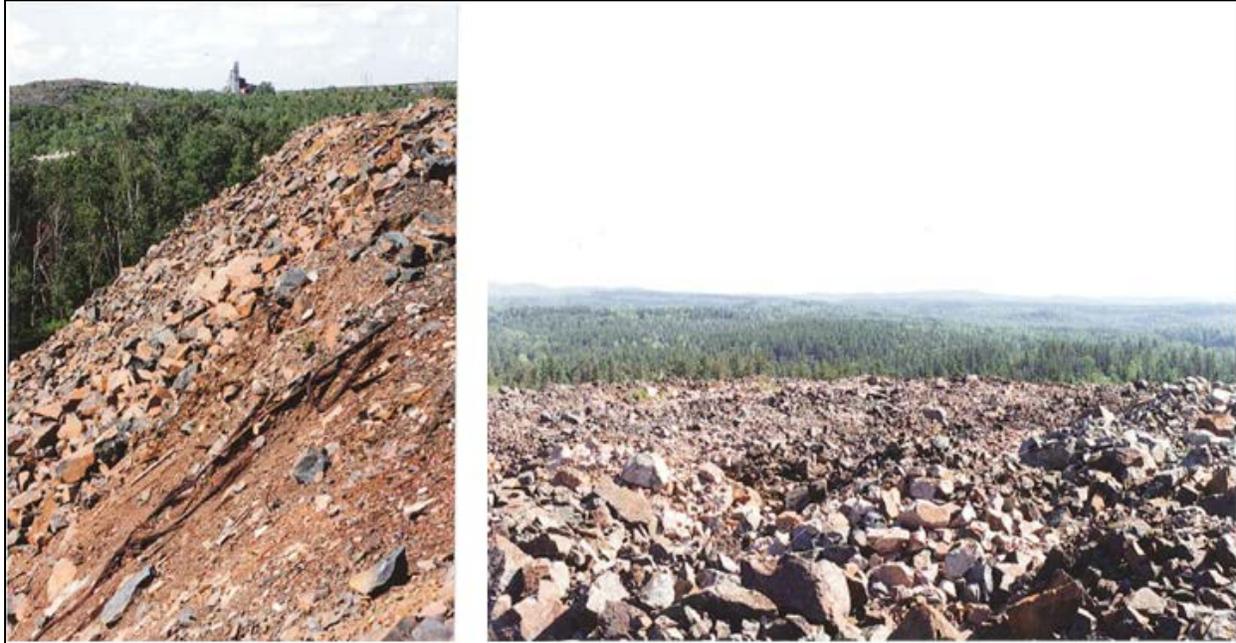
Figure 1-6 Waste Rock at Whistle Mine¹³

The two piles of waste rock were both adjacent to the pit; the northwest waste rock pile was mainly granite rock, the northeast pile was acid generating mafic rock [14] (Figure 1-6). The porosity of the stockpiles was greater than 20%, and 92% of the material was greater than 100 mm in diameter (Figure 1-6 below). This resulted in an estimated net infiltration of >50% of

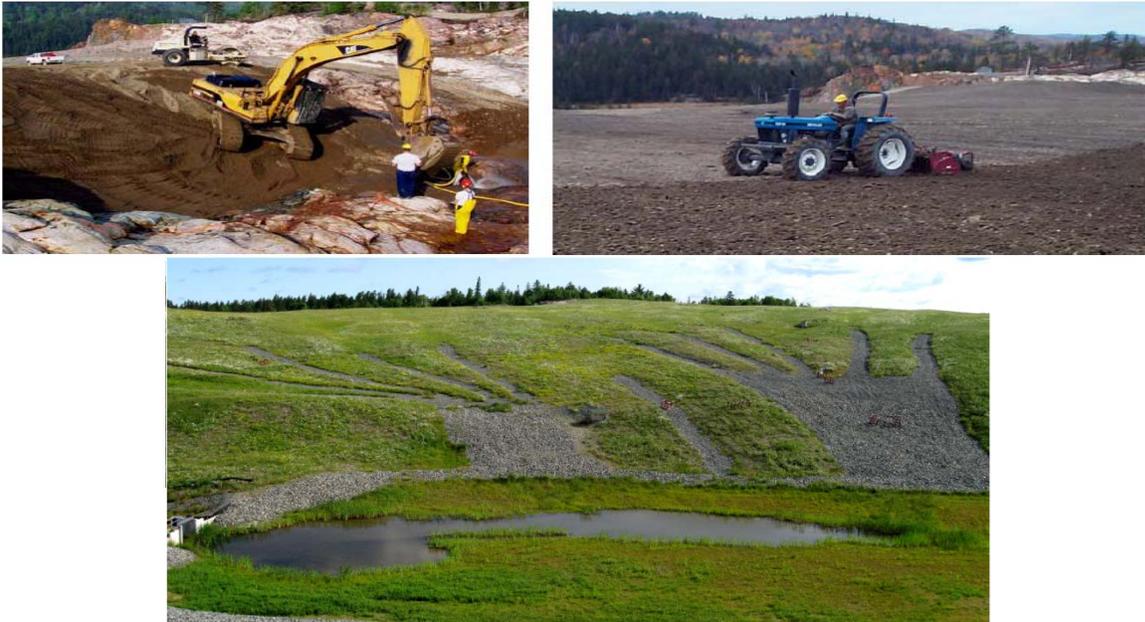
Figure 1-7 Whistle Photos. (Clockwise from top left: cleaning of the pit perimeter prior to barrier layer construction, cross-slope ripping of topsoil into the granular cover material, and the finished pit cover in July-08 [5] with the collection Pond overshoot gate in the foreground) [6]

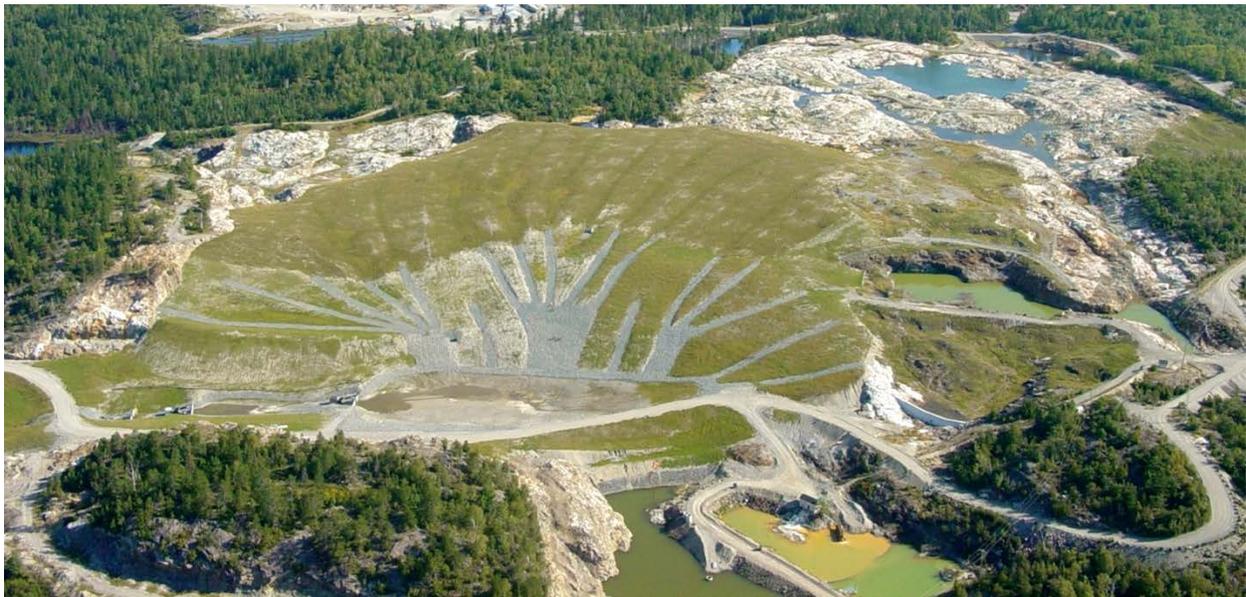
Figure 1-9 **Arial Photo for Final Covered Backfilled Pit at Whistle Mine [8]**

The final landform consisted of several catchments oriented parallel to the slope with progressively higher levels of erosion protection in the channels down slope (Figure 1-8 and Figure 1-9). The resulting landform was more analogous to natural systems and provided a micro-topography to aid re-vegetation. The overall design included a series of managed ponds at the base of the slope. Over time a wetland area would be established to provide long-term attenuation of peak surface flows and diversified habitat for wildlife [15].

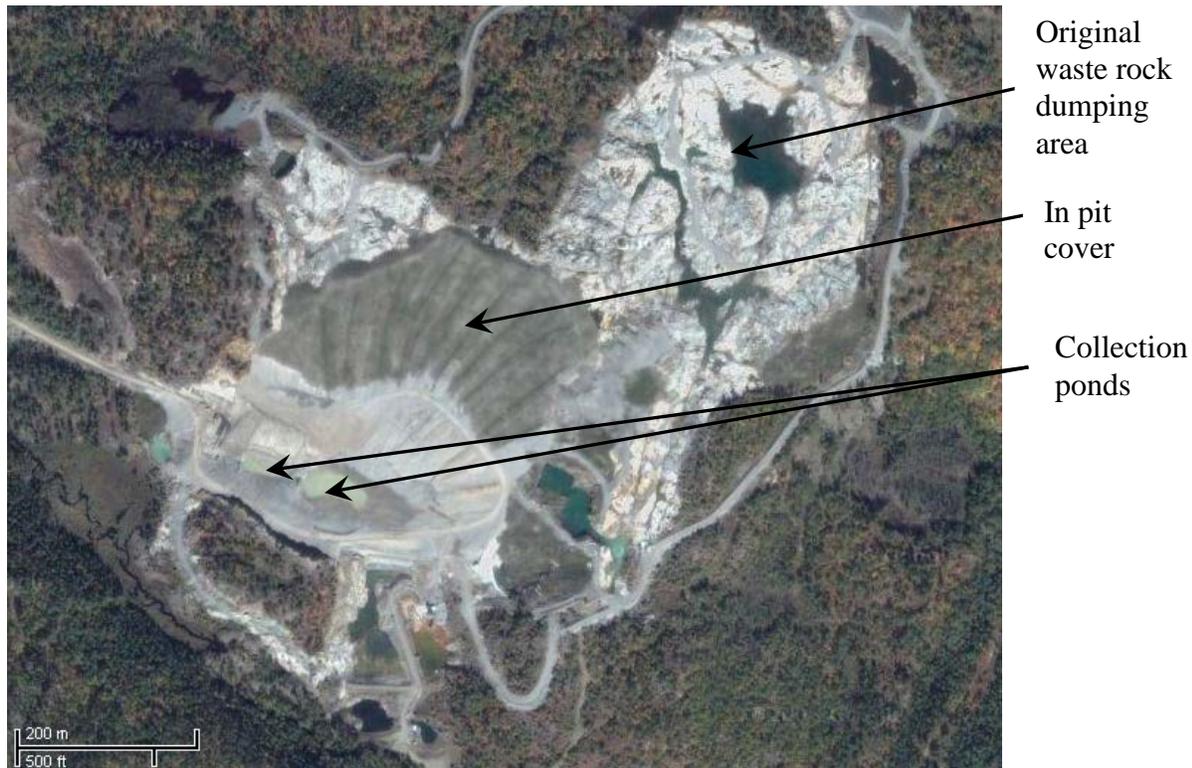
Figure 1-10 Aerial view of Whistle Mine after Remediation (Google Maps)

An important aspect of the backfilling and covering was the presence of an onsite testing laboratory routinely confirming that borrow materials conformed to specifications. Testing of completed work areas, particularly the barrier layer, consisted of in situ density, water content and permeability measurements, as well as surveying to check that the specified minimum layer thickness was achieved [6]. A perspective of the site immediately following the pit backfilling, cleaning of waste rock storage areas and pit covering is shown in Figure 1-10.

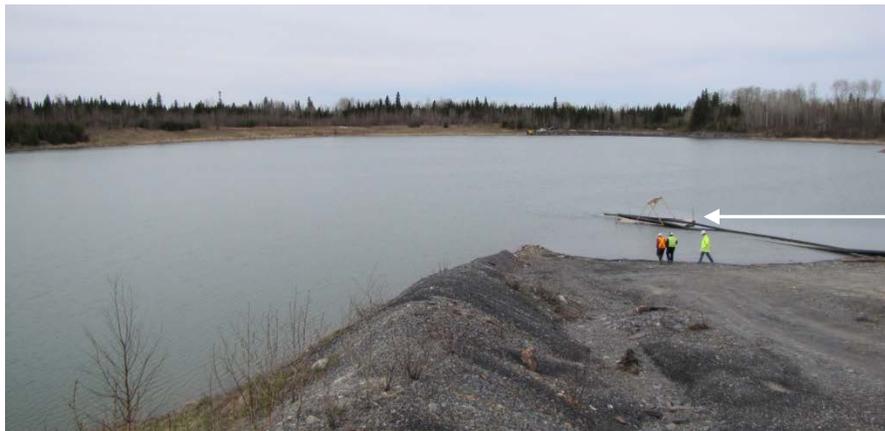
Figure 2-4 Photo of Owl Creek Pit Lake, May 2010 (Feasby)

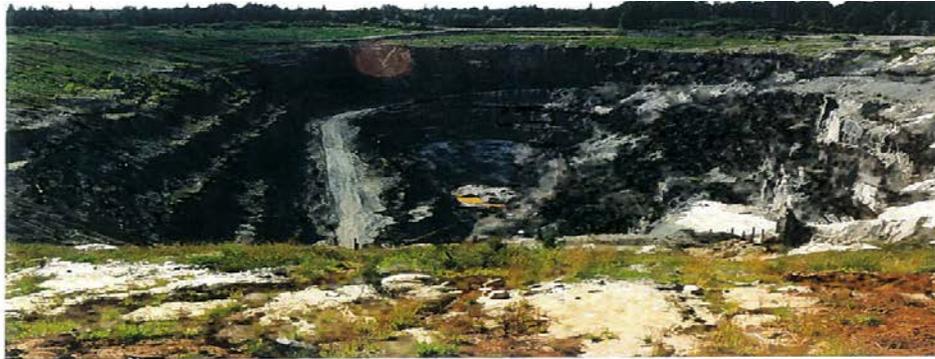
Figure 2-6 Photograph of the Owl Creek Open Pit (looking westward) Prior to the Relocation of Waste Rock to the Pit [13]

The original mined-out pit has a surface expression of approximately 300 m by 500 m and was 100 m deep. The mined out pit is shown in Figure 2-6 [11].

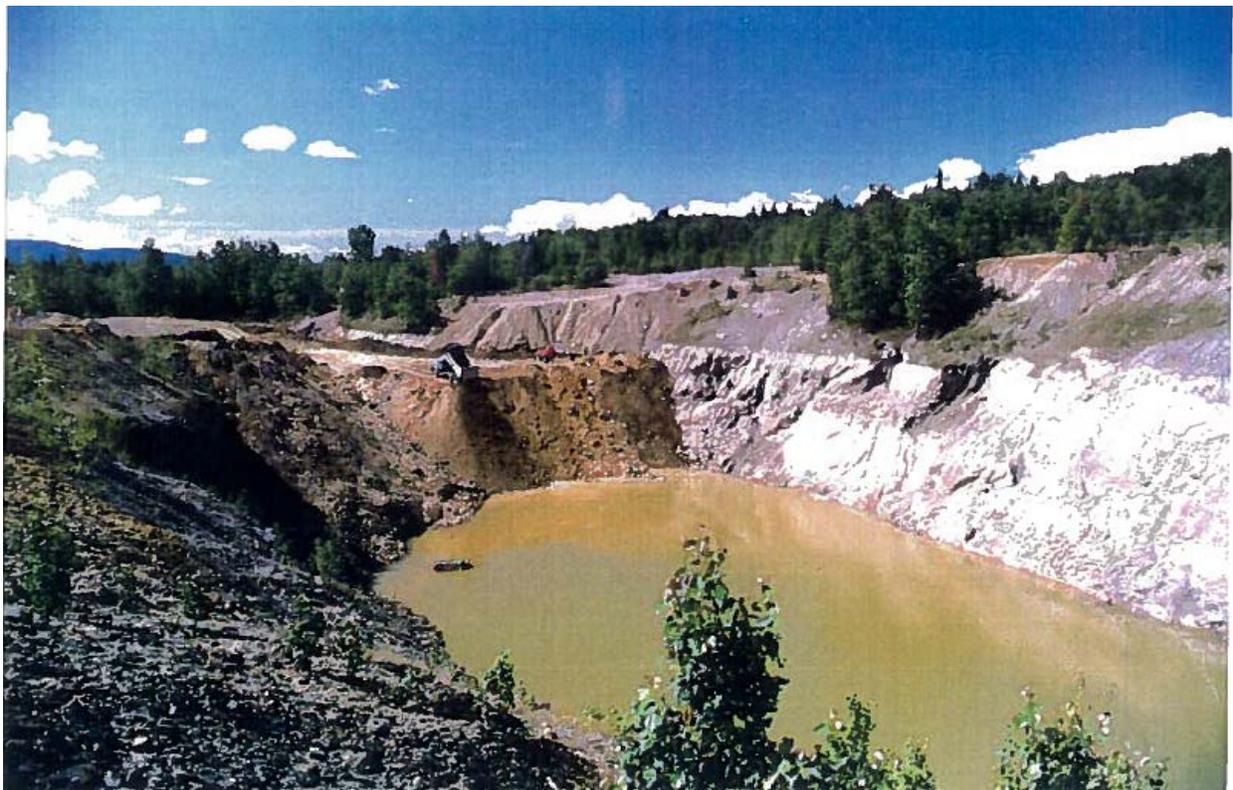
Figure 3-5 Photo of the Pit filling Operation at the South End of the Solbec Open Pit 1998 [8]

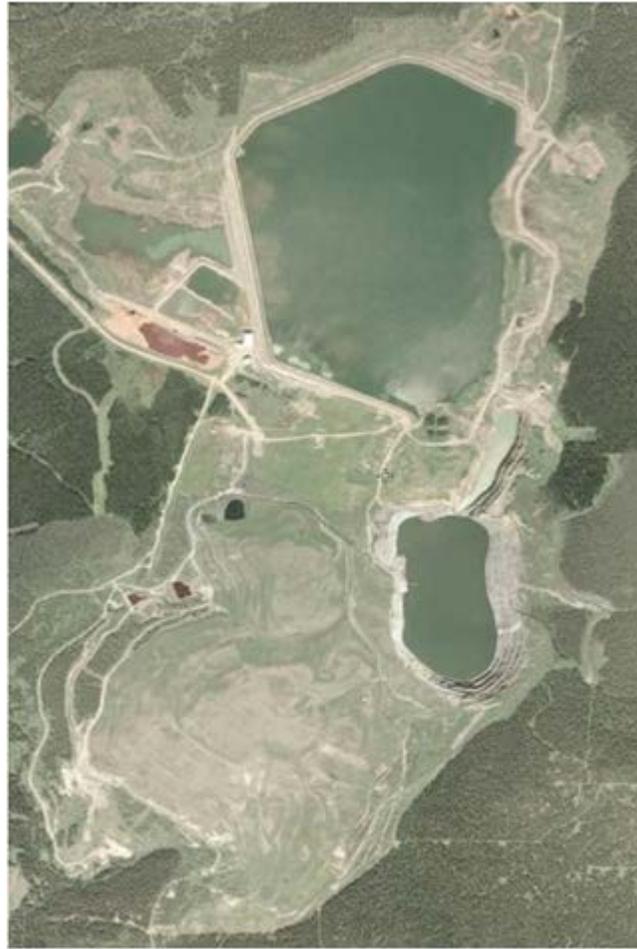
Figure 4-2(b) Recent Aerial View of Equity Silver Mine

The waste rock was piled in three locations: initially in the Main and Bessemer dumps, and later in the Southern Tail pit (Figure 4-2(a)). In 1981, some acid drainage was observed to be originating from one waste pile, and in 1982 ARD was confirmed to be a significant issue for much of the waste rock. Initial remedial actions included the installation of a partial containment system to reduce the acid drainage into Bessemer Creek [7]. Tailings were also determined to be PAG and were deposited under a water cover to prevent oxidation and acid generation - a flooded condition that remains in place 20 years after operations ended as shown in Figure 4-2 (b).

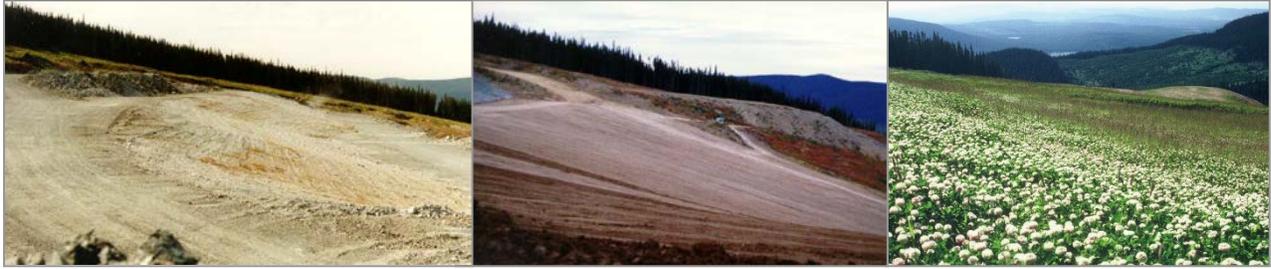
Figure 4-6 Profiling and Covering Sequence of the Southern Tail Pit Waste Rock Dump [9]

In 1984 after mining of the Southern Tail pit ceased, the pit was partially backfilled with 5 Mt of PAG waste rock from the Main Zone pit, to one metre below the final accumulated water elevation at that time [3]. At the air water interface of the filled pit, a 2 m layer of non-acid generating gabbro was placed on top of the backfilled waste rock [4]. The Southern Tail pit and footprint was later used as a waste rock dump, which by the end of operations consisted of 12 Mt of PAG rock from the Main Zone pit. The Southern Tail pit zone holds approximately 17 Mt of waste rock. During Equity site remediation (1990-97), the Southern Tail waste rock dump was resloped, and covered with 0.5 m of compacted, and 0.3 m of uncompact clay till to support a vegetation buffer, as illustrated in Figure 4-6 [3].

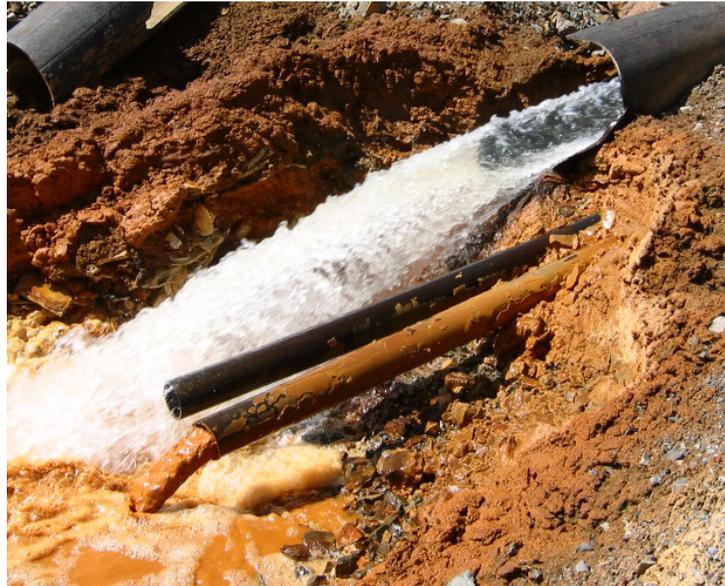
Figure 4-7 Treated Water and Sludge Discharge to Main Zone pit from HDS [9]

The ARD sludge from the HDS treatment plant is pumped from the plant and co-discharged into the Main Zone pit with treated water, as shown in Figure 4-7. While this co-discharge may seem to be counterintuitive, this method has proven to assist in moving the sludge into deeper zones of the Main Zone pit lake. The pit lake provides surge capacity needed to accommodate water discharge during the freshet period and for meeting water quality objectives in the receiver.

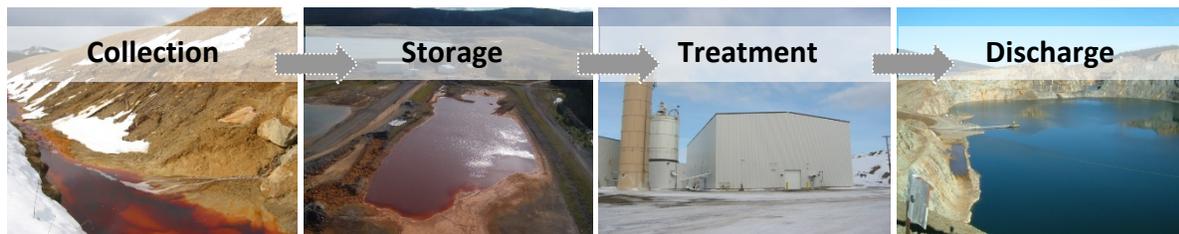
Figure 4-8 Movement of ARD from the Equity Silver Mine Site Through the ARD Collection and Treatment System to Disposal (Photographs [9])

Acid rock drainage emerging as surface seeps from the waste rock dumps flows into collection ditches surrounding the perimeter of the waste rock dumps, and subsequently flows into collection ponds and is pumped into a storage pond near the treatment plant (Figure 4-8) [3]. The waste rock dumps contributes 65% of the mine ARD volume but 94% of the site acidity; seepage from tailings pond Dam #1, accounts for 20% of the volume and 4% acidity, and the former plant site contributes 15% of the volume and 2% of the acidity [9]. Treatment is achieved by adding lime slurry in the HDS treatment plant to a pH of 8.5 and then pumping the sludge and treated water to the Main Zone pit.

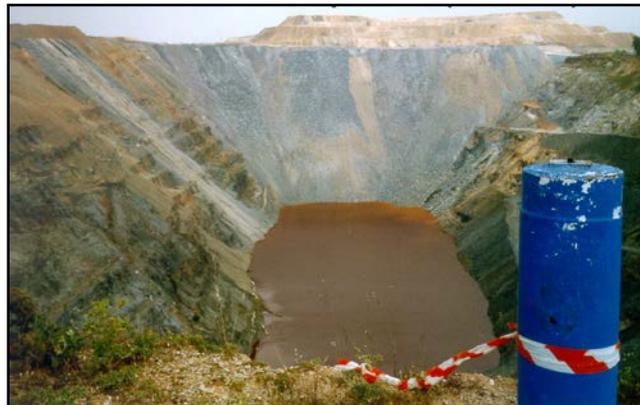
Figure 5-3 Los Frailes and Aznalcóllar Pits During Operation early 1998 [9]

The two Los Frailes mine site pits are of considerable size: the Aznalcóllar Pit measuring 1,200 m × 600 m × 275 m deep; and Los Frailes Pit measuring 800 m × 600 m × 265 m deep (Figure 5-3). The mine site is located at the eastern end of the Iberian Pyrite Belt, a 230 km-long east-west mineral belt, well-known for its massive sulphide deposits. The deposits are in rhyolite-hosted pyroclastics as either mineralised pyroclastics or pyritised zones [9].

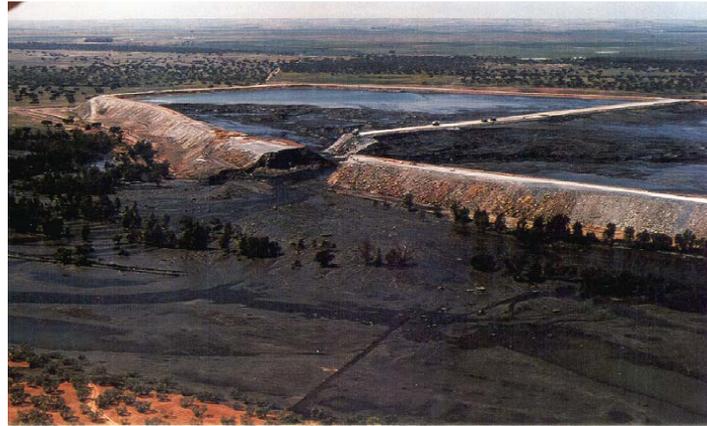
Figure 5-4 Photograph of Tailing Impoundment Wall Breach Looking Southwest [11]

Approximately, 7.8 Mm³ of spilled tailings and contaminated soils were deposited into the Aznalcóllar pit in 1998-9 after the failure of the tailings dam (Figure 5-4). The pit had been used as a disposal site for a number of waste materials including acid seepage from waste rock piles after 1995. Waste rock from the adjacent Los Frailes pit (~ 18.2 Mm³) was dumped into the pit from 1995 to 1998.

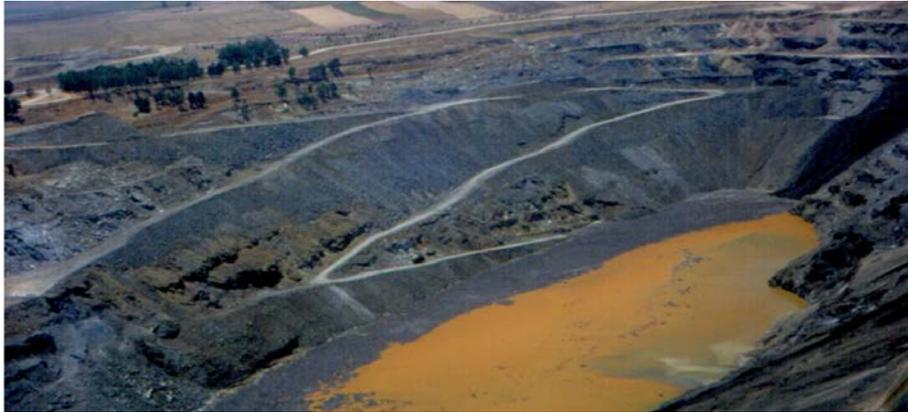
Figure 5-6 The Aznalcóllar Pit Being Filled with Recovered Tailings (G. Feasby, 1998)

Before the tailings spill, some small amounts of waste materials including waste rock, contaminated soils and industrial wastes (scrap metal and concrete) had been dumped into the Aznalcóllar pit (Figure 5-6 and Figure 5-7). The major pit filling resulted from the emergency created by the tailings release.

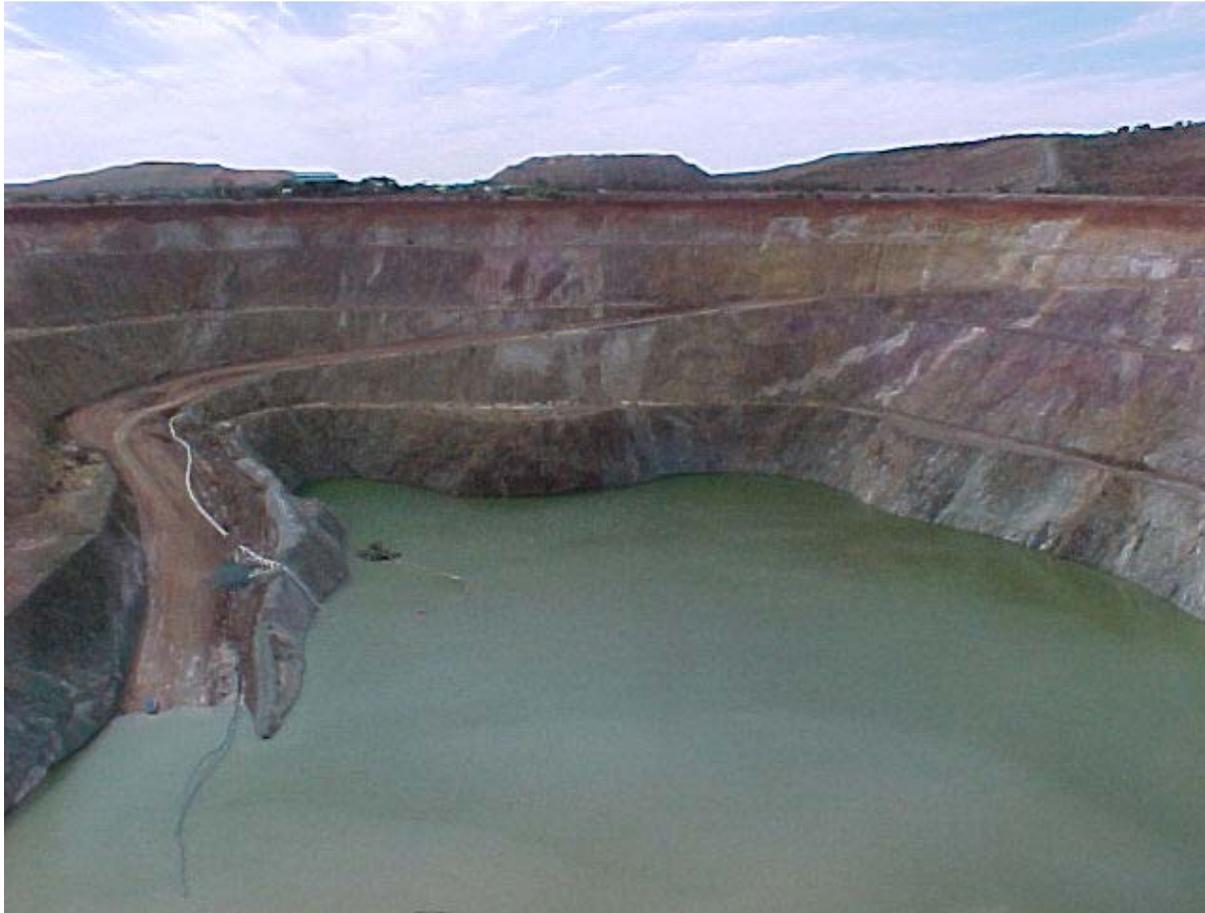
Figure 7-6 Fisher Pit Partially Filled with Tailings (R. Hague, 2005)

There is no discharge of process or tailings water at Jundee. The Fisher in-pit facility is unlined, but has several recovery bore sites down gradient to intercept any seepage [1]. In 2007, the Fisher Pit Recovery Bores were re-drilled to increase potential water recovery from the Fisher Pit. Jundee incorporated a management practice of bore rotation in the village potable and mine water supply system to ensure specific areas of the aquifers are not being over-stressed [7].

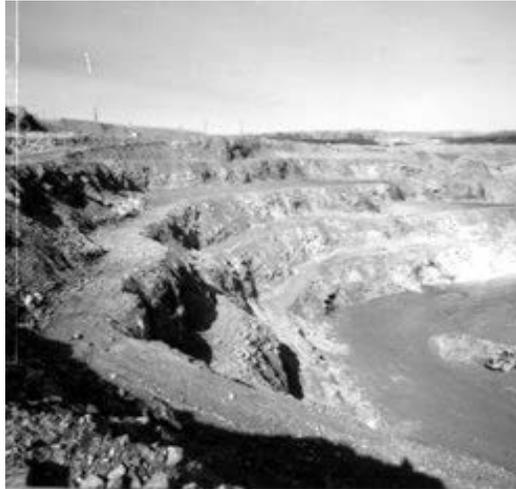
Figure 9-3 Rabbit Lake Pit during Operations in 1979 (Sask. Gov't # 1453-232) [5]

The original Rabbit Lake open pit surface dimensions were approximately 460 m by 365 m with a maximum depth of about 122 m [28]. The pit was mined by conventional methods from 1975 to 1984, and had a low inflow of mine water (about 25 m³/hr). Figures 9-3 to 9-5 depict pit conditions during and post mining of the Rabbit Lake open pit.

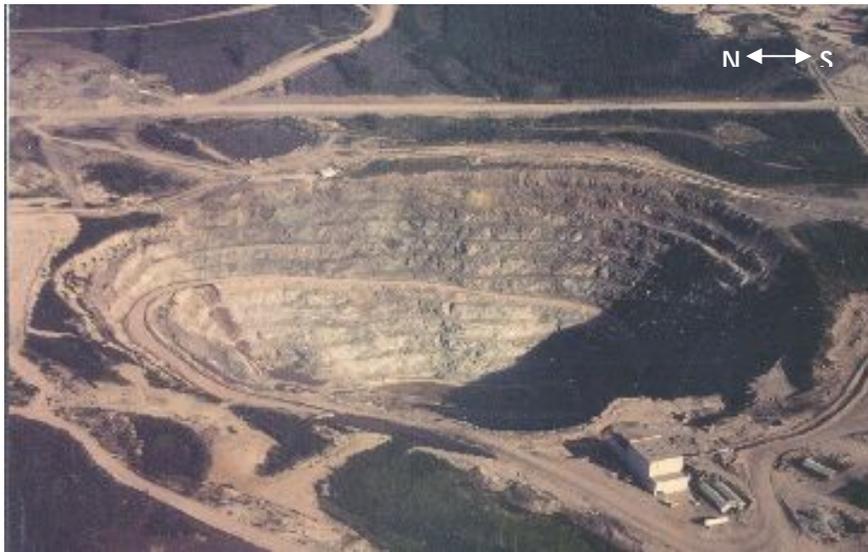
Figure 9-4 Rabbit Lake Pit at the Start of Tailings Deposition in 1985 [27]

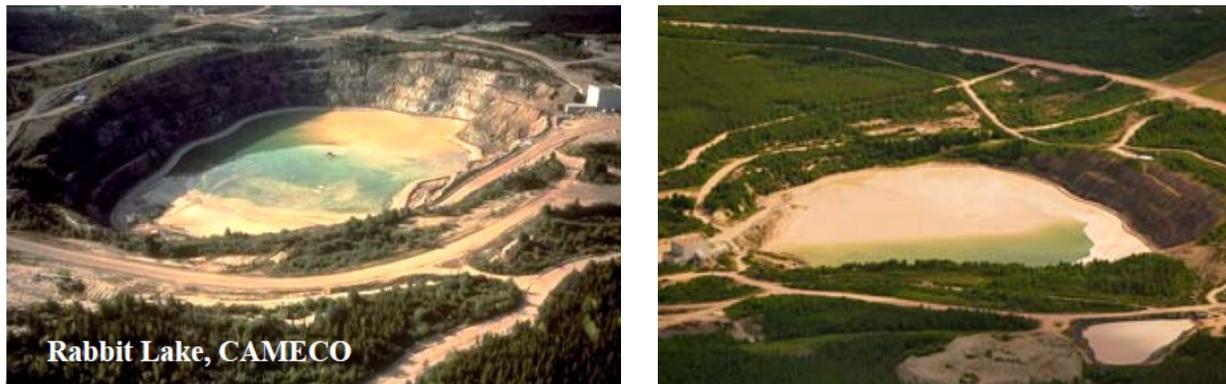
Figure 9-9 Rabbit Lake During Tailings Filling in 1992 (left) and in 2009 (right) [28][2]

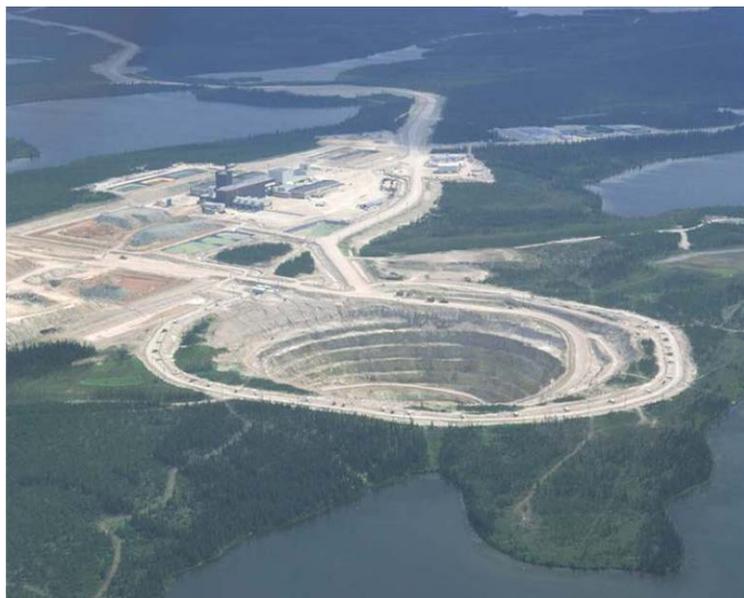
Figure 10-4 Aerial view of JEB Pit before Filling [22]

The mined out JEB pit had a volume of 4.8 million m³, with a maximum diameter of 420 metres and a depth of 118 metres. Figure 10-4 shows the JEB pit when mining was completed, before the pit was backfilled. Figure 10-5 shows a later illustration of the site with a partially filled pit, (Figure 10-6 shows the site plan). Three important aspects of the facilities are shown – (1) mill is in close proximity to the JEB pit, (2) the footprint of the facilities is relatively small and (3) the facilities are surrounded by lakes.

The Saskatchewan provincial regulatory authorities have a preference for uranium mines, that no new separate above ground tailings storage facilities would be considered, making in-pit disposal of uranium mine tailings the preferred strategy. This preference is reinforced by the technical advantages in isolating both reactive tailings and waste rock in mined-out pits. One of the challenges at McClean was to design in-pit tailings and waste rock disposal systems that would isolate the contained heavy metals, arsenic and radioactivity present in tailings and mineralized waste rock. McClean pits including the JEB pit are in close proximity to local lakes (see Figure 10-4) and the sandstone pit walls are hydraulically conductive.

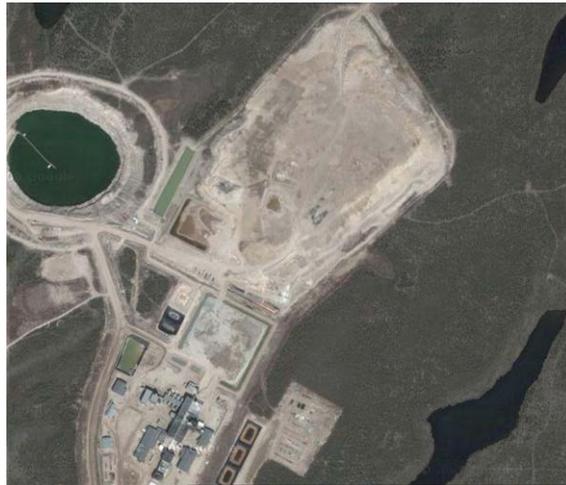
Figure 10-5 View of JEB open pit tailings (from Google)

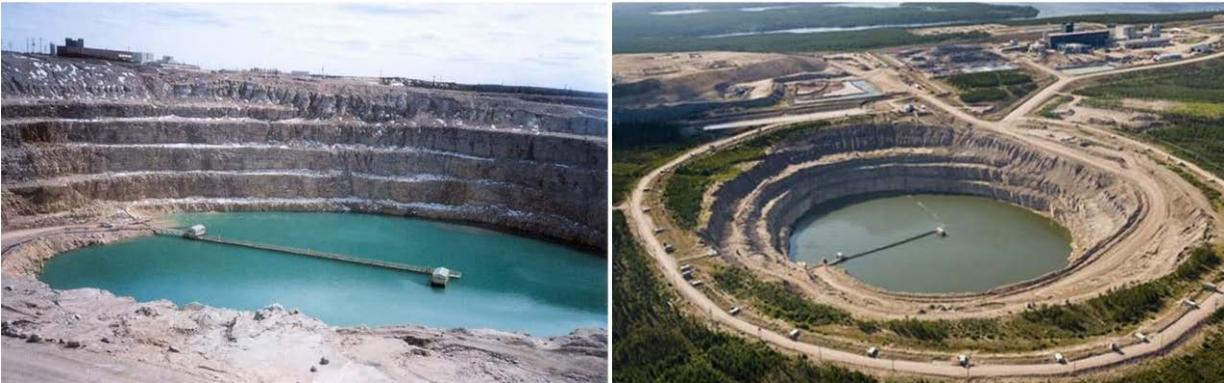
Figure 10-9 JEB Tailings Management Facility [19] [7]

The ability to use subaqueous deposition is important for tailings produced from high grade uranium ore because it provides shielding from gamma radiation, blocks radon emanation and prevents frost entrainment which has been observed during the surficial discharge period at the Rabbit Lake in-pit uranium tailings facility. In addition, dust dispersion, especially from freeze drying in winter, is eliminated. It was decided that the tailings would be deposited using a tremie pipe under a cover of water that would be deep enough to absorb most of the radiation emanating from the material. The pipe would be suspended from a floating barge shown in Figure 10-9 below.

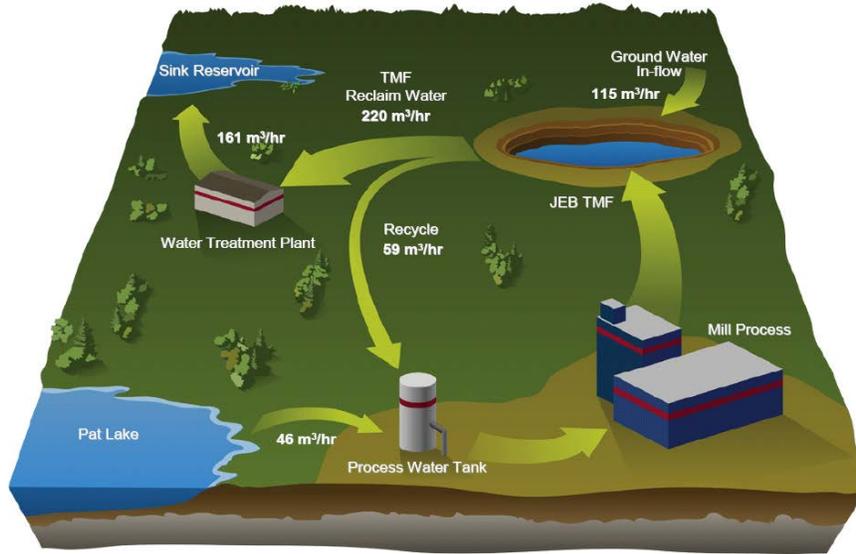
Figure 10-12 Water balance summary within the McClean Processing Facility [19]

As shown in Figure 10-12, TMF reclaim water is a major component in the mill site water balance. Both the JEB TMF and Sue C site have active treatment plants Lake Mine effluent data collected between 2004 and 2011 show contaminant levels far below Canadian Metal Mine Mining Effluent Regulations as seen in Figure 10-13(a,b,c).

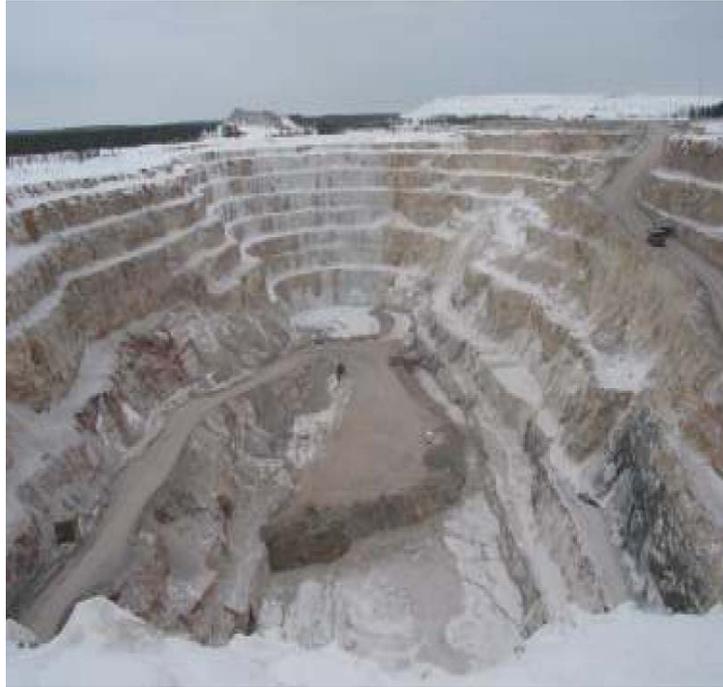
Figure 10-18 Waste Rock Placement in the Sue C Pit [22]

The Sue C pit has been used for disposal of mineralized or ARD waste rock (Figure 10-18 and Figure 10-19) [22]. Mining of the Sue C orebody was completed in February 2002 and all of the ore was stockpiled on the surface. Low grade special waste from the mining of JEB, Sue C, Sue A, Sue E and Sue B deposits were disposed of in the mined-out Sue C pit. The Cigar Lake joint venture also has an agreement to dispose in the Sue C pit special (mineralized) waste from

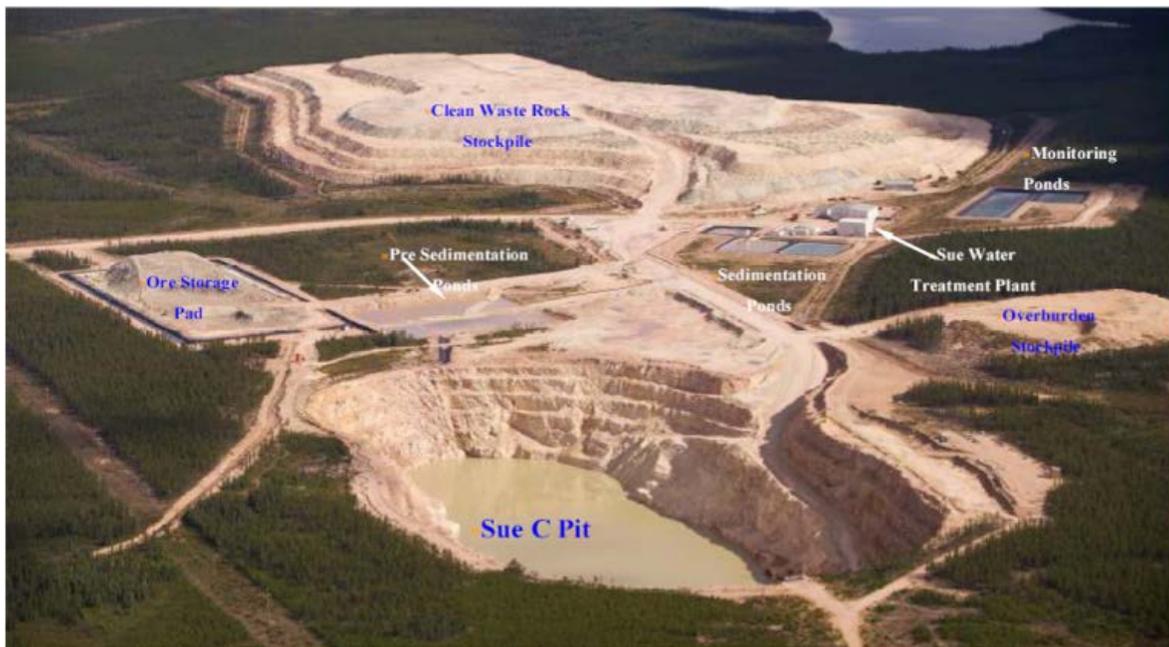
Figure 10-19 Water-covered Waste Rock in the Sue C Pit [22]

the underground mining development and future operations (1.3 Mm³ has been placed in the pit from Cigar Lake as of September 2010 [27]) [7]. For the short term the waste rock is being maintained under water to reduce metal leaching and ARD, but will have a compacted till diffusion barrier between the water cover and wastes for the long term. (Figure 10-20).

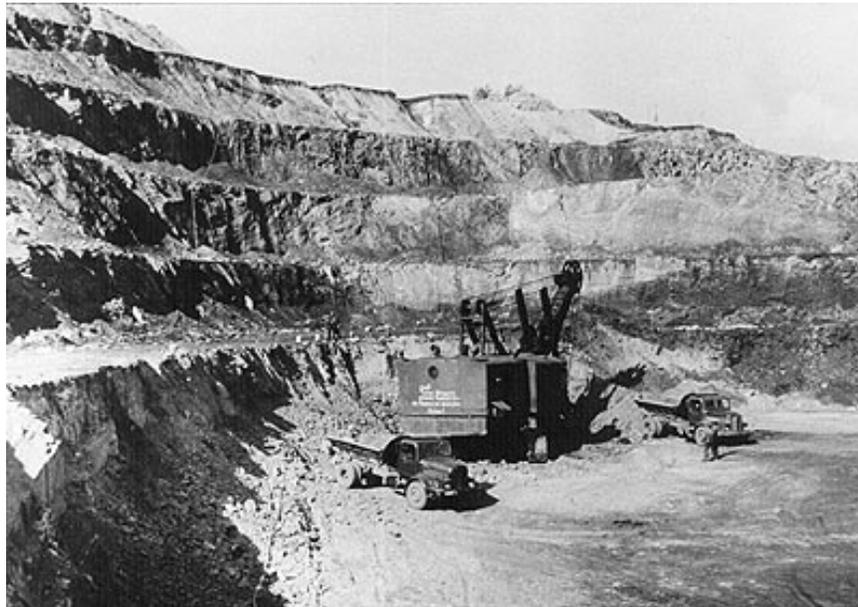
Figure 11-5 Lichtenberg Open Pit Mine During Production, circa 1960's [30]

Engineered cells within the pit body accommodated contaminated soils from the Ronneburg remediation. These cells were also used to immobilize water treatment residues from the Ronneburg water treatment plant [5]. Figures 11-5 and 11-6 below show the Lichtenberg pit during operations.

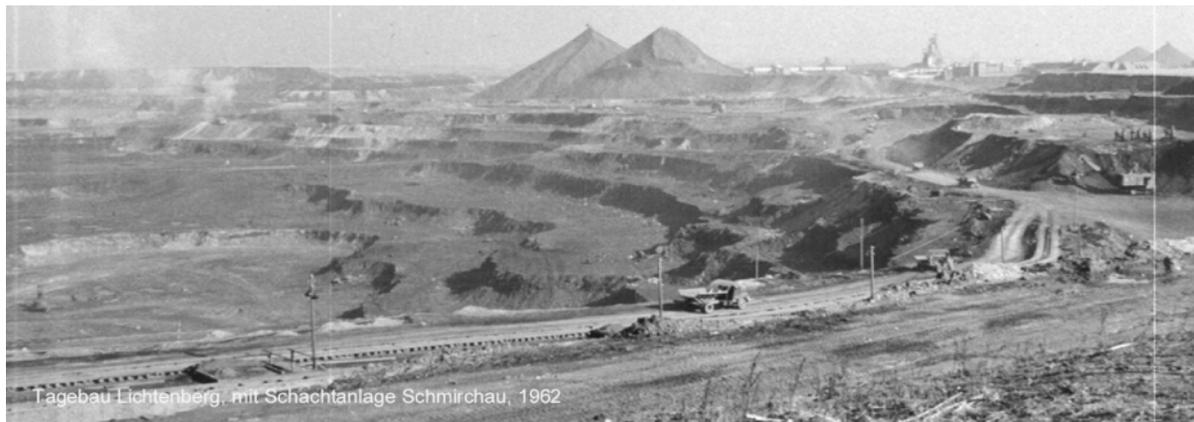
Figure 11-6 Lichtenberg Pit in 1962 [20]

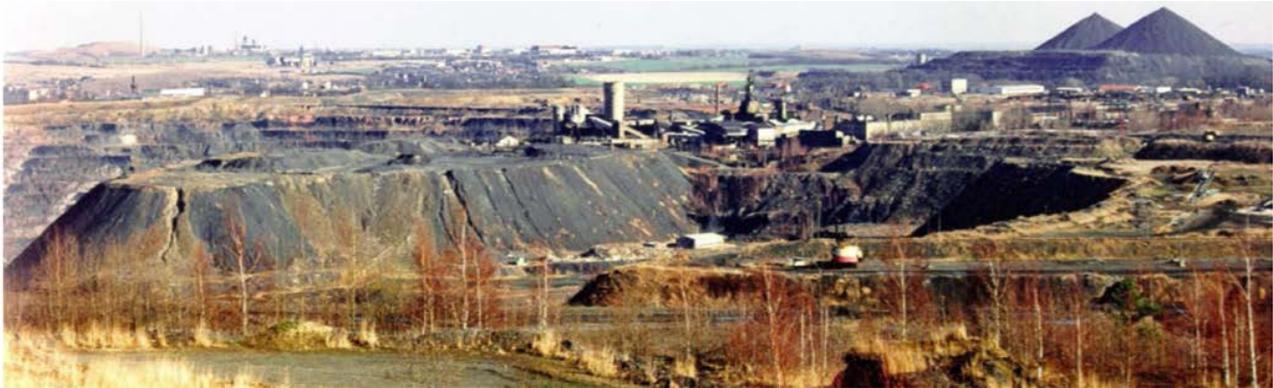
Figure 11-8 Partly Backfilled (with Innenkippe pile) Lichtenberg Pit and Ronneburg Mine Site Before Remediation [20]. (Note waste rock piles in the background).

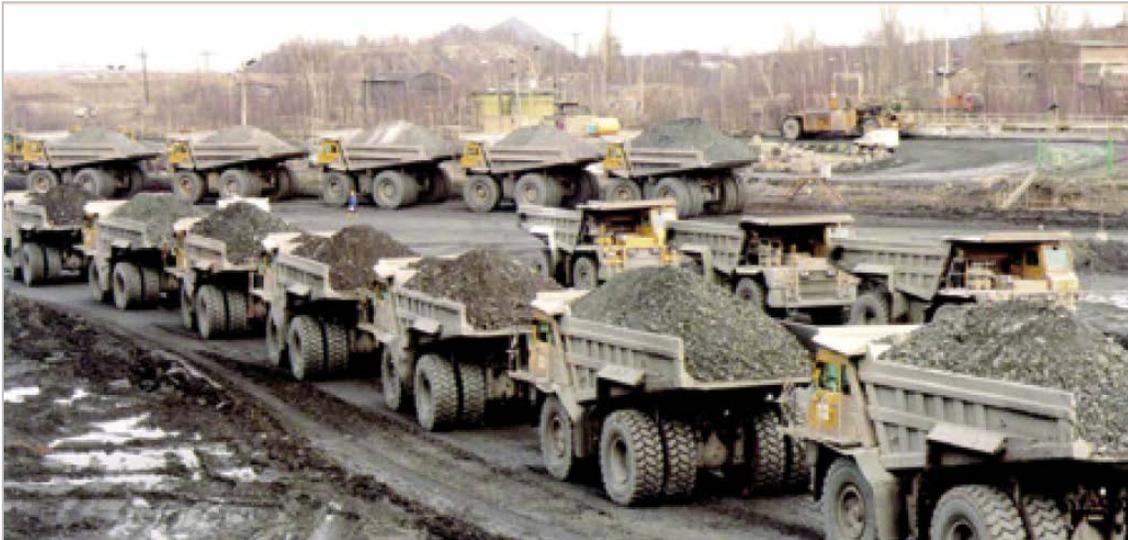
Figure 11-9 A Truck Fleet Used During the Waste Rock Pile Relocation into the Lichtenberg Open Pit (1998) [5]

From 1990 until 2008 a total volume of 131 Mm³ of waste rock and related mine waste had been placed into the pit [24]. To handle such volumes of waste rock efficiently, the largest fleet of Caterpillar equipment in Europe was put to work at Ronneburg (Figure 11-9).

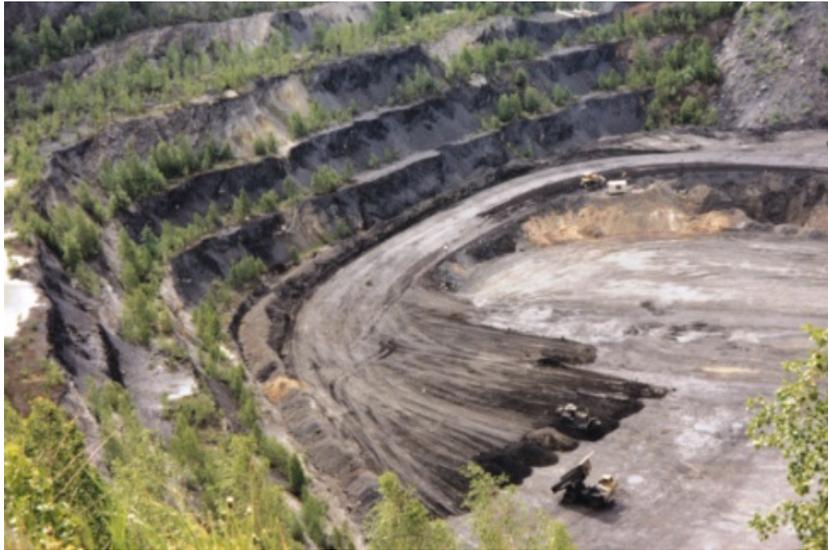
Figure 11-10 Early Stage of Backfilling the Lichtenberg Pit (1990, G. Feasby)

The annual volume relocated from 1996 to 2006 was approximately 10 Mm^3 at a rate of $40,000 \text{ m}^3$ of waste rock per day. The waste rock relocation was carried out by two fleets of dozers (CAT D1 IN), front-end loaders (CAT 994B) and heavy haul trucks (CAT 785 and 773) (Figures 11-10 and 11-11). The scale of the equipment and the target productivities made the relocation very similar to medium scale open pit mining [12].

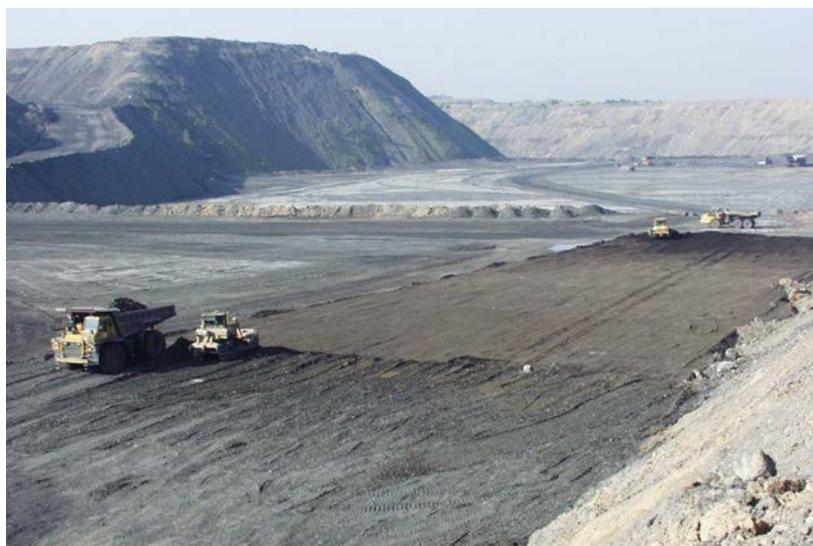
Figure 11-11 Advanced Stage of Pit Backfilling (2002, M. Paul) [16]

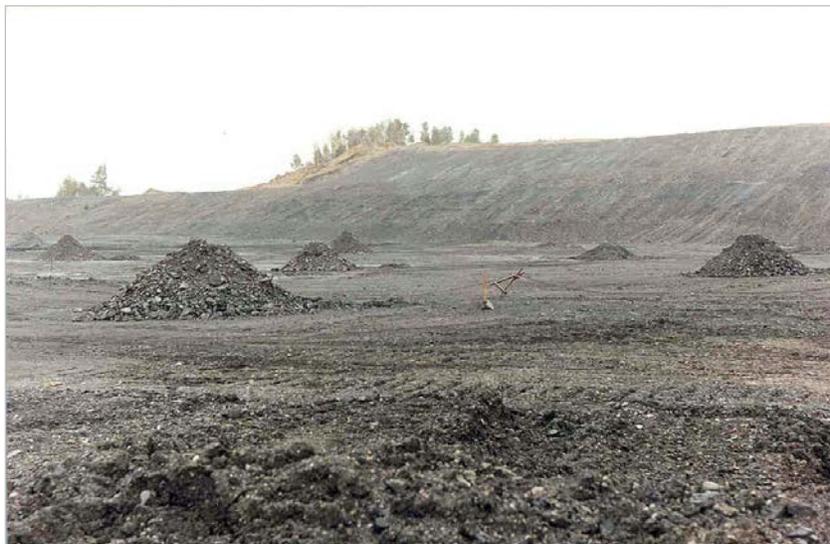
Figure 11-13 Test Pits on one of the Waste Piles in a 25 m by 25 m Grid [18]

To optimize pit backfilling of waste rock destined for Zones A, B and C within the pit, the relocation was planned and controlled with methods similar to those used for grade control in open pit mines. Long-term and medium-term planning used waste pile drill hole data and "kriging" estimates. Short-term planning was carried out one to three months ahead of actual backfilling, and included a detailed delineation of material types in terms of their acid generating potential. To provide the information needed for the more detailed delineation, test pits were excavated on a 25 m grid and samples were characterized using the paste pH and NAP (net acid potential) pH methods. Where quicklime (CaO) addition was required, a paste conductivity correlation was used to estimate lime addition rates. In general, the relocation was carried out according to the short-term plan. Quality control samples were also taken from the excavation face to confirm material classifications and to allow correction of the short term plan where necessary [12].
