**In-Pit Disposal of Reactive
Mine Wastes: Approaches,
Update and Case Study
Results**

MEND Report 2.36.1b

June 2015

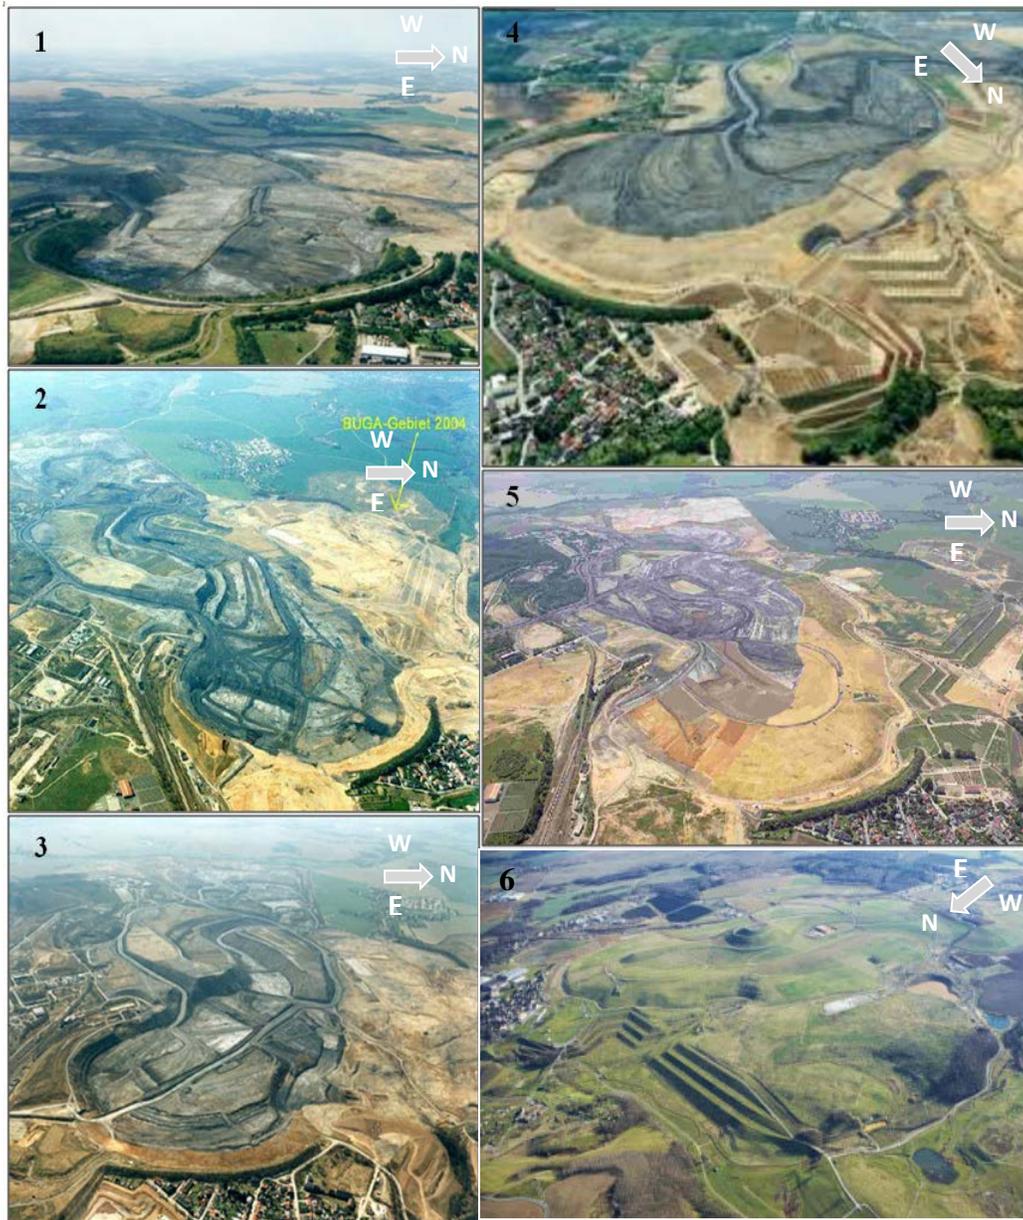
Figure 11-17 Lichtenberg Pit During Remediation - (1) in 2002 [7]; (2) & (3) During Back Filling [30]; (4) in 2005 [14]; (5) in 2006 [19] and; (6) in 2010 [1]

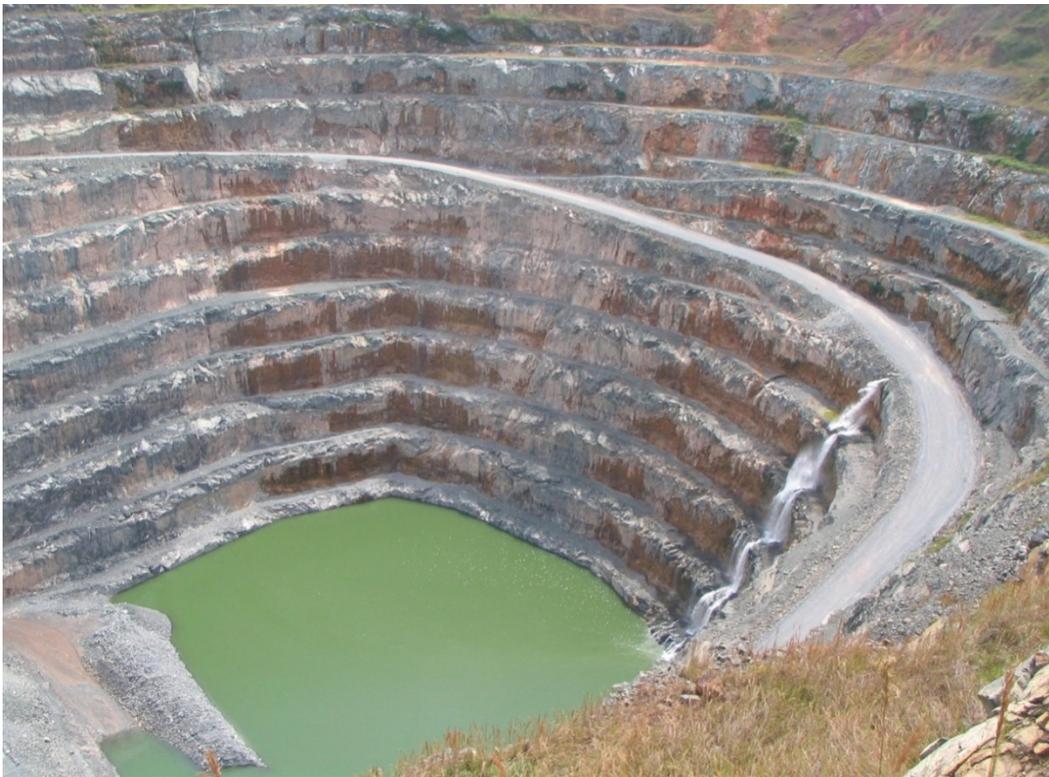
Figure 12-6 Transfer of In-Pit Tailings Decant Water into the Mined-out Fennel Pit

The third application of in-pit disposal at Omai was the transfer water from the Wenot in-pit tailings disposal facility while a low grade ore stockpile was being processed. This allowed Omai to maintain pit waters, which had significant concentrations of suspended solids, ammonia and cyanide complexes (cyanide and cyanate), below the predetermined level. The water transfer is shown in Figure 12-6.

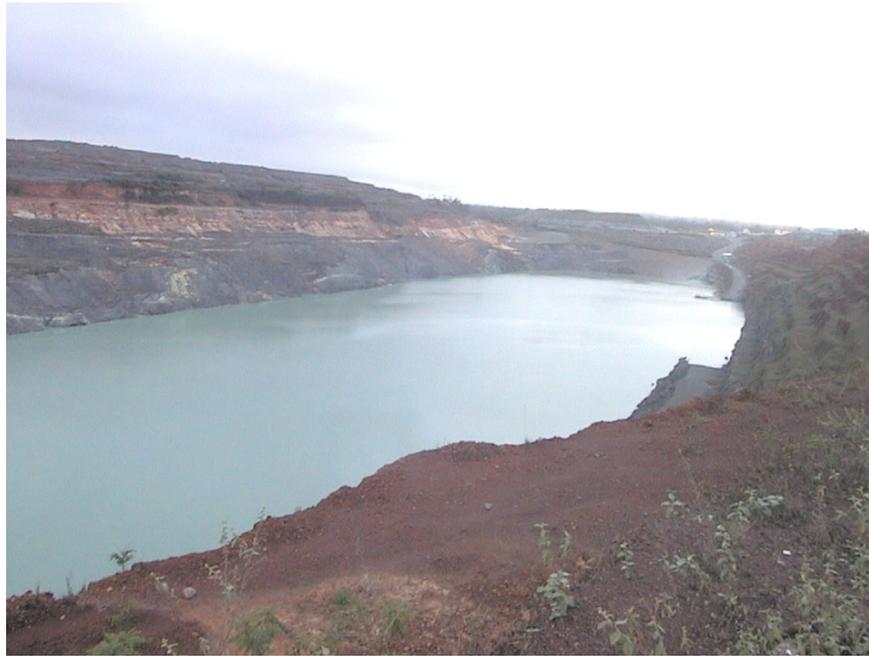
Figure 12-7 Wenot In-Pit Tailings Disposal after Mill Shutdown

Activity 2, the in-pit disposal of tailings in the Wenot Pit, supplemented by relocation of decant waters to the Fennel Pit, met conservative long term tailings disposal objectives and provided for natural degradation of cyanide to meet very stringent discharge water quality objectives. The completed in-pit disposal is show in Figure 12-7.

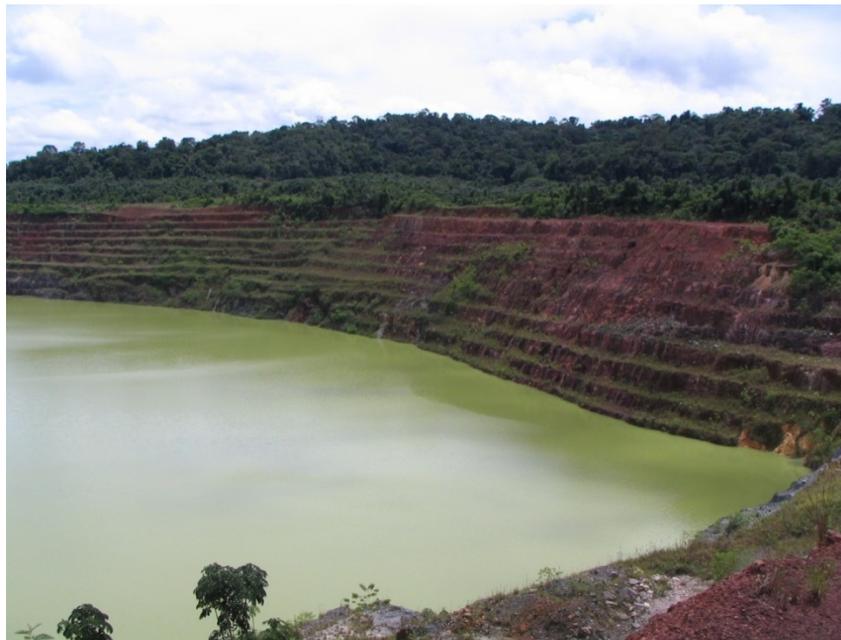
Figure 12-9 Nitrogen-enhanced Algal Activity in Closed Out In-Pit Tailings Facility

The ammonia promoted algal activity in the pit lake as indicated in Figure 12-9. This phenomenon is observed to be unusual in tropical waters that are typically nutrient poor. Biological activity included birds, amphibians, and cayman (species similar to alligator) and capybaras (the world's largest rodent) were observed drinking the pit lake water.

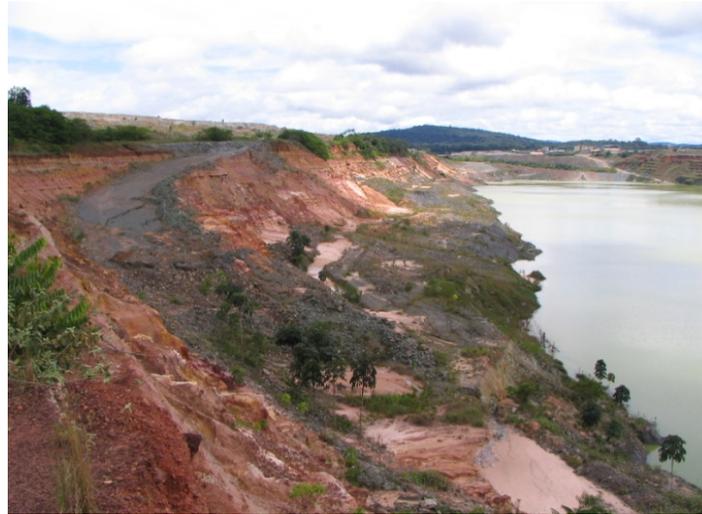
Figure 12-10 Slumping South Pit Wall – Wenot Pit

As commonly experienced with many pits when a pit lake forms, pit walls that are stable during mining can be destabilized as a result of increased phreatic pressures in the pit walls as water levels rise. This was the case on the south side of the Wenot facility, as shown in Figure 12-10, where hydraulically conductive sands were present. On the north side, which was composed of saprolite/laterite earth, the slopes remained stable, with vegetation self-established, as shown Figure 12-11.

“Regular sampling of the pond water at previously established monitoring locations indicate that the Wenot Pit lake water meets direct discharge criteria”; “it is considered that the Wenot Pit lake water level will likely stabilize in the Berbice Sands above the 488 metre elevation”; “at the time of our recent inspection, the laterite/saprolite benched along the north wall of the Wenot Pit were performing satisfactorily... with relatively minor sloughing observed. The Berbice sands in the south wall have generally sloughed and/are slumped to or near a natural angle of repose - additional sloughing or slumping can be
