**A Review of Non-
Traditional Dry Covers**

MEND Report 2.21.3b

*Dr. M.D. Haug, Ph.D.
Gordon Pauls, M.Sc.
Dept. of Civil Engineering,
University of Saskatchewan*

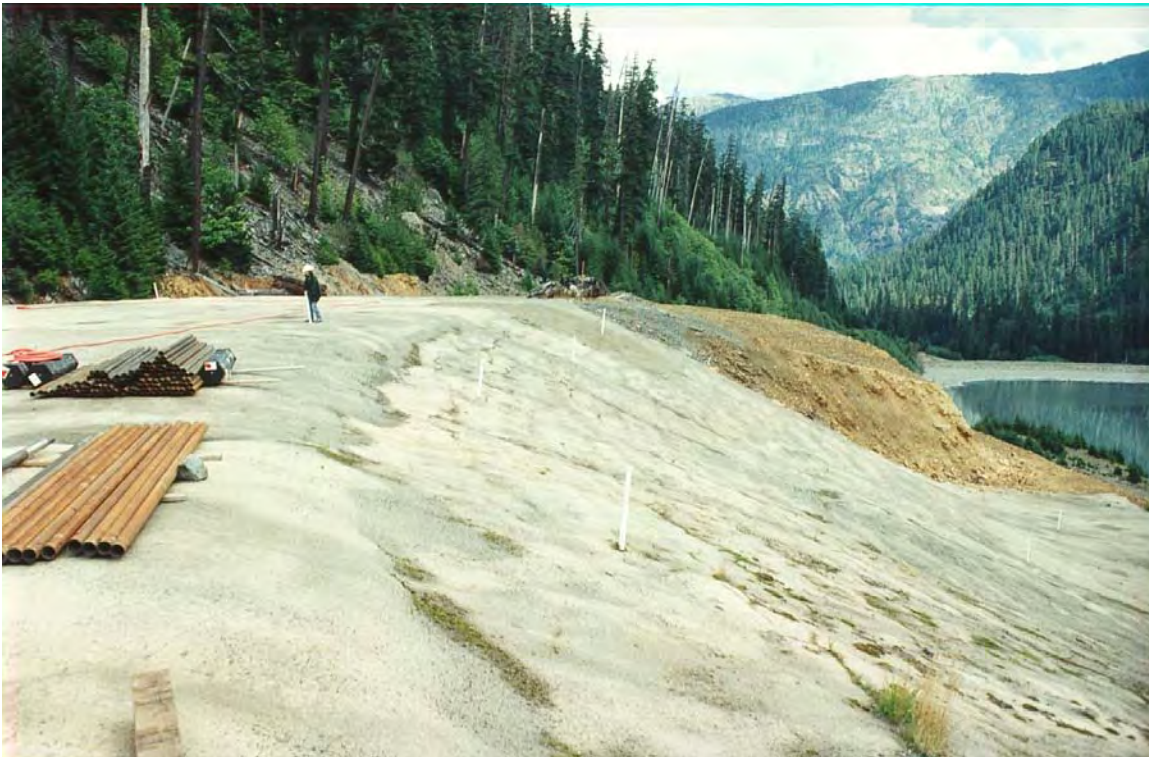
Fig. 3.1. View of Myra Falls Shotcrete Cover showing sharp change in slope (Photo by M.D. Haug).

The robotic application system appeared to produce good quality application with high rates of productivity and a uniform of placement of shotcrete. Difficulties encountered have led to suggestions for design modifications for the robotic system. The shotcrete material exhibited good compressive strength and moderate ductility as measured by laboratory tests. The cover was intact and functioning well one year after application (Jones and Wong, 1994). Some shrinkage cracks were observed immediately after

application; however, the cracks did not appear to have expanded after one year of exposure. Some reduction in compressive strength was observed in the shotcrete after 400 days and this was attributed to oxidation of the sulfide minerals in the mine tailings materials used in the shotcrete. The mine tailings at Myra Falls have high sulphur content. The study did not evaluate the effectiveness of the cover in restricting acid generation in the waste rock. Site inspections carried out in 1997 and 1998 found that this cover was intact, however, cracking appeared to be progressing on the steeper sections of this cover.

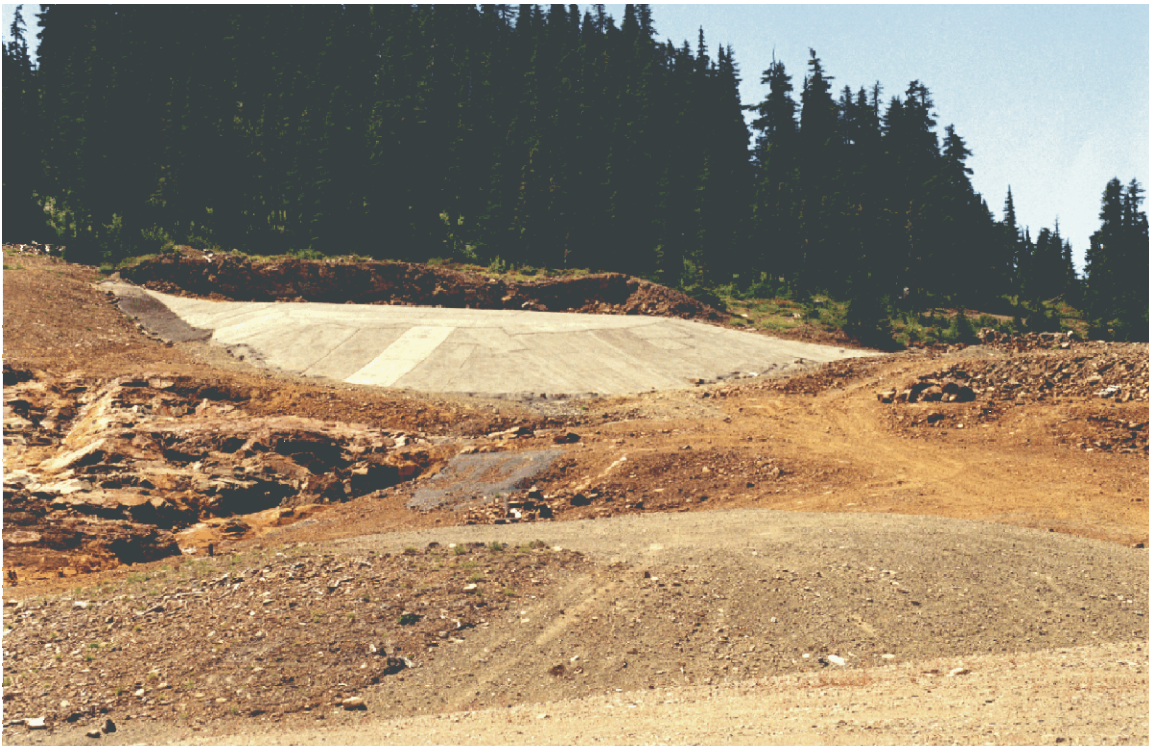
Fig. 3.2. View of Mount Washington Shotcrete Test Cover (Photo by M. D. Haug).

many different tests to control acid generation, approximately 2300 m³ of waste was recontoured and encapsulated with a 40 - 50 mm thick layer of polypropylene fibre reinforced shotcrete in 1991 (Seabrook, 1992). As a result of the different capping scenarios, the rate of copper leaching from the site in the spring of 1992 was reduced by an estimated 15% (Galbraith, 1993). The Mount Washington project has been put on hold at present, however, inspection carried out in 1998 and 1999 (Figure 3.2) indicate that the fibre reinforced shotcrete cap is in relatively good shape.

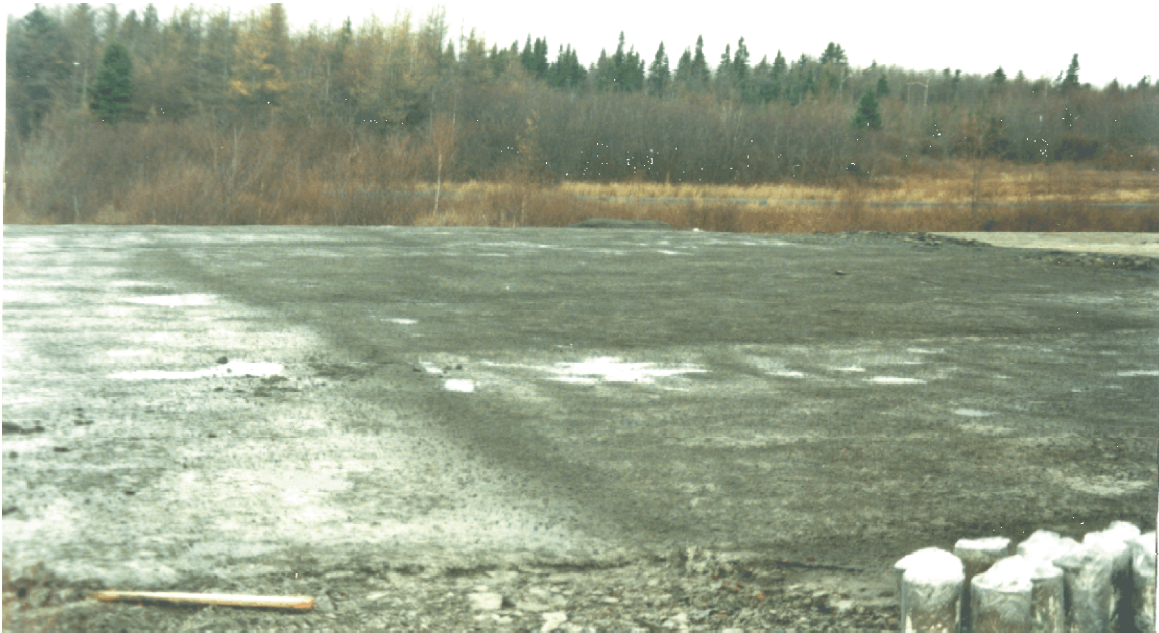
Fig. 3.3 – Halifax Shotcrete Test Covers (Photo by M. D. Haug).

Figure 3.3 shows a section of the test covers a few weeks after construction. According to Langley (1991) crack repair may not be necessary unless very low hydraulic conductivity is required. Crack repair would be labour intensive and costly. Elastomeric

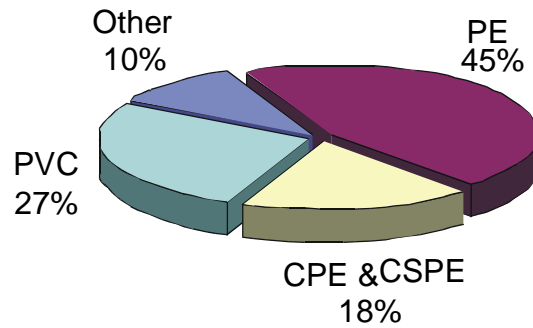
Fig. 4.2. Geomembrane use in North America (Sadlier, 1993).

An indication of relative usage of different types of geomembranes in North America is given in Fig. 4.2. Polyethylene has been established as the most frequently used polymer for geomembranes, largely because it has good resistance to chemical exposure, low cost and ease of seamability.

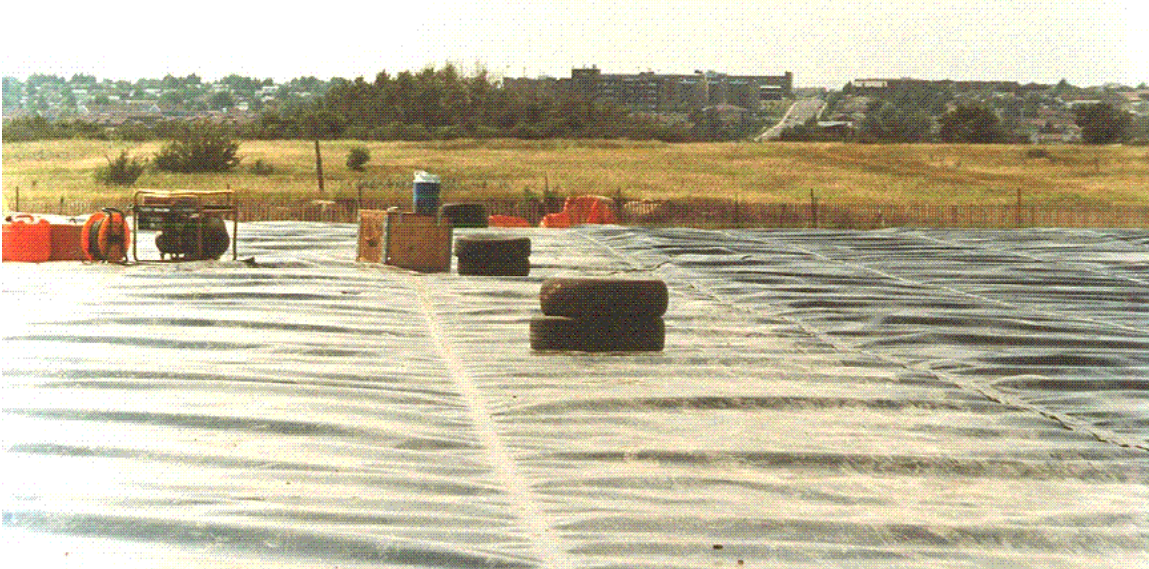
Fig. 4.8 – Construction of U of S Chemical Landfill Cover (Photo by M. D. Haug).

a 40 mil sheet of HDPE sandwiched between two layers of compacted till (300 mm each) (Figure 4.8). Finally, the upper compacted till layer was covered with 500 mm of topsoil and seeded to grass. Surface slopes of the cover were 50H:1V on the top of the cap and 3H:1V along the sides of the cap.

The 40 mil thick HDPE liner consisted of ten individual rolls, welded together on site to form a continuous barrier. Stringent quality control was enforced to ensure integrity of the welded seams. Initial testing of a weld consisted of performing a peel test on small sections of the weld which had been removed. If areas selected for testing failed, the entire weld was pulled apart and rewelded. After passing the peel test, the weld was subjected to 25 psi of air pressure, which had to be maintained for 30 minutes. Any leaks detected were repaired by bonding a patch with an extrusion weld. Placement of the HDPE geomembrane and compaction of the till on top of the geomembrane were restricted to the mornings, in order to prevent thermal expansion of the geomembrane in the warmer afternoon air.

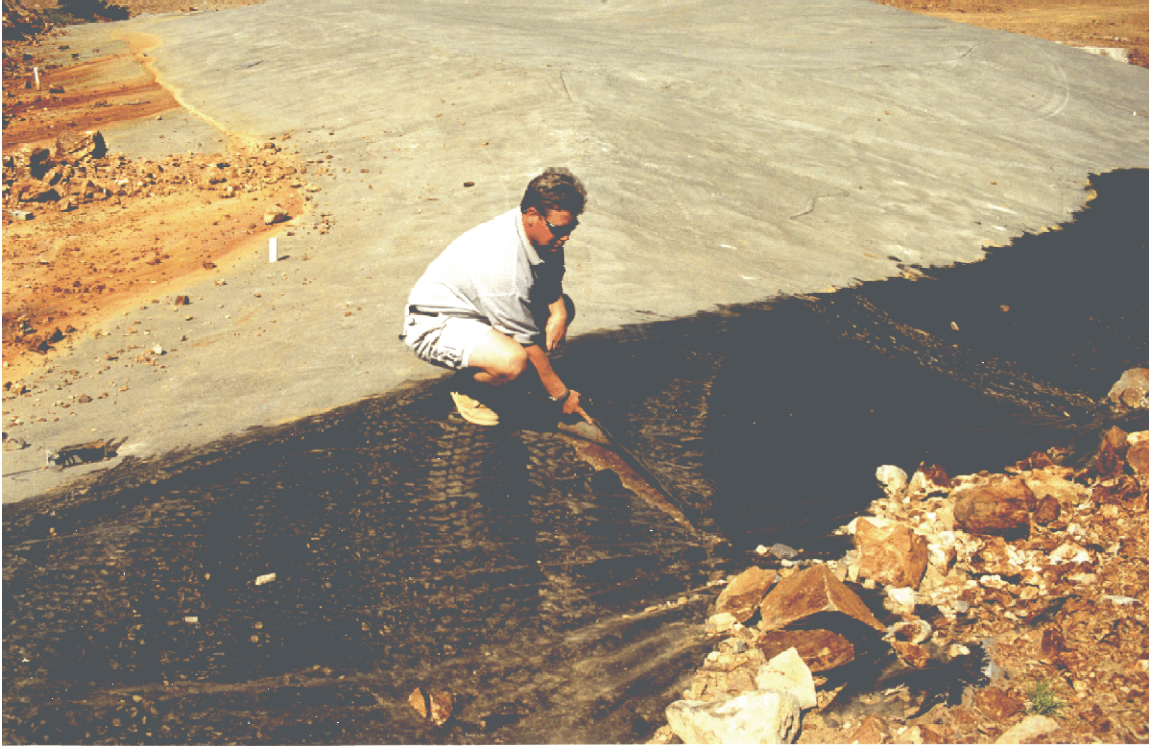
Fig. 4.13 – Asphalt emulsion/ geotextile waterproof membrane (Photo by M. D. Haug).

An asphalt emulsion/geotextile waterproof membrane was placed in a 1991 pilot program on the surface of acid generating waste at Mount Washington, to inhibit infiltration (Galbraith *et al.*, 1992). Figure 4.13 shows a view of the cover taken in 1999. Material costs of the asphalt emulsion/geotextile membrane were about \$5 Cdn per square metre. Galbraith (1993) found that although the use of the asphalt emulsion/geotextile membrane held promise for providing the strength, low cost and flexibility essential for a waste cover, it was difficult to construct. Galbraith (1993) recommended that because asphalt is not a material amenable to hand work, further use of this type of cover should await development of a mechanical application method. Transportation of the material to this particular site is also a challenge.

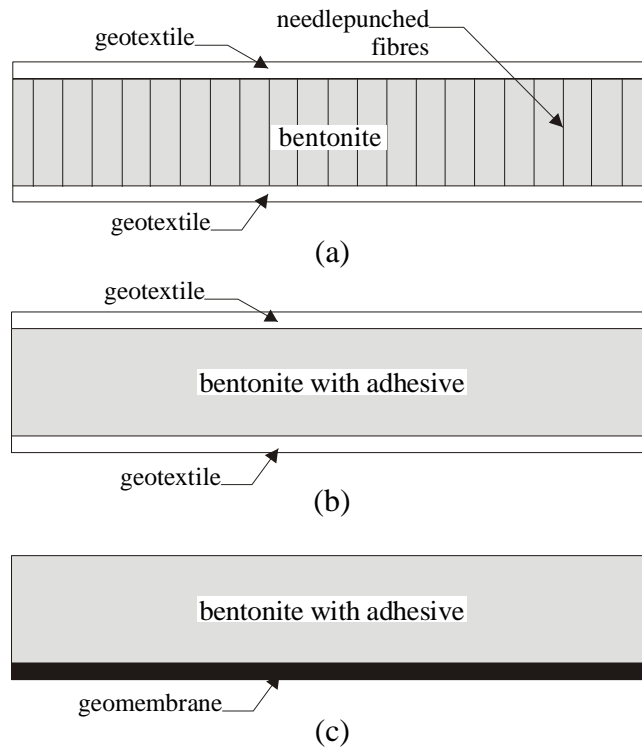
Fig. 4.14. Schematic diagram of three geosynthetic clay liner configurations.

GCLs are manufactured in two configurations, bentonite sandwiched between two geotextiles (Figs. 4.14a & b), and bentonite mixed with an adhesive and glued to a geomembrane (Fig. 4.14c). With the case of bentonite sandwiched between two geotextiles, the bentonite may be held in place either by needle-punched fibres (Fig. 4.14a) or by mixing the bentonite with an adhesive (Fig. 4.14b). Needle punching is done to contain the bentonite, as well as to enhance the in-plane shear strength. GCLs typically contain between 3 and 6% bentonite per square metre, and are manufactured in widths of 4 to 5 m. GCLs are typically 7 to 10 mm thick in their hydrated state.

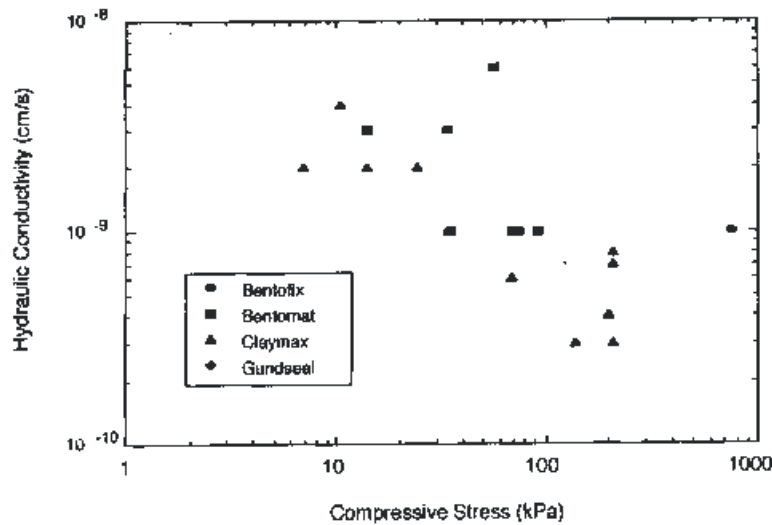
Fig. 4.15. Hydraulic conductivity of geosynthetic clay liners as a function of compressive stress (Daniel, 1993a).

Daniel (1993a) presented a summary on the hydraulic conductivity data of GCLs (Fig. 4.15). The hydraulic conductivity of GCLs was found to vary between 10^{-12} and 10^{-10} m/s, depending on the compressive stress. Estornell and Daniel (1992) conducted bench scale (2.4 m x 1.2 m) hydraulic conductivity tests on individual and seamed sheets of GCLs. Except for the case where low (< 7 kPa) vertical effective stress was employed, the hydraulic conductivities of overlapped materials were almost identical to values measured on control samples with no overlap.

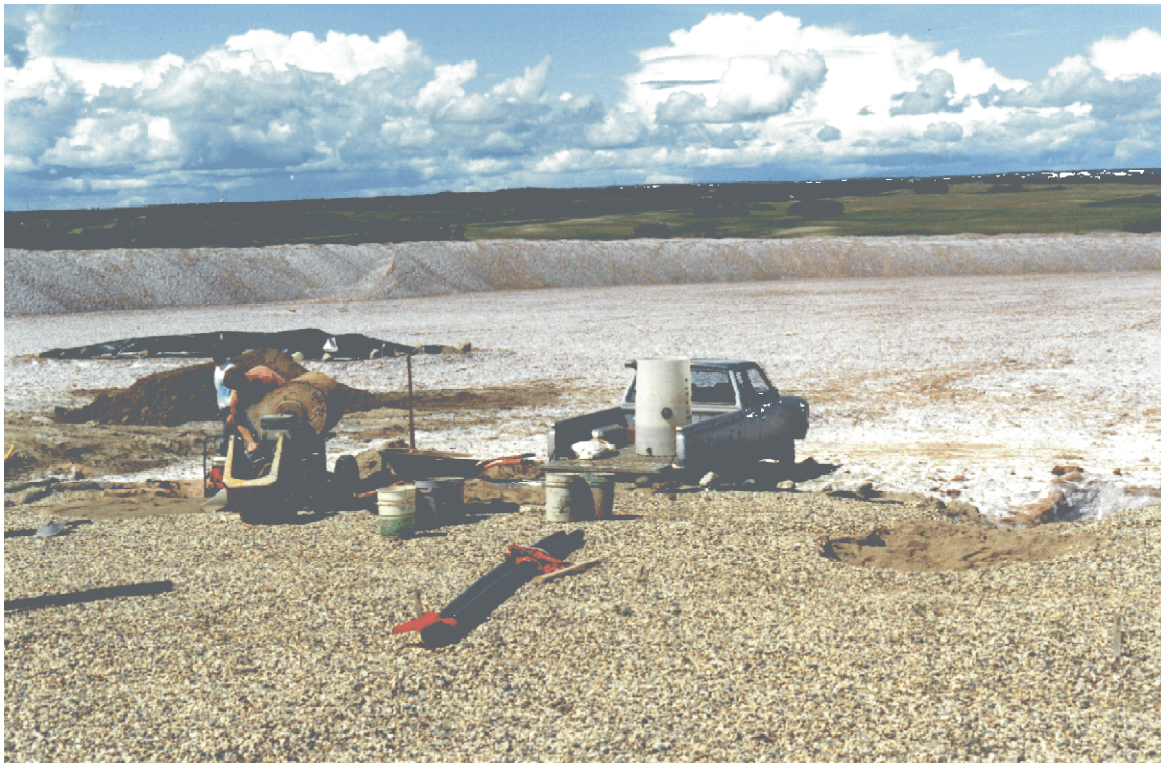
Fig. 5.2 – Repair Work on the Soil Bentonite Test Cover at the Patience Lake Potash Mine in Saskatchewan (Photo by M. D. Haug).

The most significant problem associated with the sand-bentonite test cover at Patience Lake was erosion along the outside perimeter. Erosion was largely the result of dissolution of tailings, resulting in large holes (up to 10 m deep) which had eroded back and undercut the test cover (Haug *et al.*, 1994). Repairs were necessary and the holes were filled with tailings. Repairs were also made to the perimeter of the cover.
