**EVALUATION OF THE USE OF  
COVERS FOR REDUCING ACID  
GENERATION FROM  
STRATHCONA TAILINGS**

**MEND Project 2.25.3**

**EVALUATION OF THE USE OF COVERS  
FOR REDUCING ACID GENERATION  
FROM STRATHCONA TAILINGS  
7777-112  
MEND Project 2.25.3**

Final Report

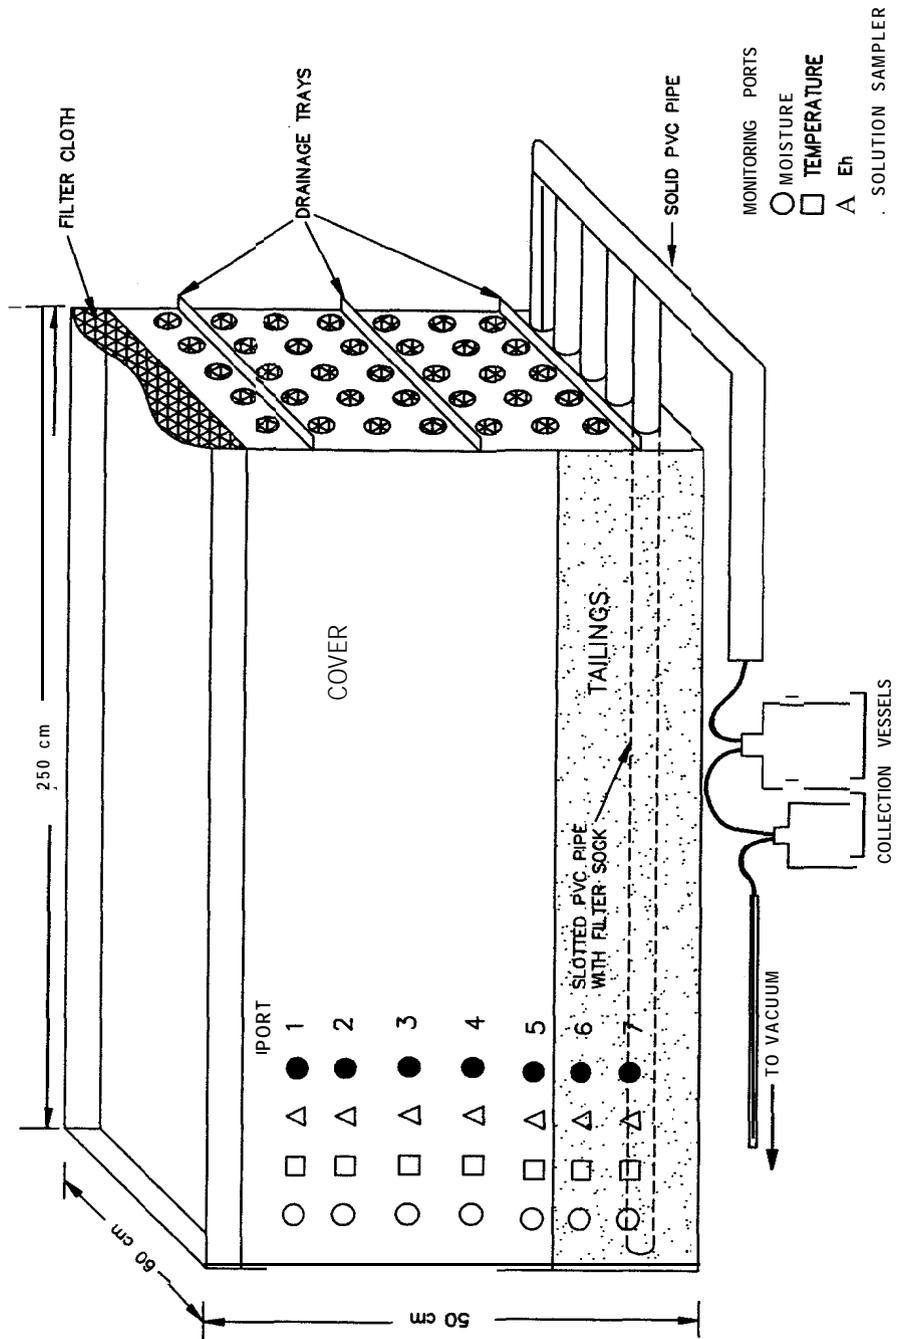
**Fig 3 Pi C Schem**

Seven sets of sampling ports and monitoring sensor ports were installed vertically in the Plexiglas™ side of the cells, to allow for the collection of pore water profiles and sensor data

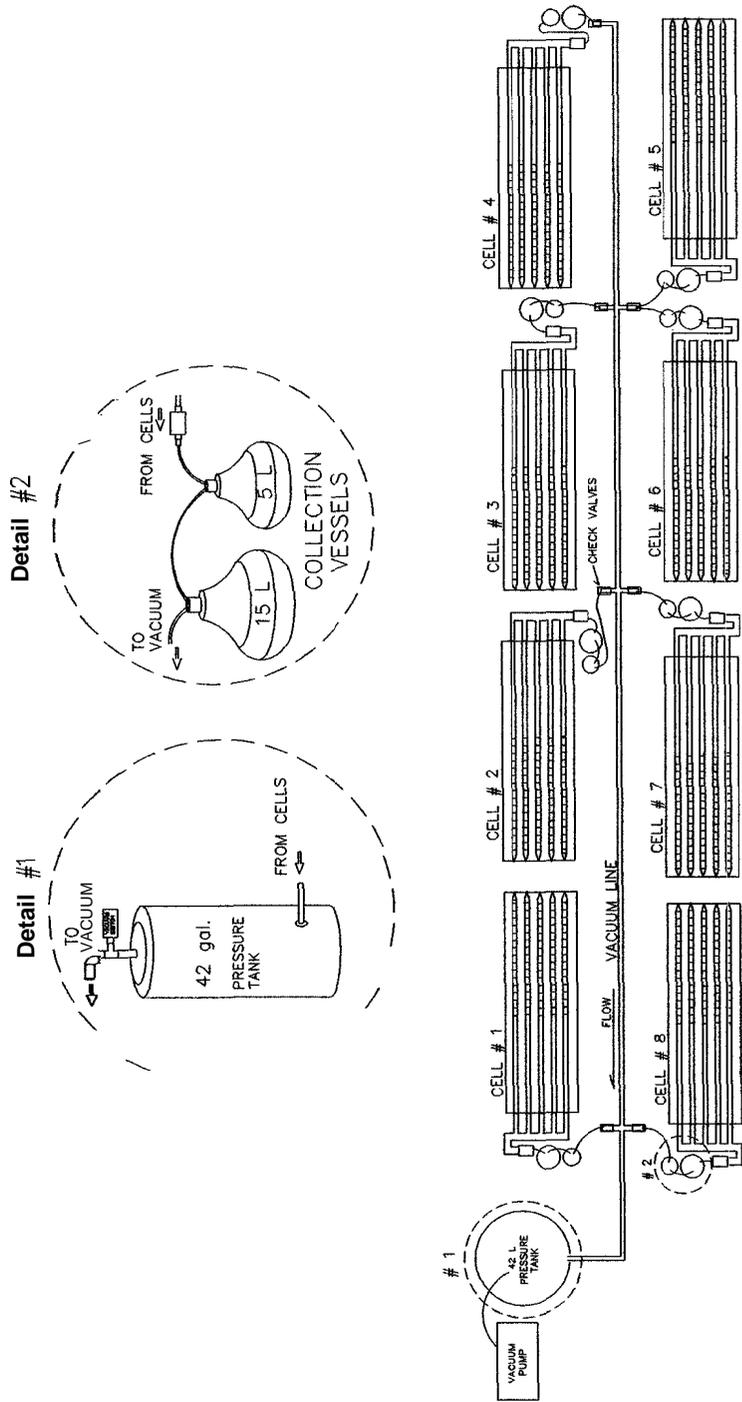
**Fig 4    S h n P i C V u u m S m P l a n**

Construction and installation of the vacuum system was initiated on January 18, 1995. The vacuum system was installed in the pilot cells before cover addition but after the addition of the tailings. This encouraged further draining and compaction of the tailings prior to cover application. Vacuum compaction resulted in the development of large cracks at the surface

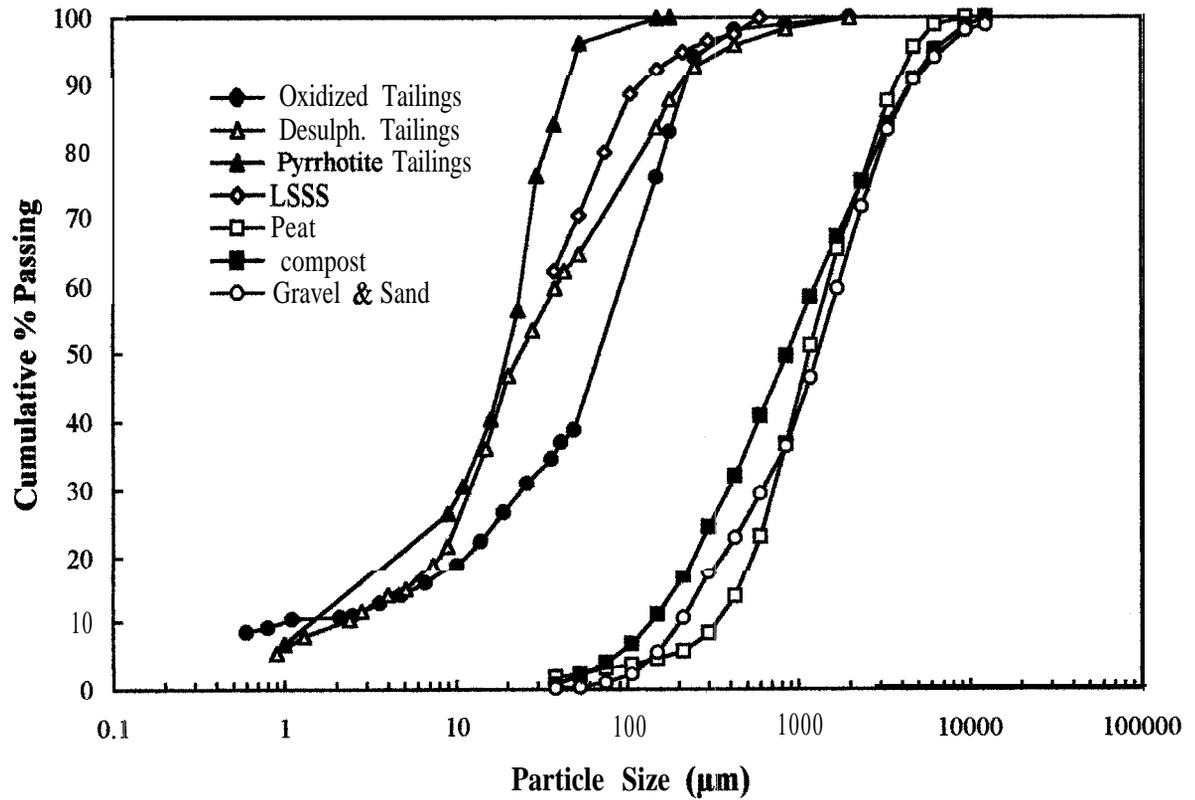
Figure 5. Grain Size Distribution for Tailings and Cover Materials

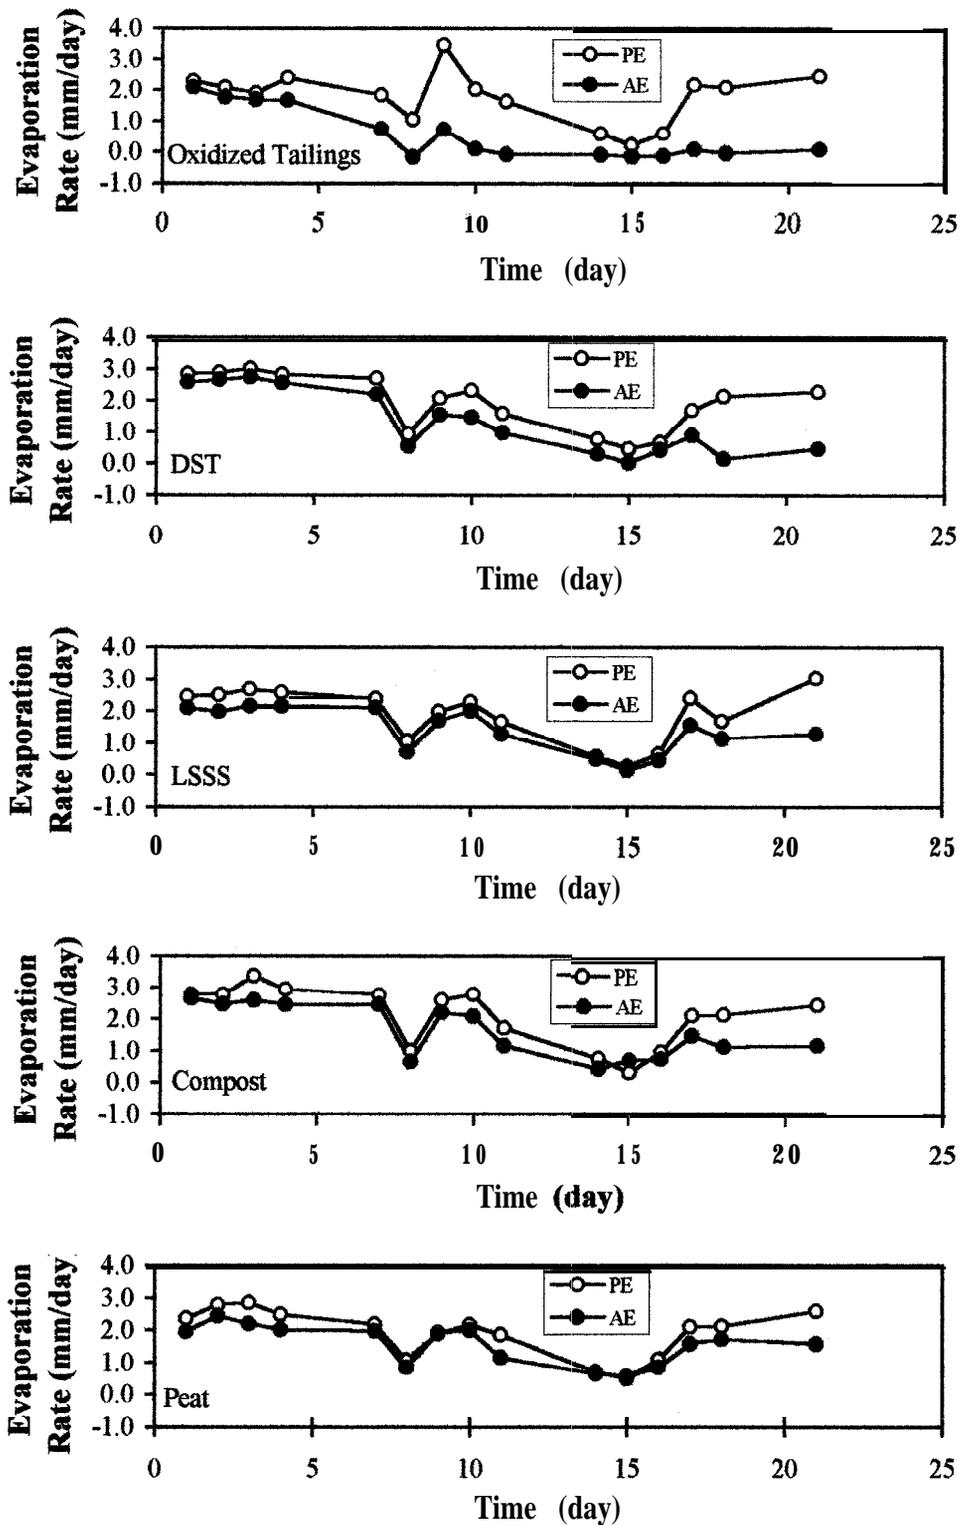
Figure 6. Evaporative Rate vs. Time for Different Materials

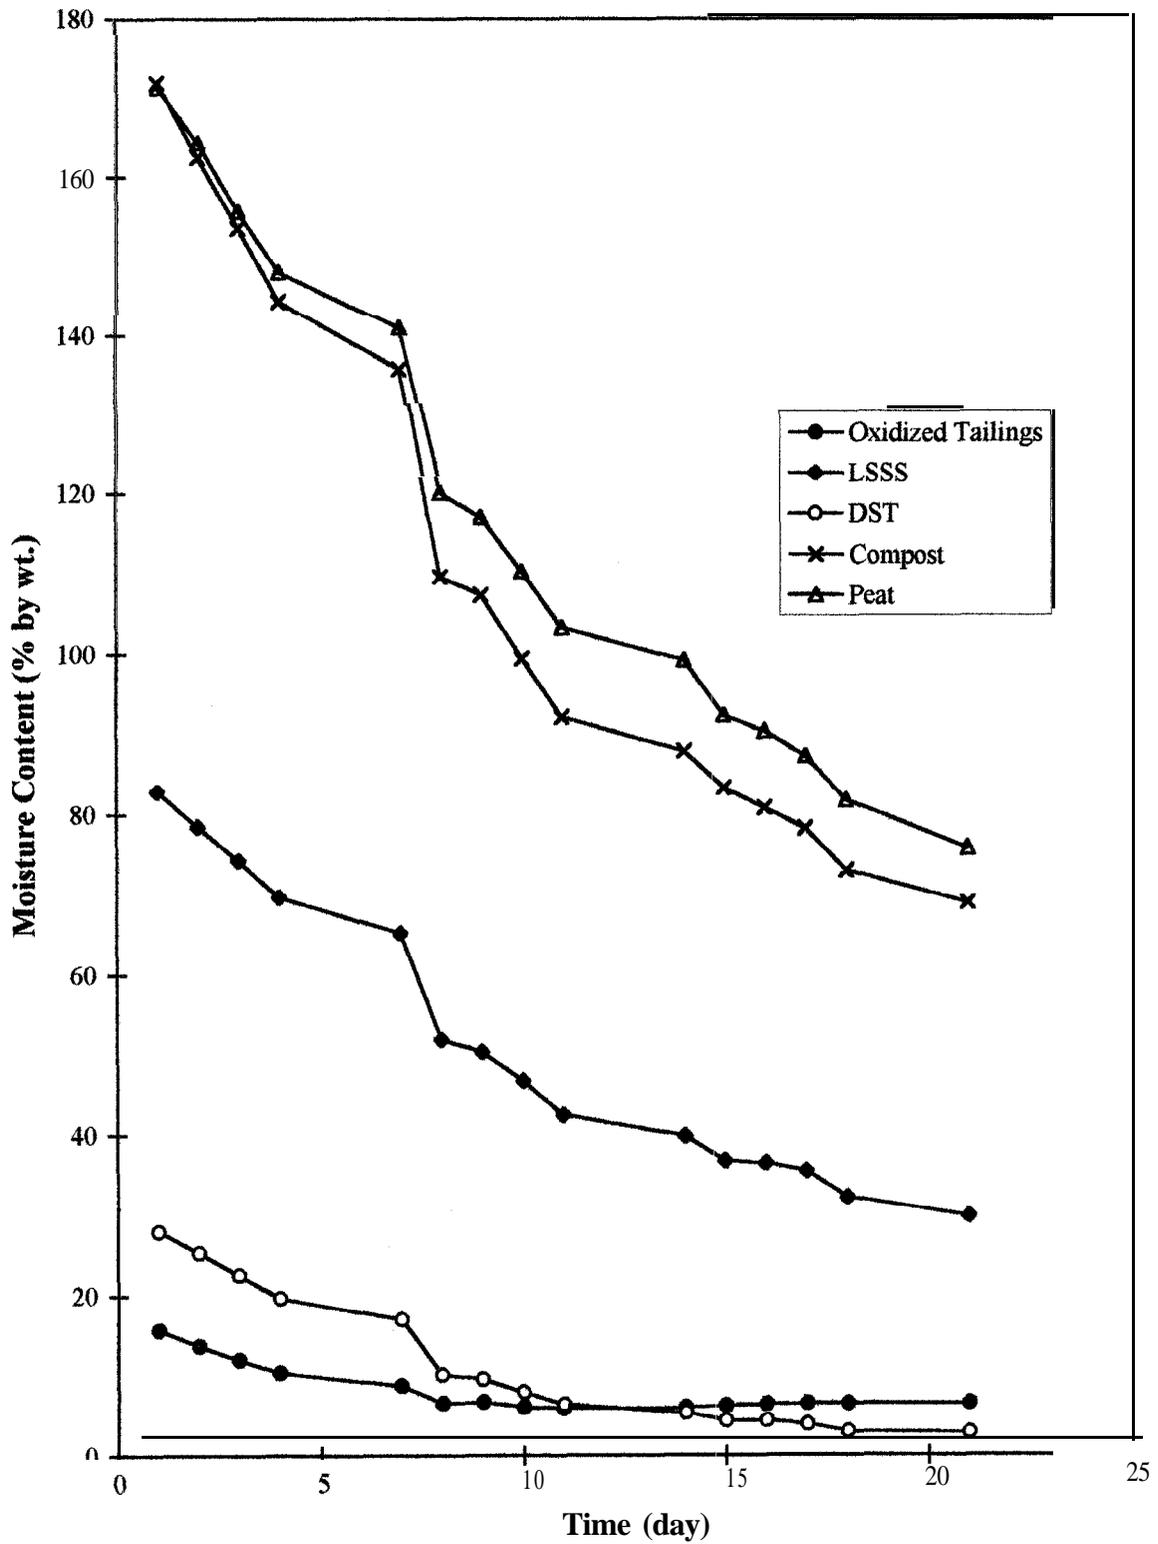
Figure 7. Moisture Content vs. Time During the Evaporative Flux Test

Figure 7 shows the gravimetric moisture content retained by the different materials during the evaporative flux tests. The moisture contents decreased as the evaporation period increased. The moisture contents of both peat and compost decreased at a higher rate throughout the testing period than the LSSS, which in turn decreased at a higher rate than the desulphurized tailings and oxidized tailings. The desulphurized tailings had a higher moisture content than the oxidized tailings initially. The moisture content for the oxidized tailings was 16% by weight or 29% by volume. Assuming that a porosity of 40-50% would be more realistic for tailings, the degree of saturation for the oxidized tailings would be 58-73%. This suggests that the oxidized tailings were not fully saturated. This also points to the difficulty of saturating fine-grained sediments in such experiments.

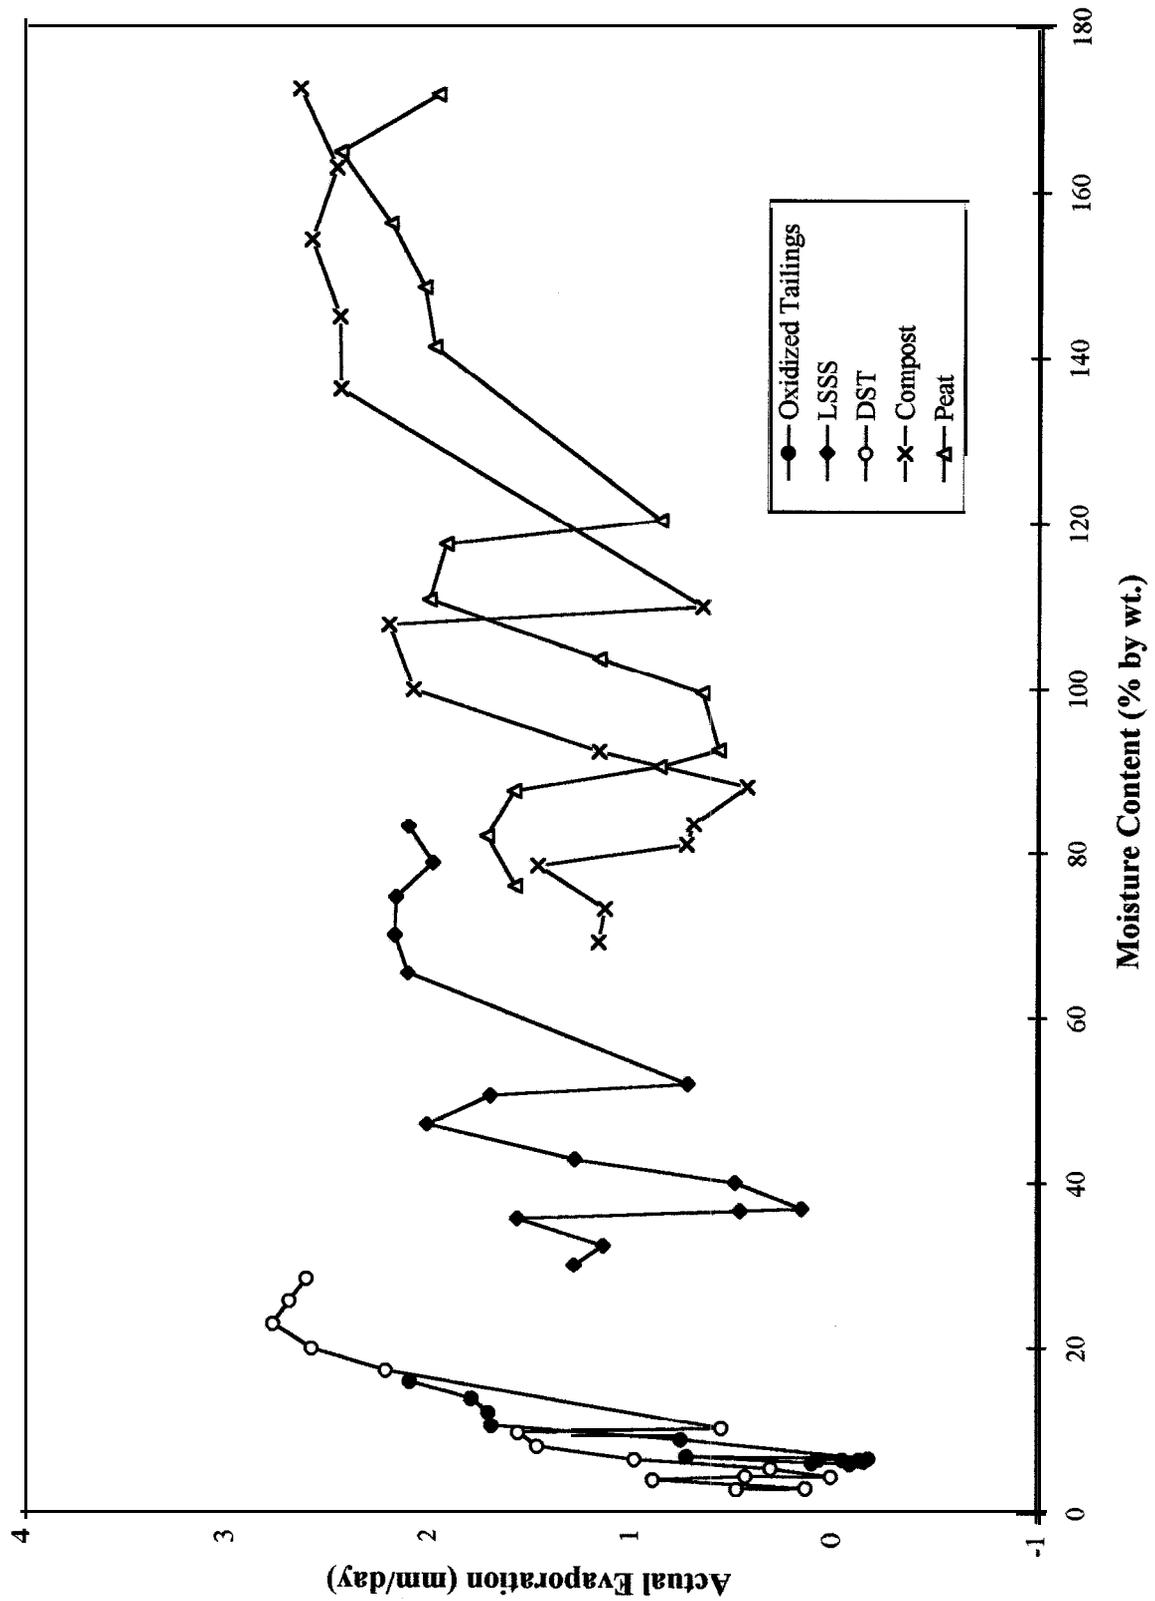
**Figure 8. Actual Evaporation Rate vs. Moisture Content Retained by Different Materials**

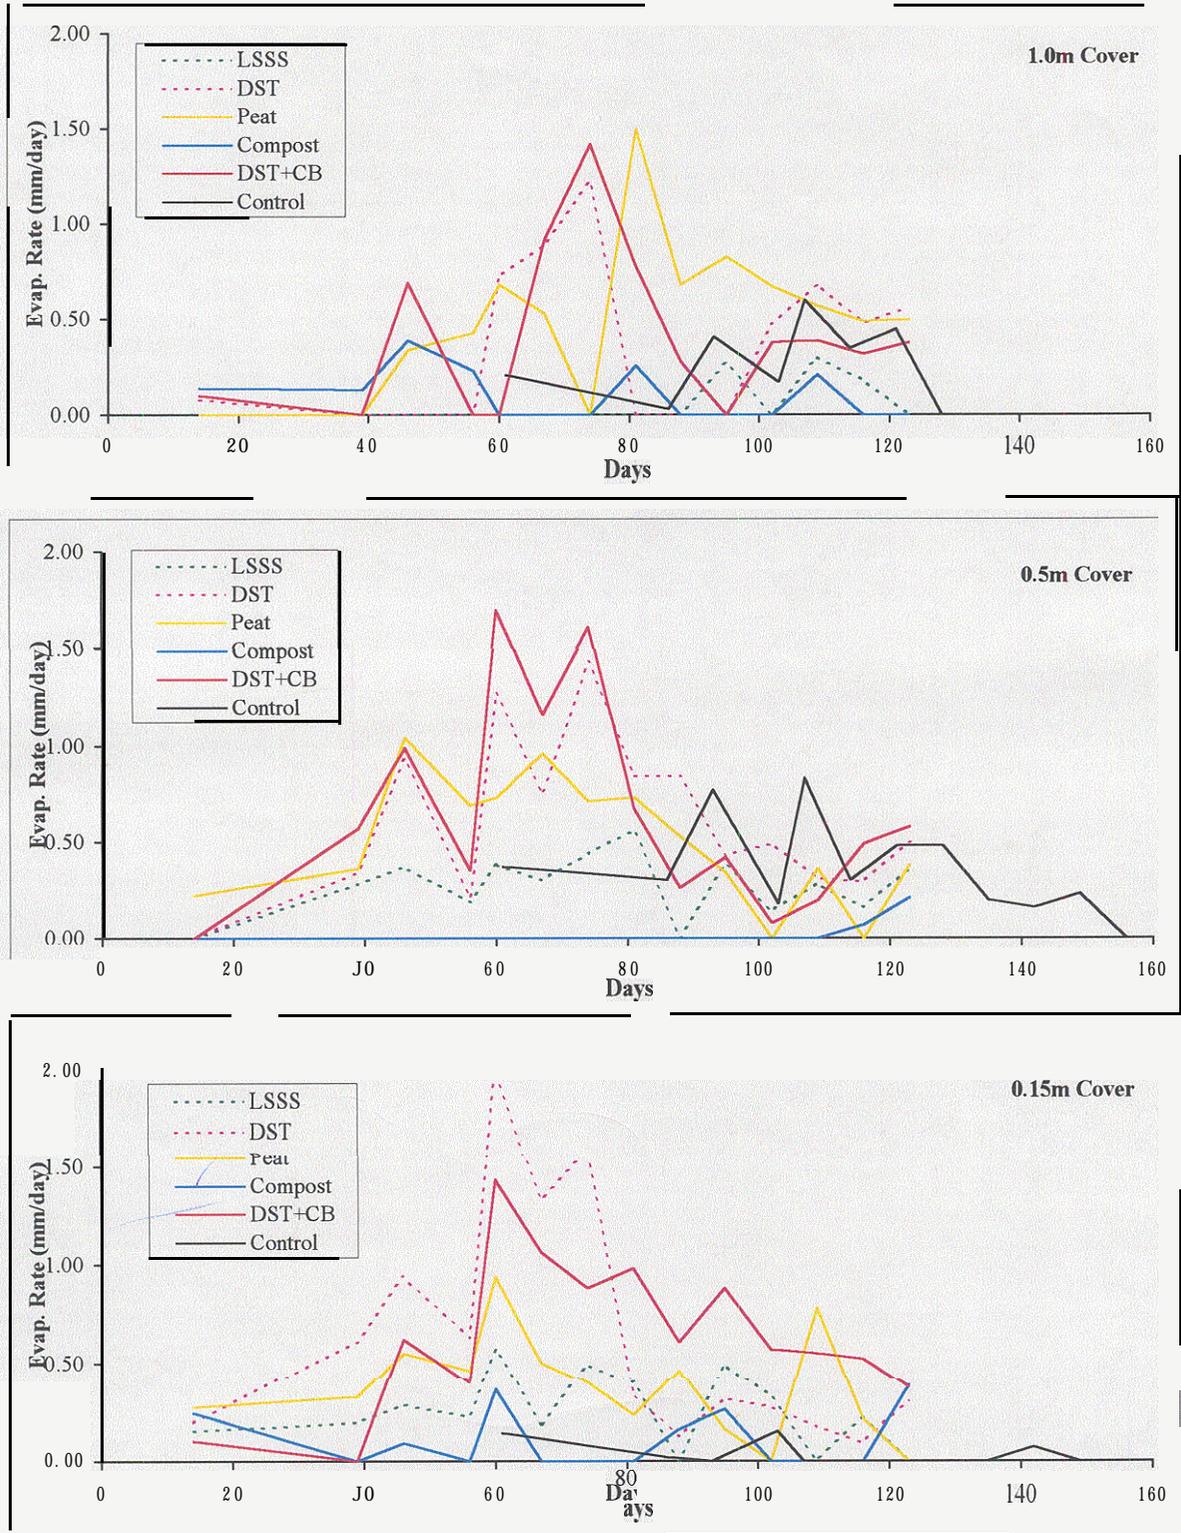
**Figure 9. Evaporation Rate vs. Time and Cover Depth for Different Cover Materials**

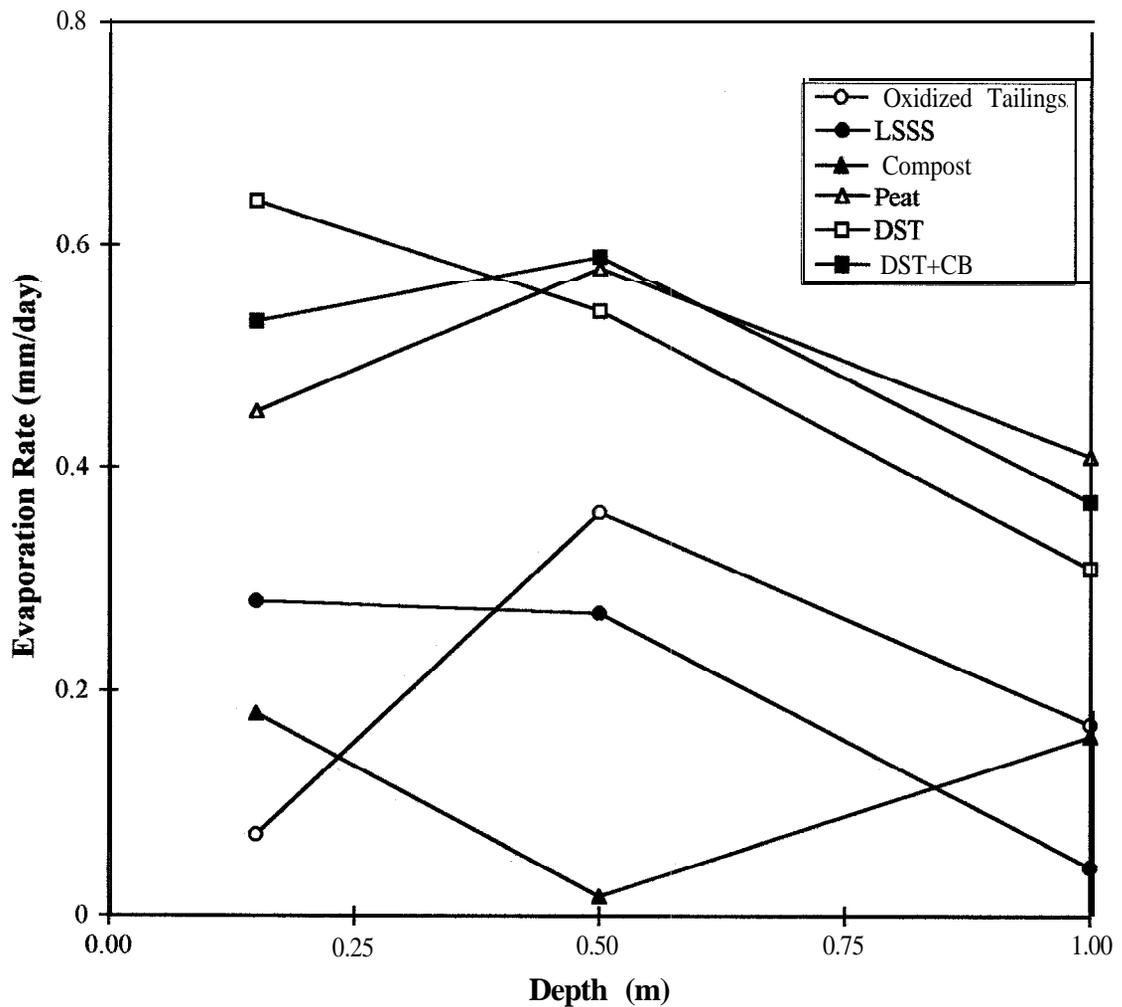
Figure 10. Evaporation Rate vs. Cover Depth for Different Cover Materials

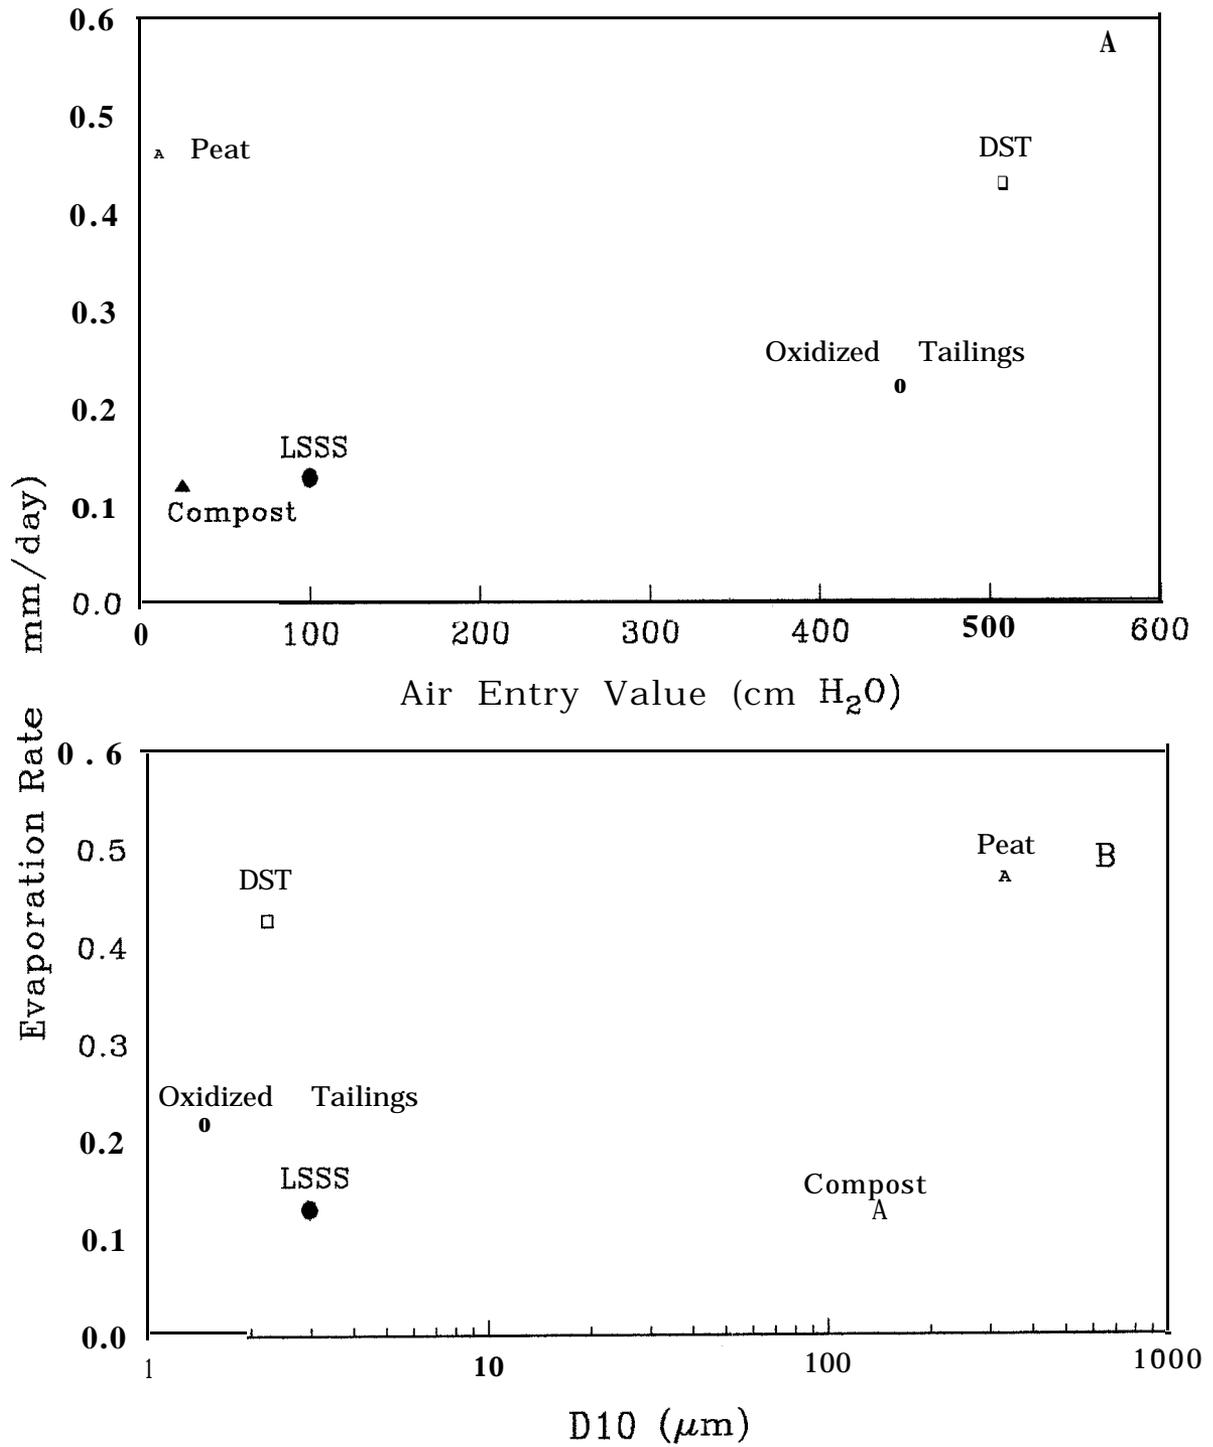
Figure 11. Average Evaporation Rates vs. Air Entry values (A) and  $D_{10}$  (B)

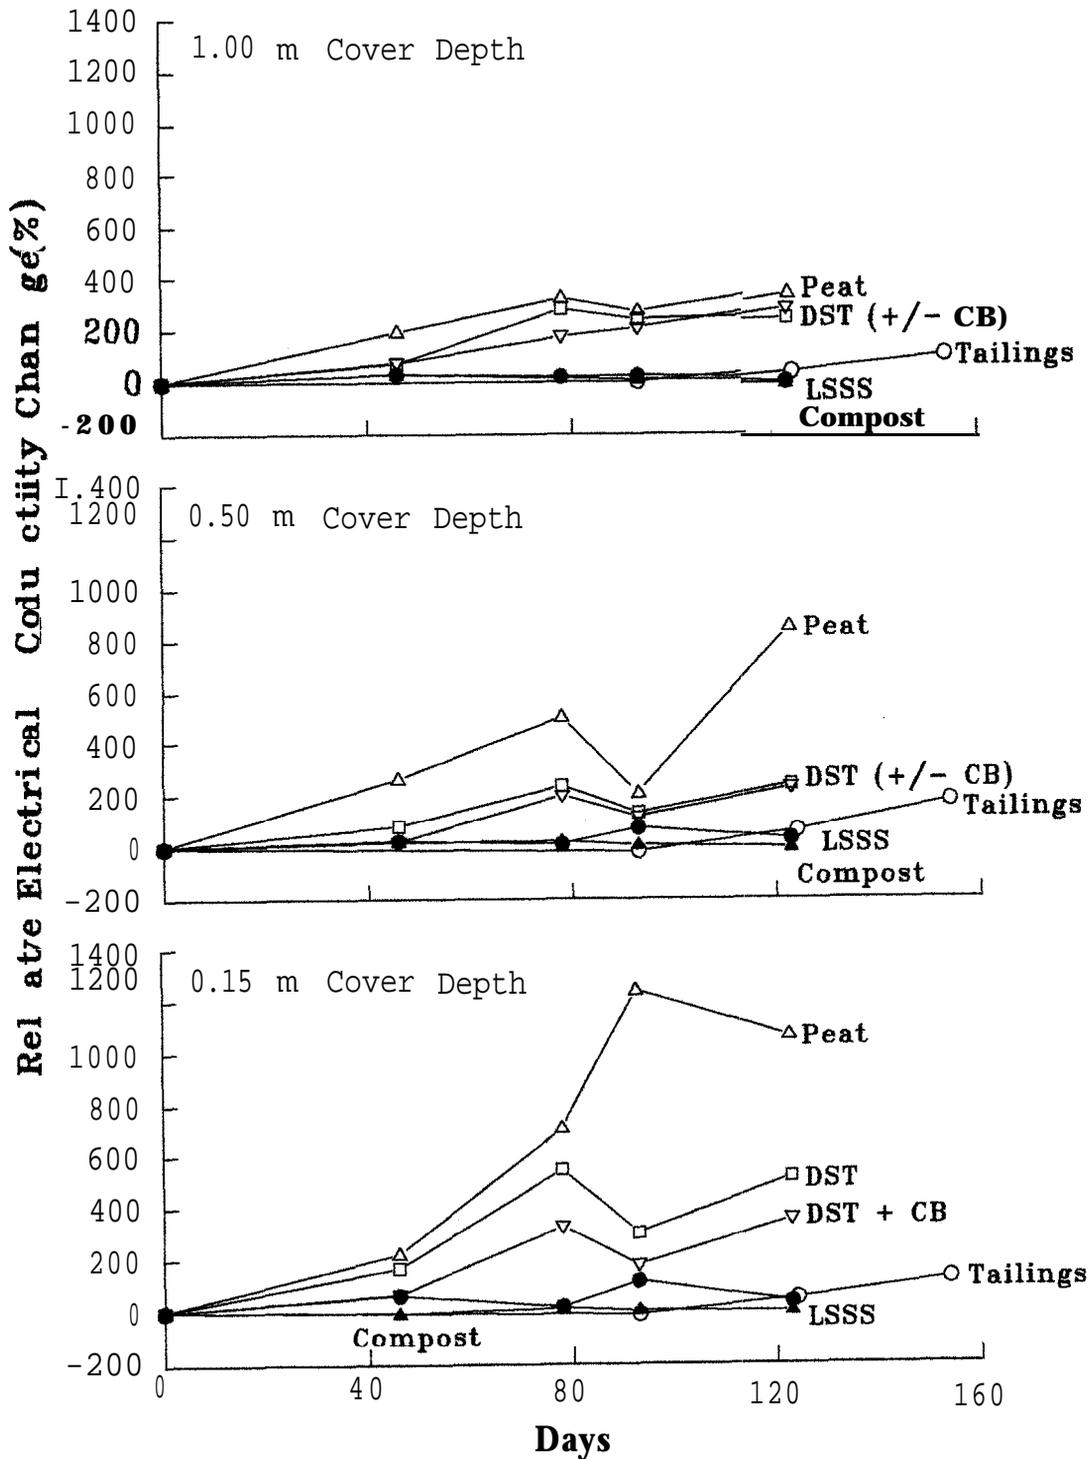
**Figure 12. Relative Electrical Conductivity Change with Time and Cover Depth at Surface**

Among the cover materials tested, peat and desulphurized tailings (with or without CB) consistently exhibited the highest percentage increase in electrical conductivity at the surface (Figure 12). The LSSS and compost consistently exhibited the smallest percentage increase in electrical conductivity at the surface. This change in electrical conductivity was closely related to the evaporation rates from the cover surface (Figure 10) (i.e. the high percentage increase in electrical conductivity at the surface of the peat and desulphurized tailings was paralleled by the high evaporation rate observed in the peat and desulphurized tailings columns.

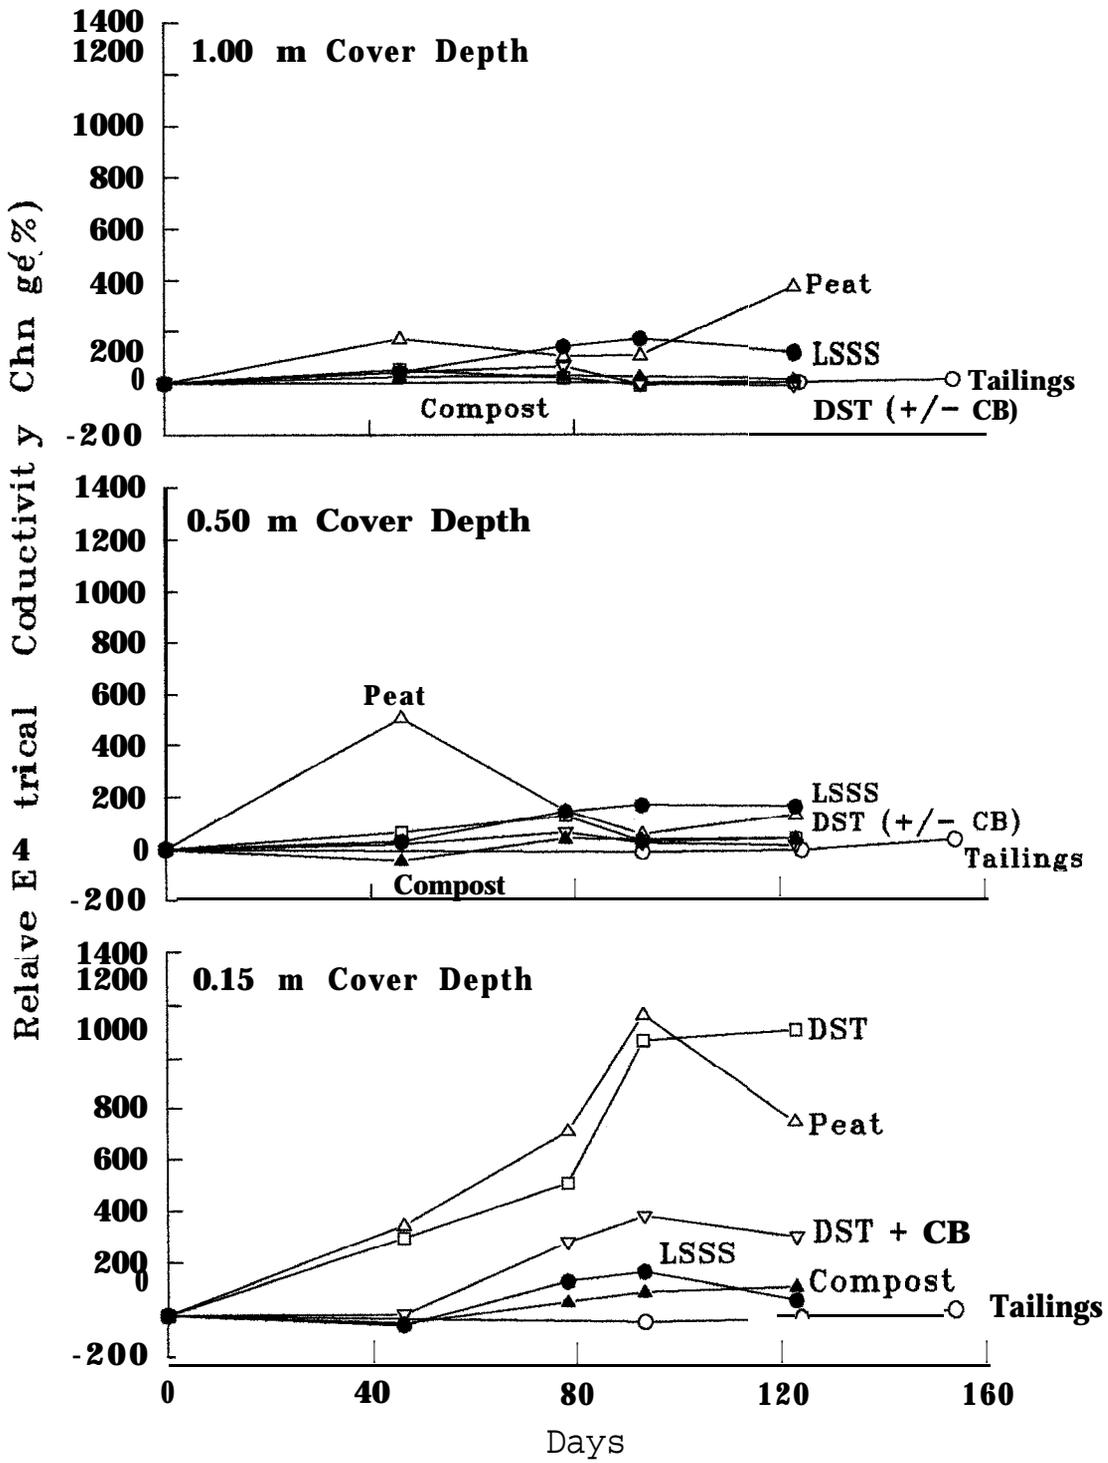
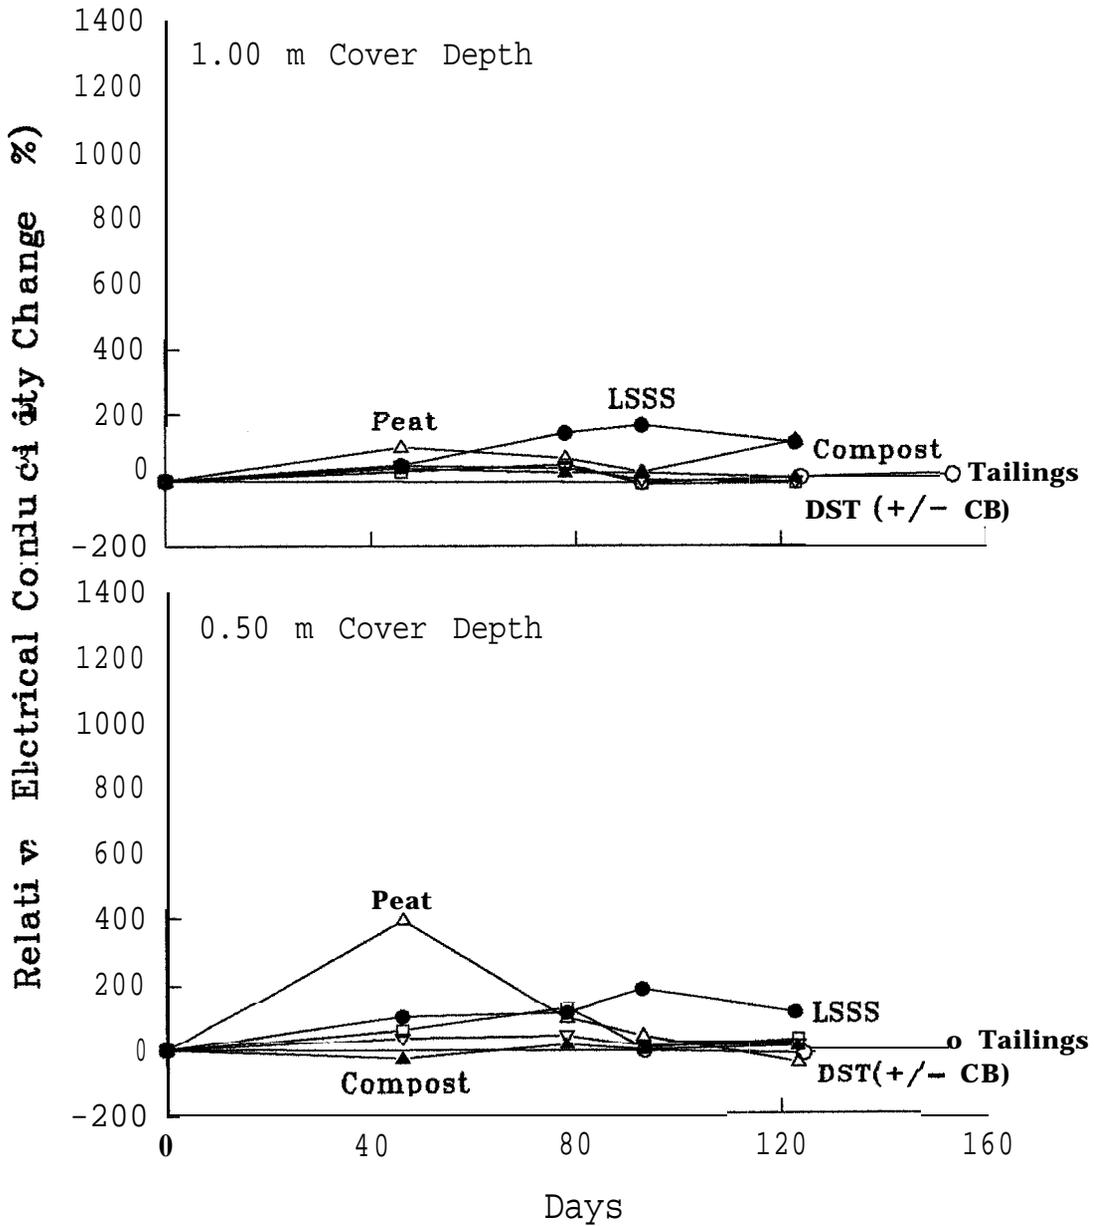
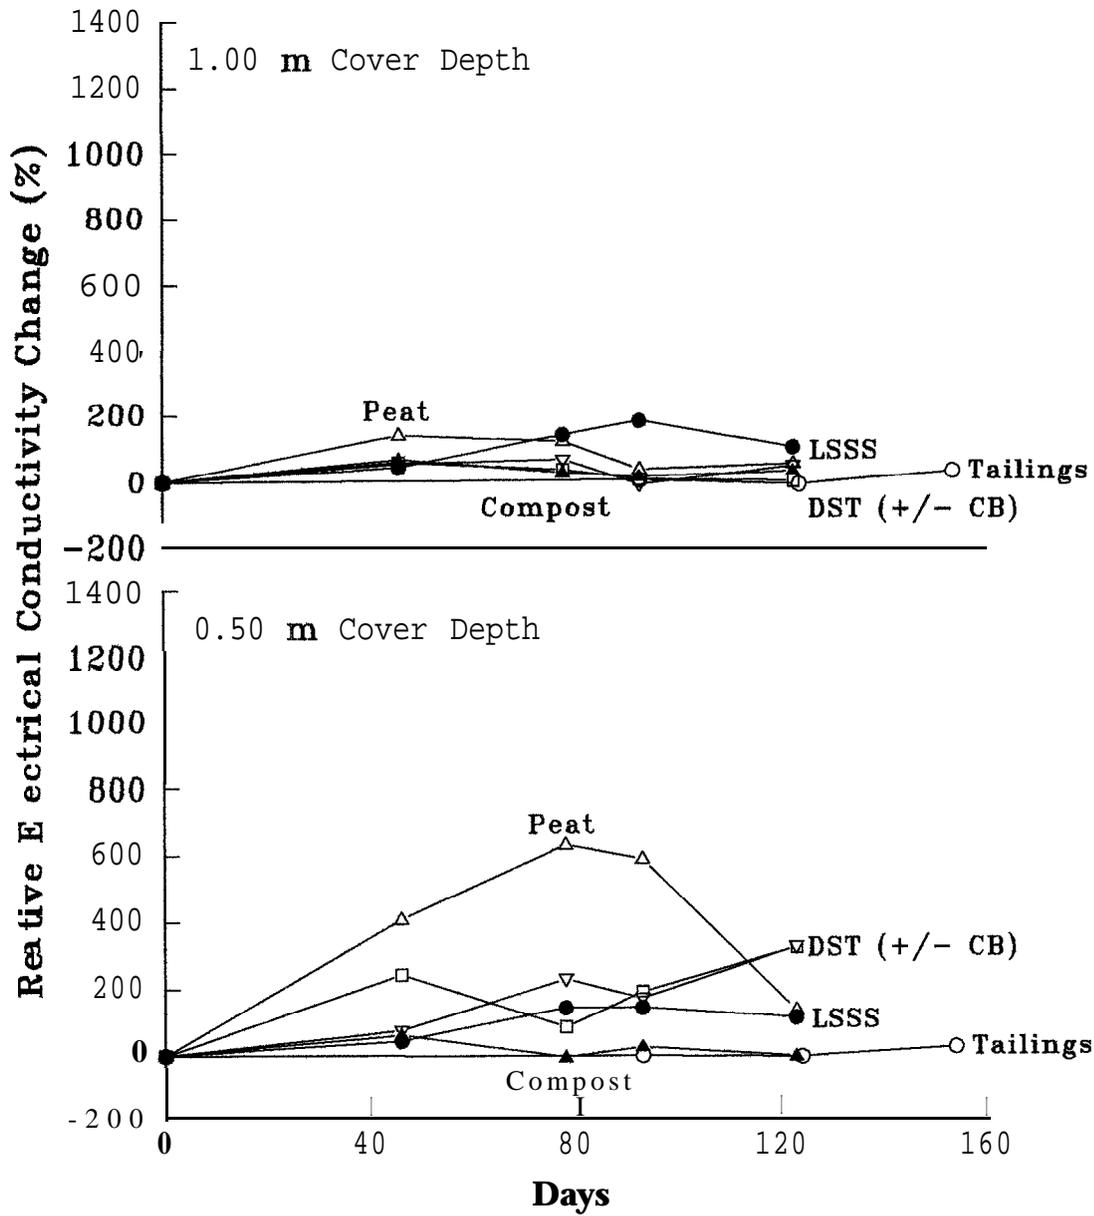
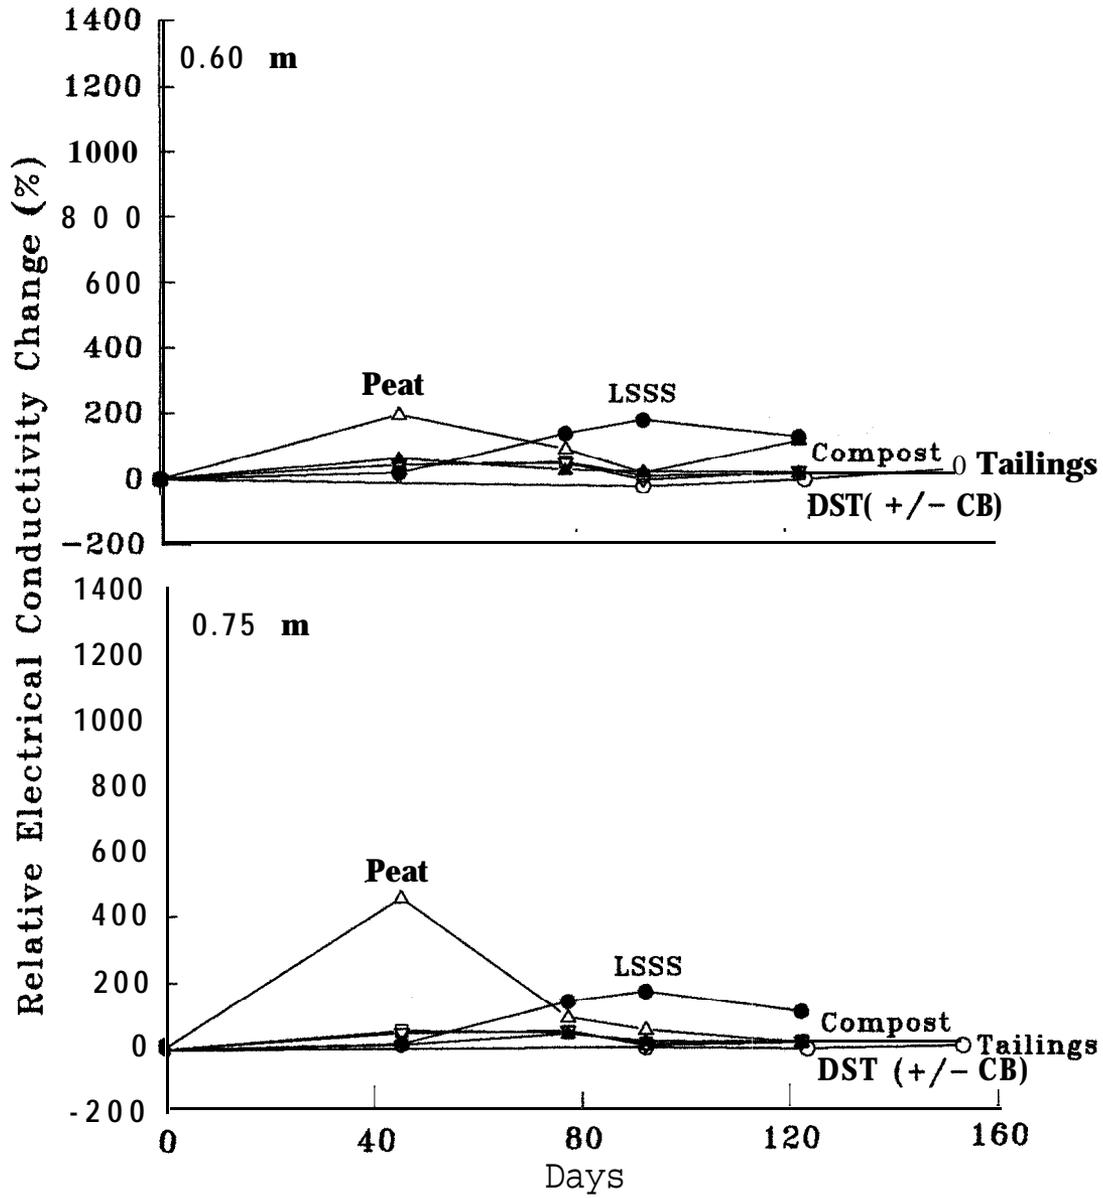
Figure 13. Relative Electrical Conductivity Change with Time and Cover Depth at 0.15 m Below the Surface

**Figure 14. Relative Electrical Conductivity Change with Time and Cover Depth at 0.30 m Below the Surface**

**Figure 15. Relative Electrical Conductivity Change with Time and Cover Depth at 0.45 m Below the Surface**

Figure 16. Relative Electrical Conductivity Change with Time at 0.60 and 0.75 m Below the Surface Under 1.0 m Cover Depth

At the 0.15 m sampling point, the LSSS exhibited a large percentage increase in electrical conductivity in all the cover depths tested (Figures 13-16). The electrical conductivity of the LSSS increased from an initial value of 2854  $\mu\text{mhos/cm}$  (Table 13) to 8181  $\mu\text{mhos/cm}$  at the 0.15 m sampling point. Because of the relatively low evaporation rates recorded for the LSSS, this increase was not considered to be attributable to the evaporation rate or the upward migration of salts from the underlying oxidized tailings. It was suggested that the LSSS may have contributed salts to the upward migrating waters, resulting in the high electrical conductivities noted. A shake flask test was performed to determine the contribution of salts to the observed electrical conductivity related directly to the dissolution of the LSSS.

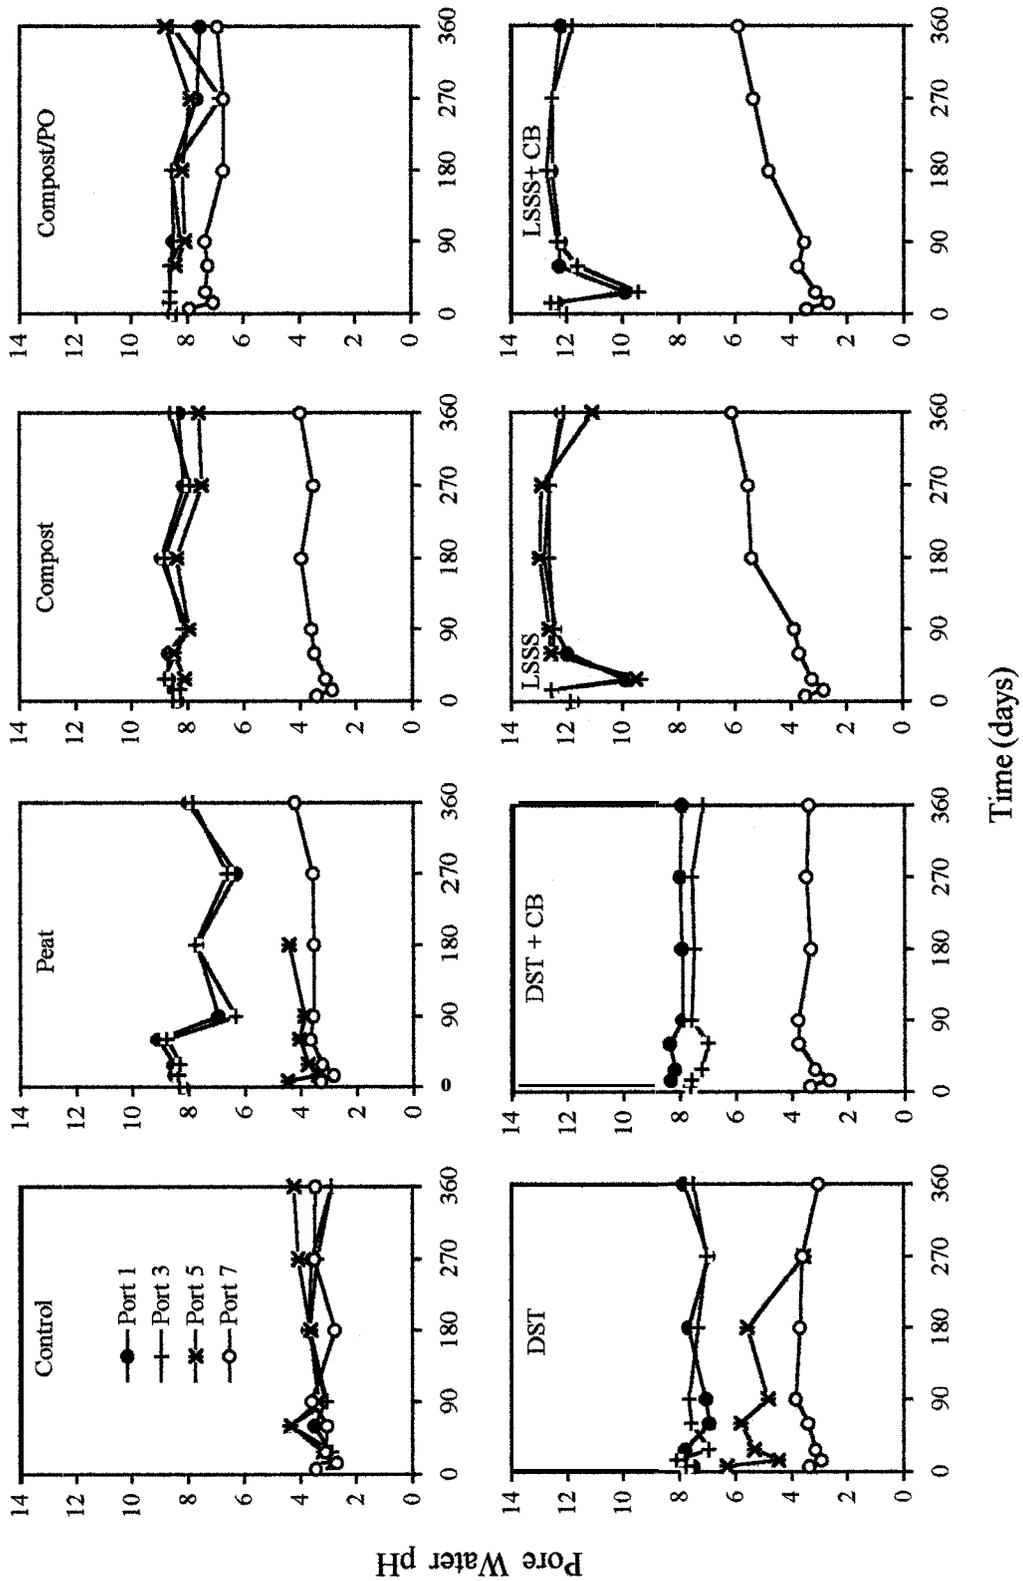
Figure 17. Pore Water pH vs. Time at Different Sampling Ports
