**EVALUATION OF THE USE OF  
COVERS FOR REDUCING ACID  
GENERATION FROM  
STRATHCONA TAILINGS**

**MEND Project 2.25.3**

**EVALUATION OF THE USE OF COVERS  
FOR REDUCING ACID GENERATION  
FROM STRATHCONA TAILINGS  
7777-112  
MEND Project 2.25.3**

Final Report

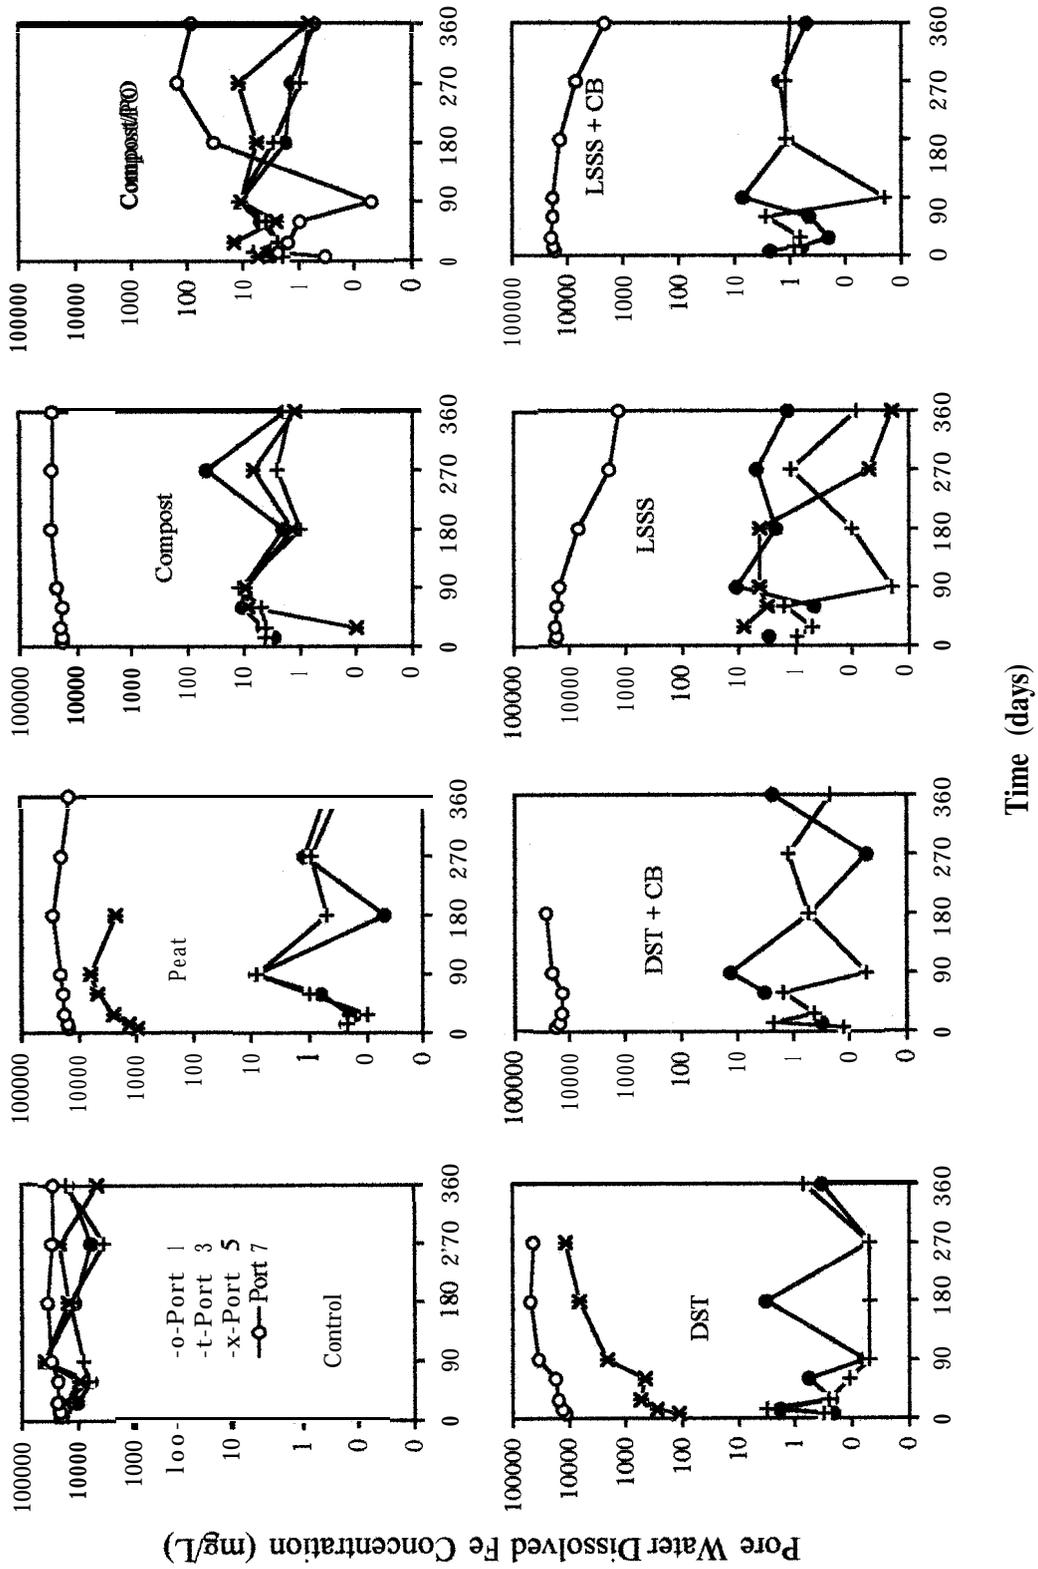
**Figure 18. Pore Water Fe Concentrations vs. Time at Different Sampling Ports**

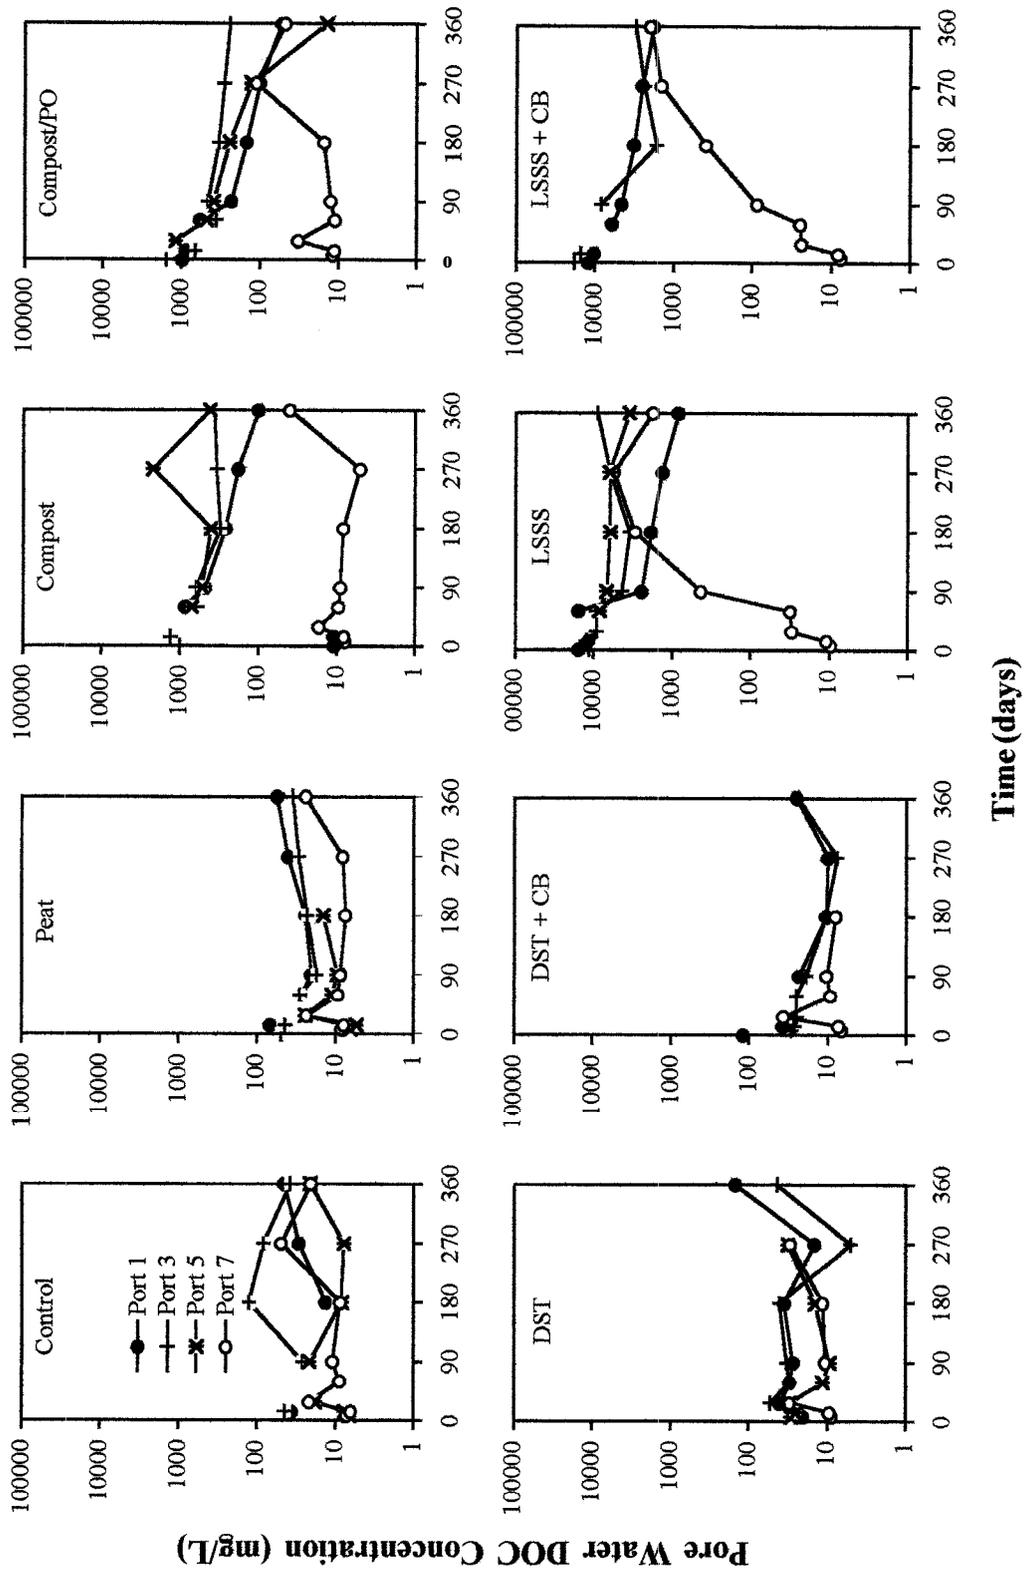
**Figure 19. Pore Water Dissolved Organic Carbon (Concentrations vs. Time at Different Sampling Ports).**

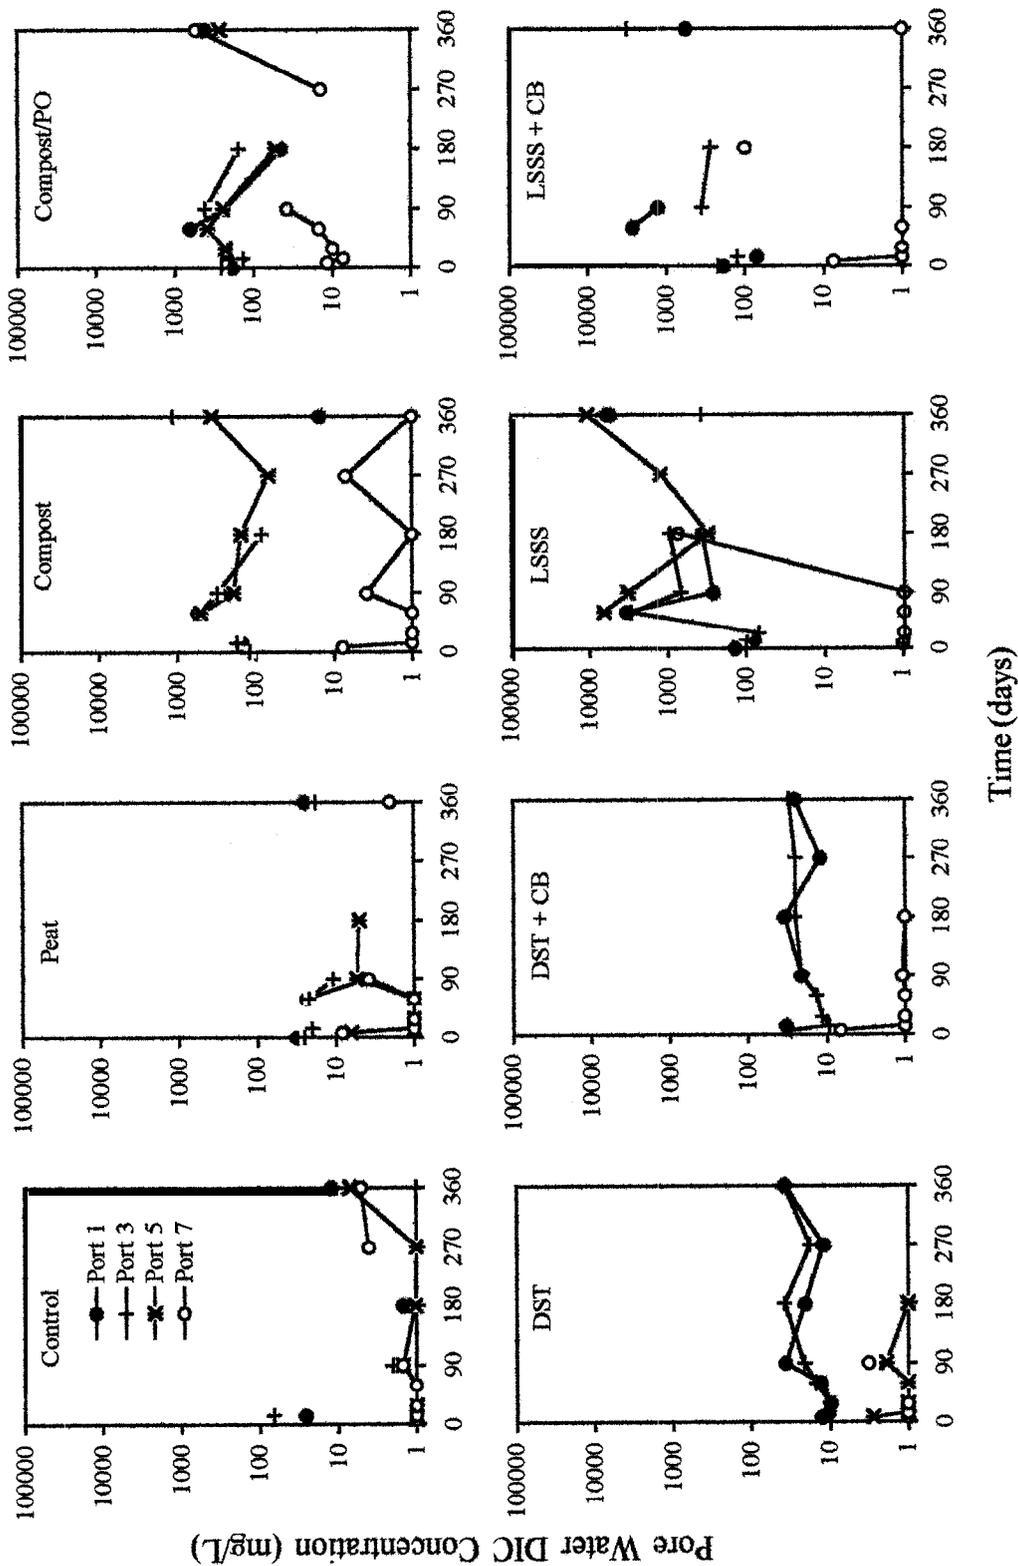
Figure 20. Pore Water Dissolved Inorganic Carbon Concentrations vs. Time at Different Sampling Ports

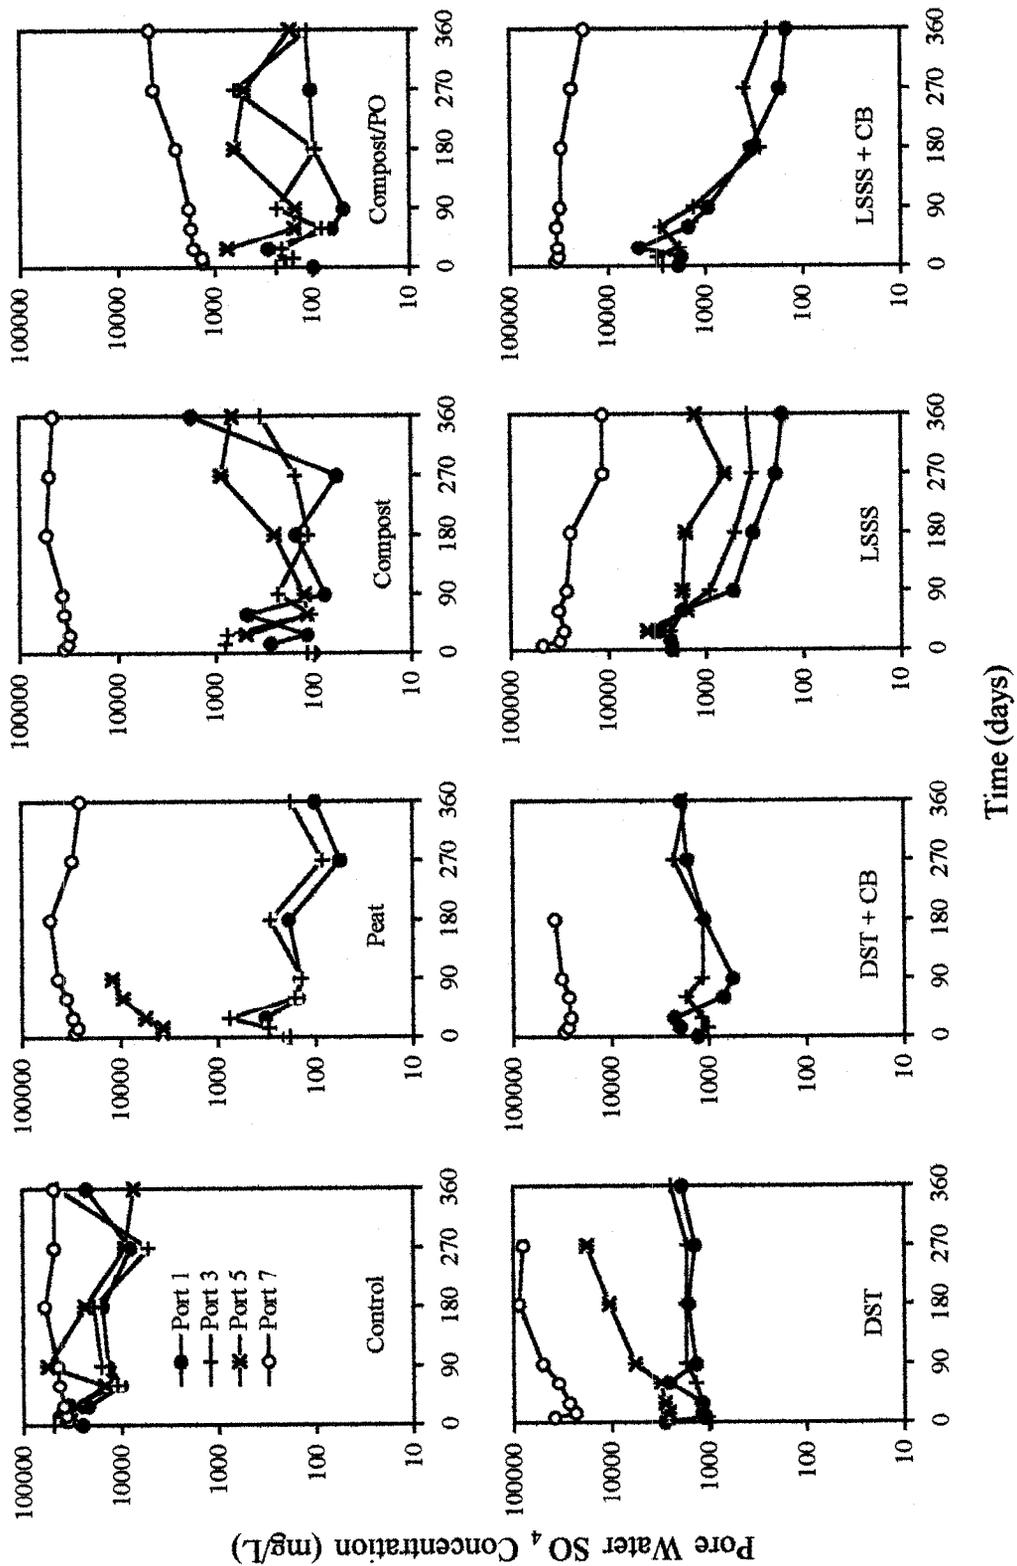
Figure 21. Pore Water SO<sub>4</sub> Concentrations vs. Time at Different Sampling Ports

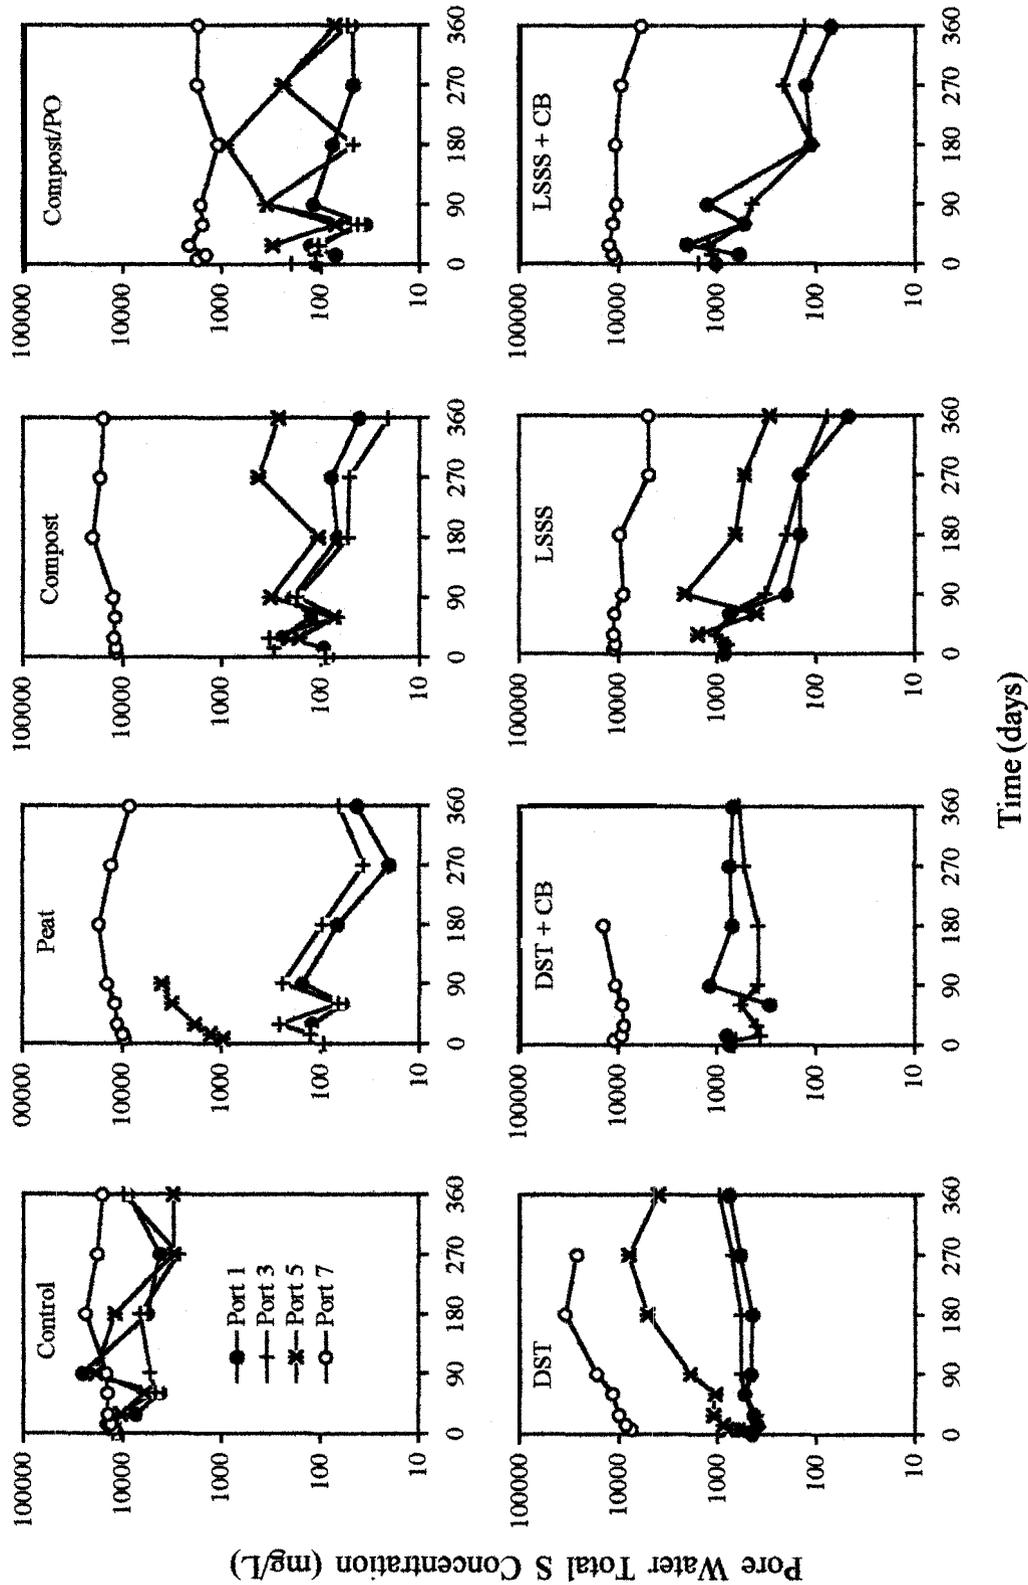
Figure 22. Pore Water Total S Concentrations vs. Time at Different Sampling Ports

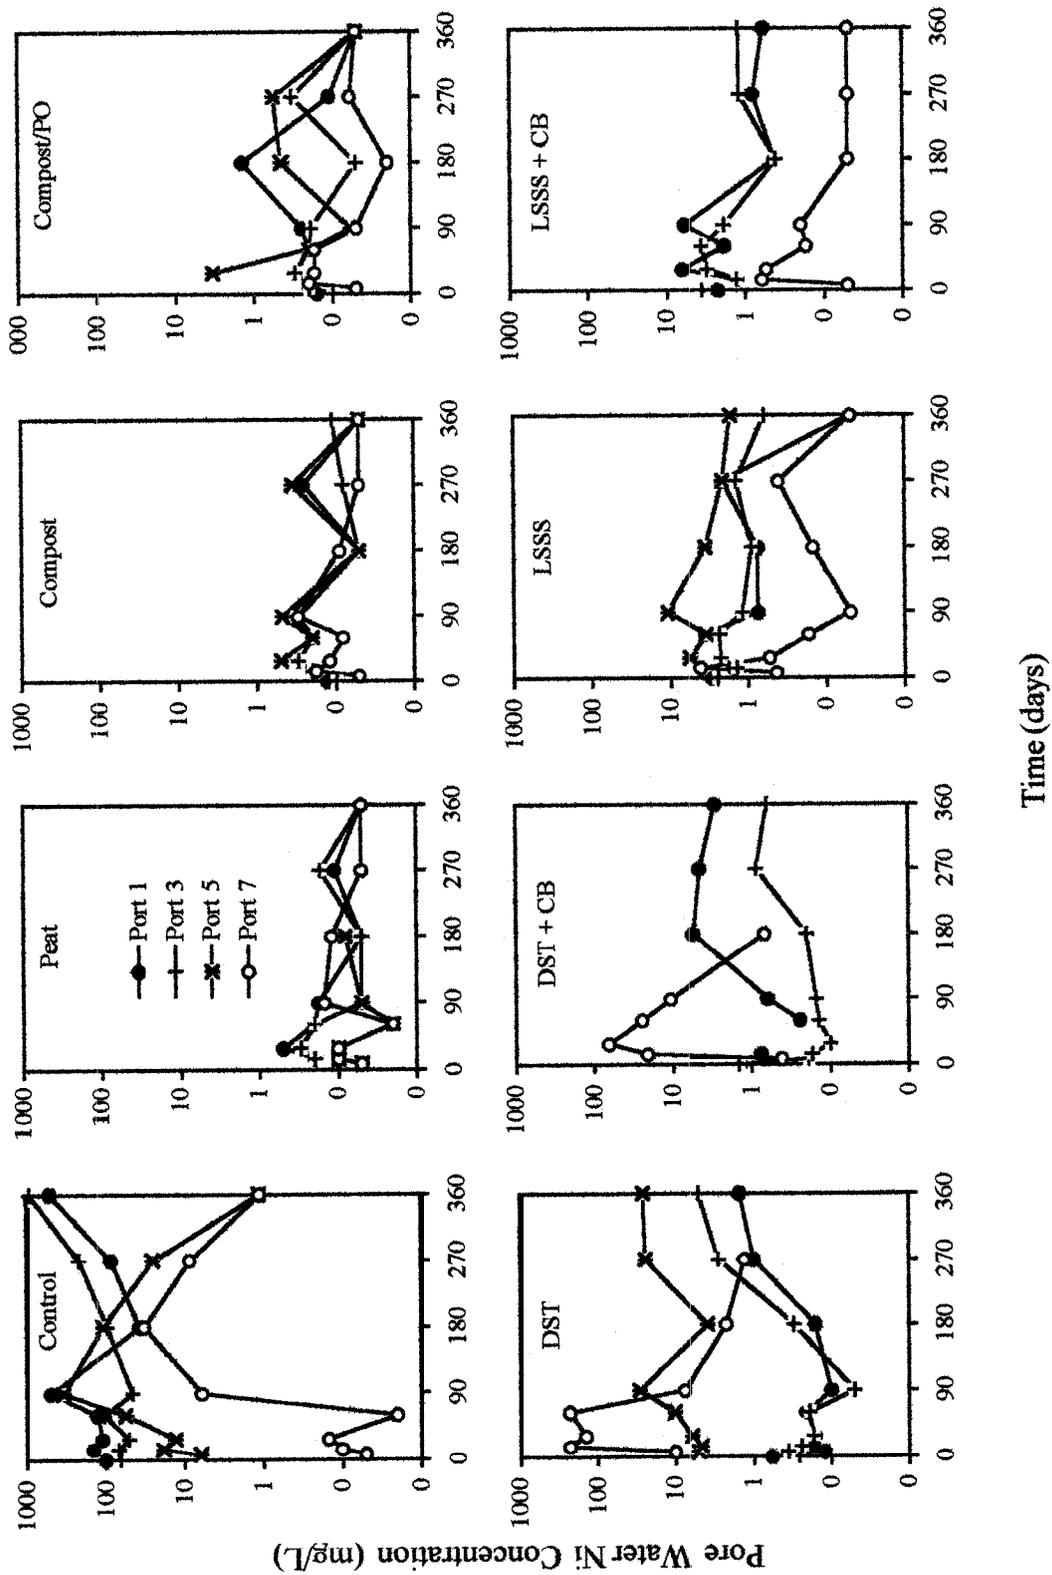
Figure 23. Pore Water Ni Concentrations vs. Time at Different Sampling Ports

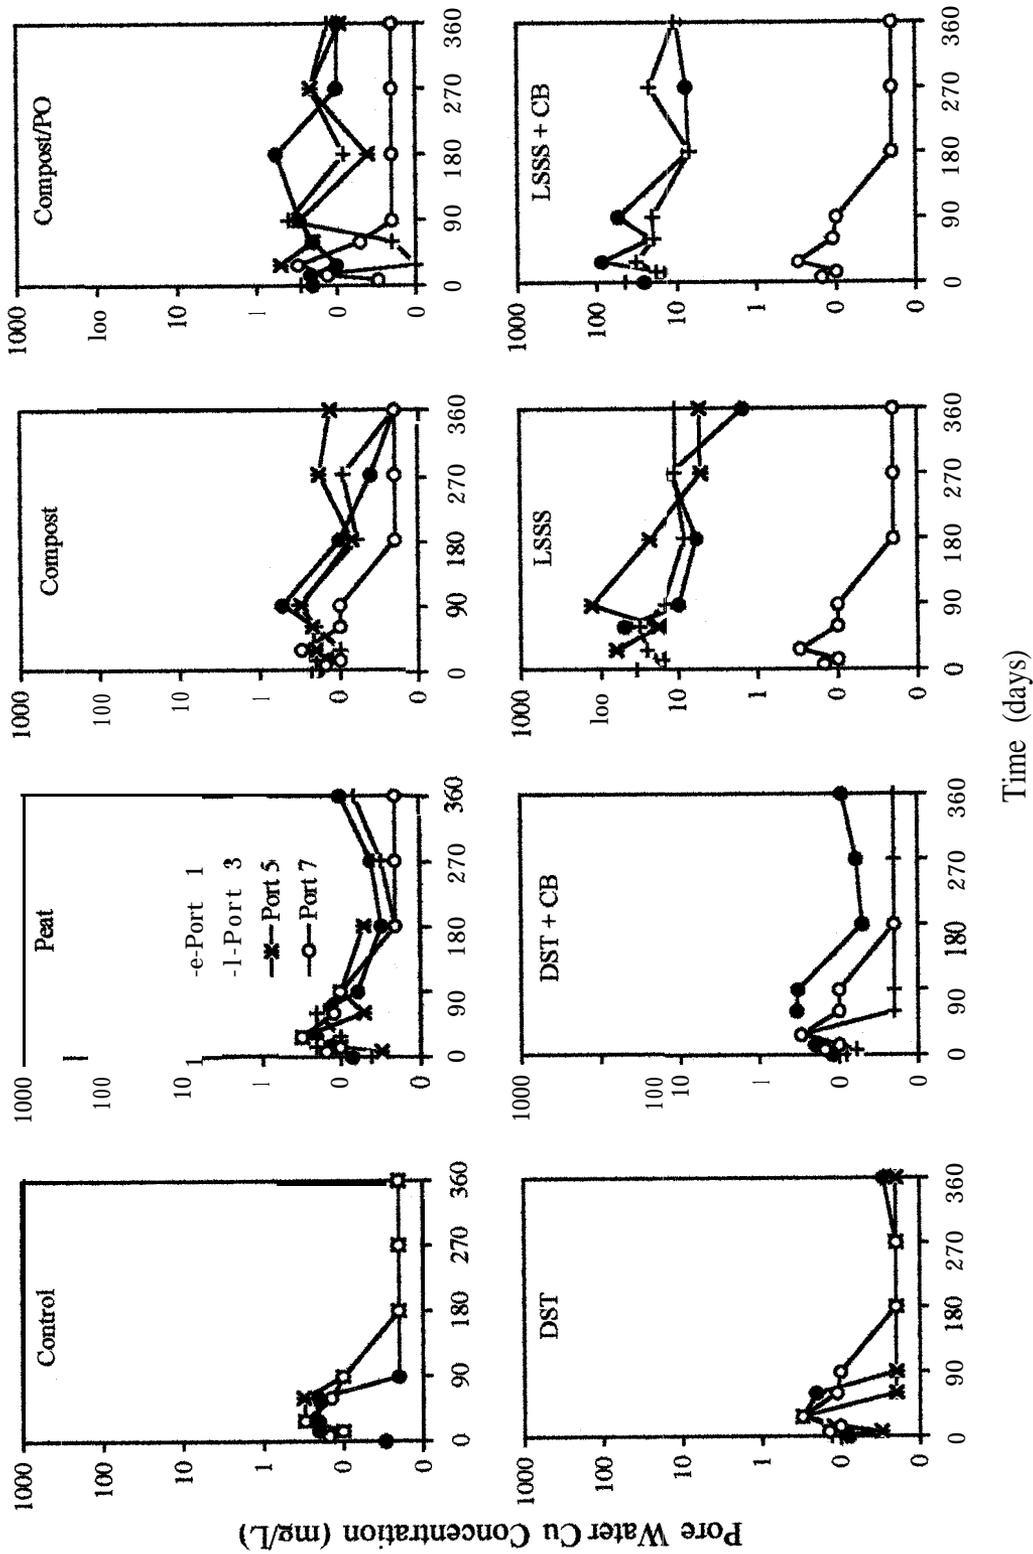
**Figure 24. Pore Water Cu Concentrations vs. Time at Different Sampling Ports**

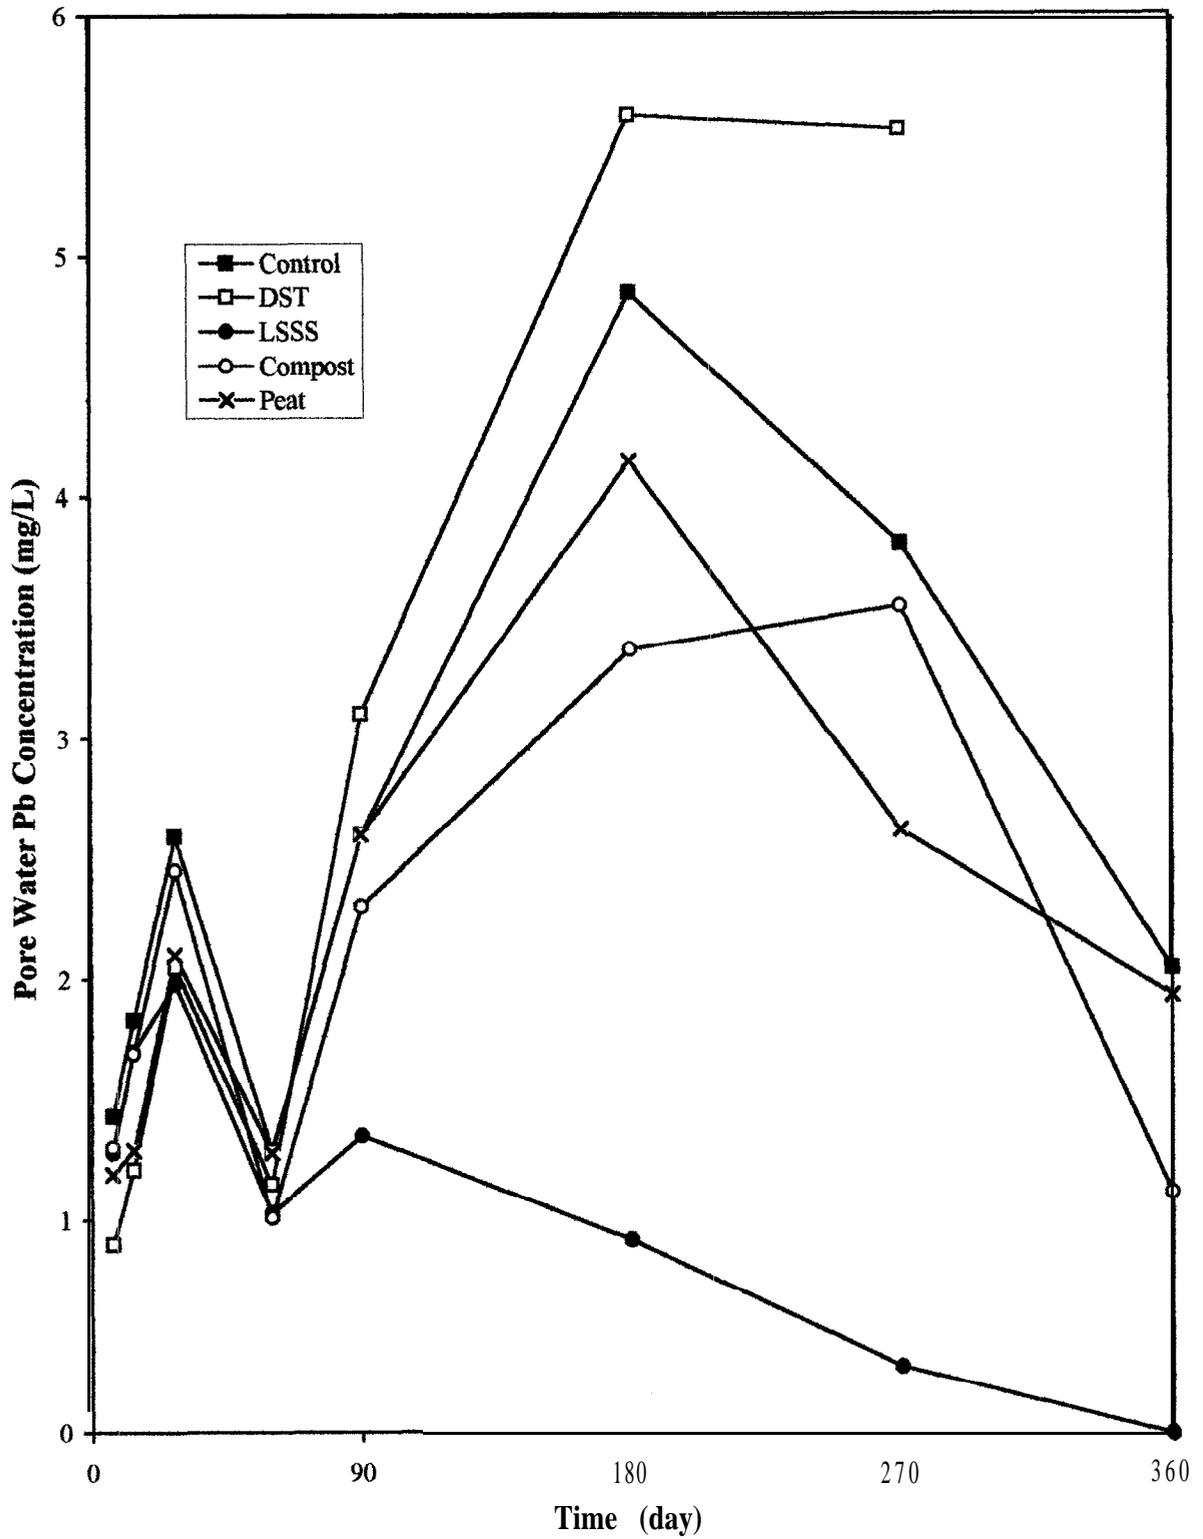
Figure 25. Pore Water Pb Concentrations in the Oxidized Tailings Under Various Cover Materials

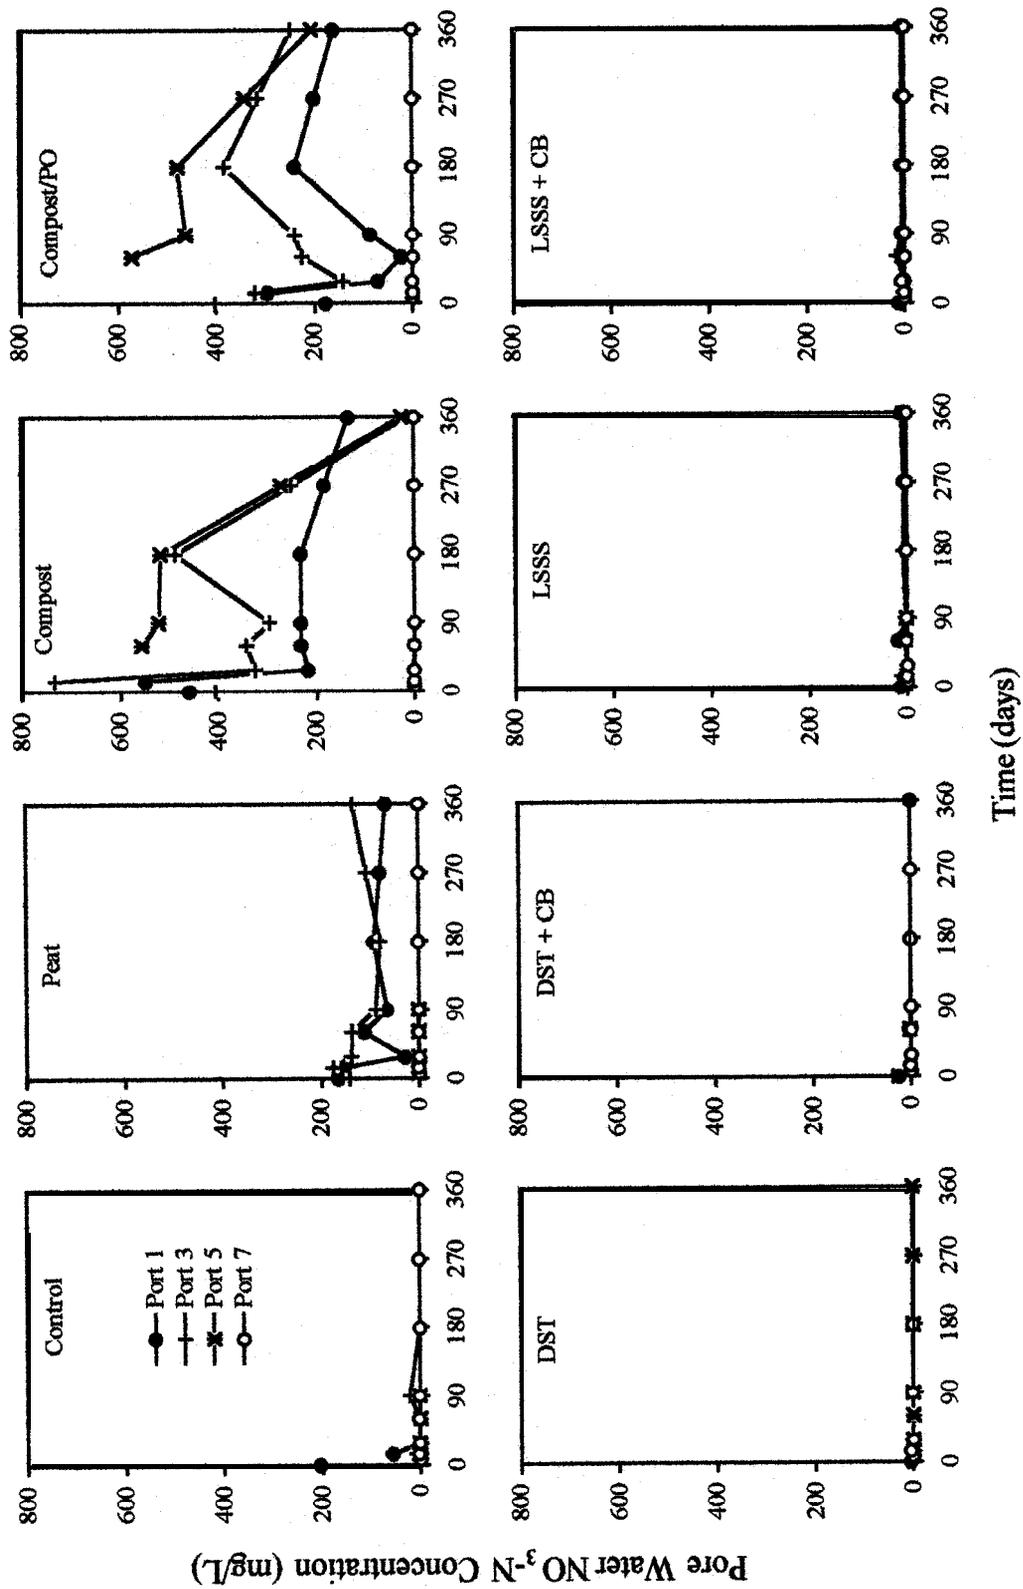
Figure 26. Pore Water  $\text{NO}_3\text{-N}$  Concentrations vs. Time at Different Sampling Ports

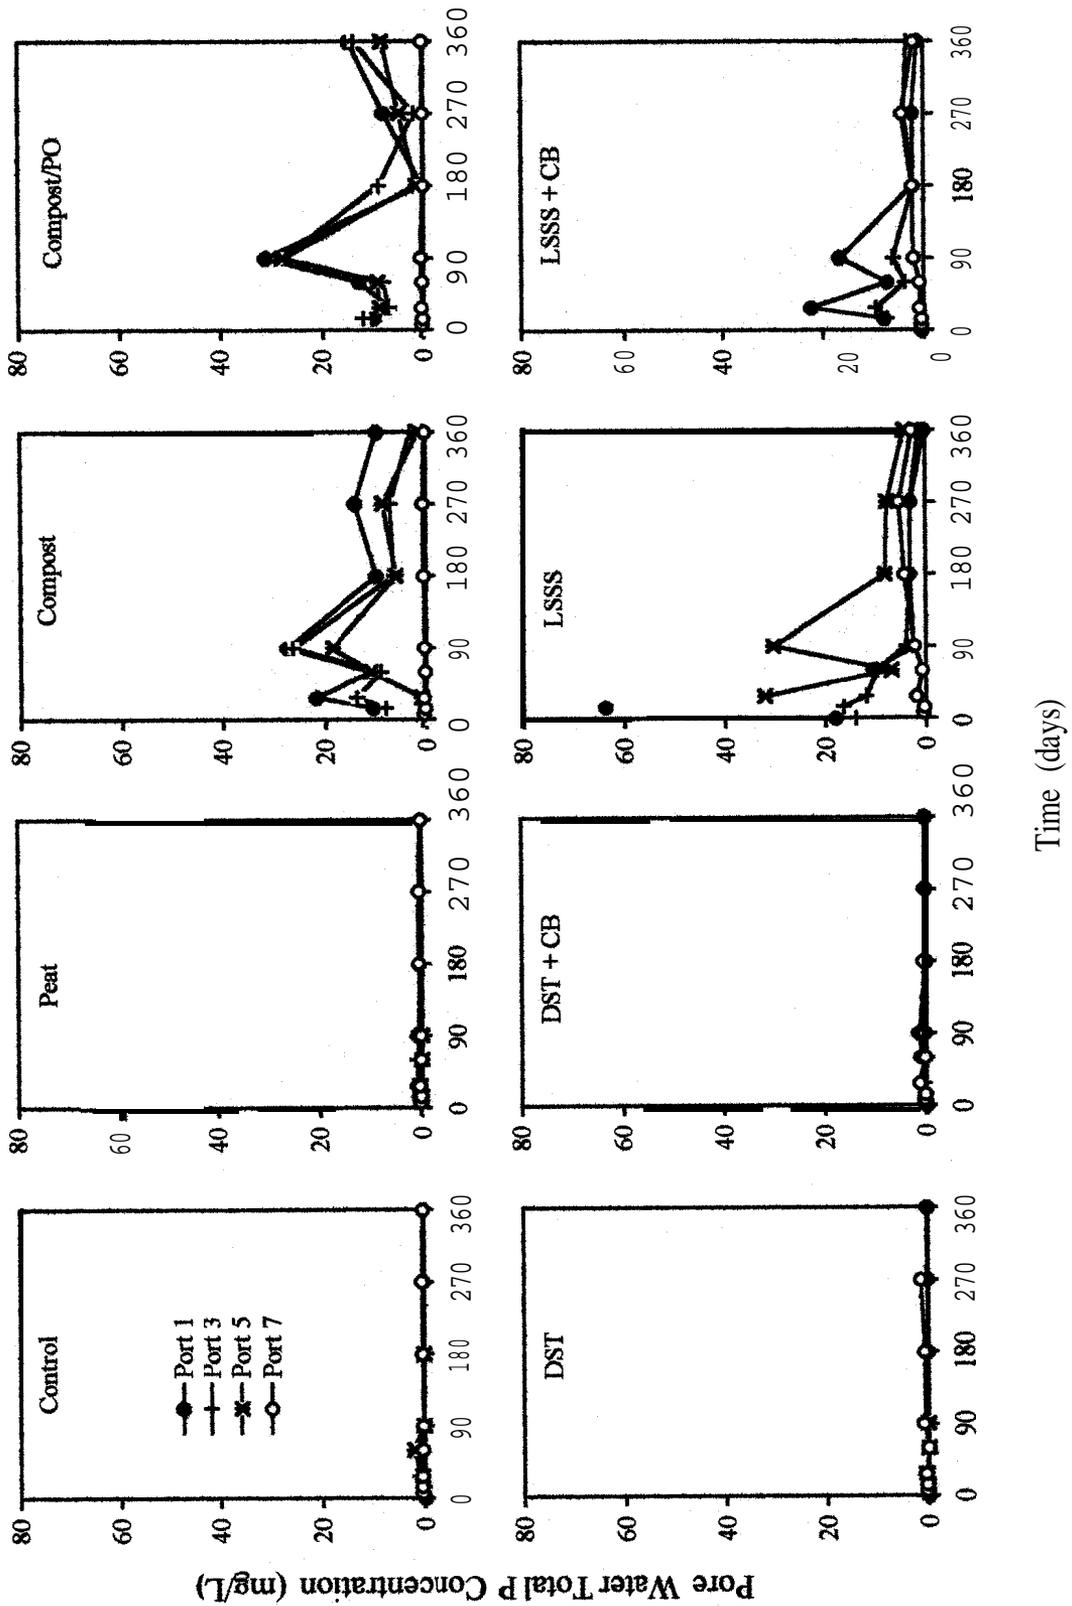
**Figure 27. Pore Water Total P Concentrations vs. Time at Different Sampling Ports**

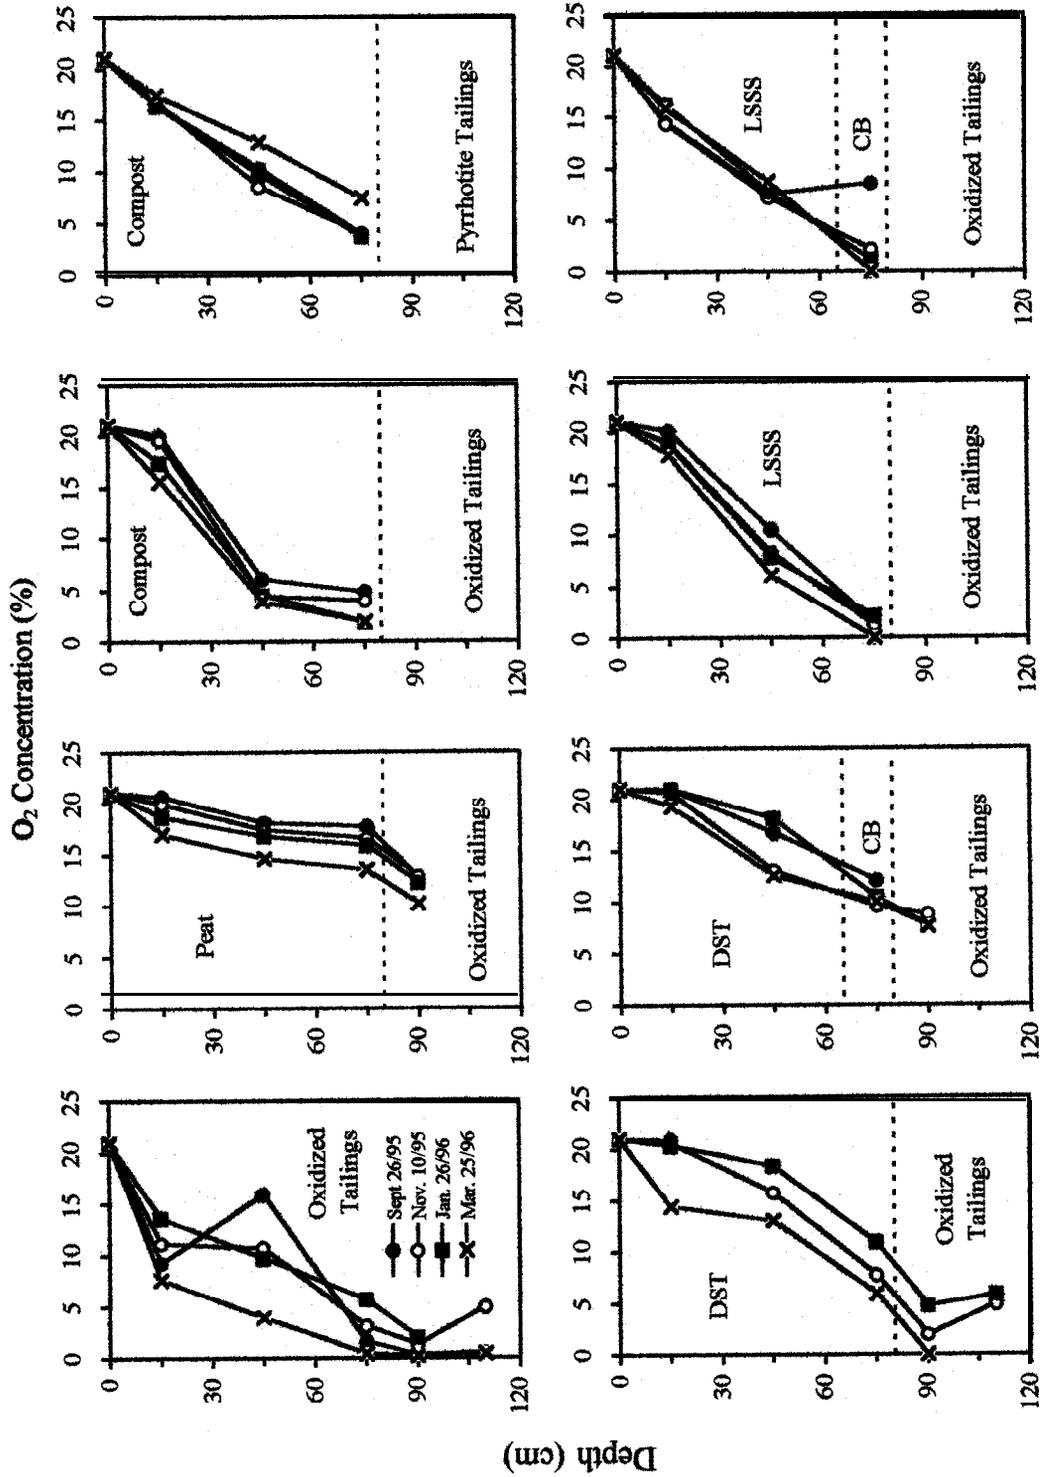
**Figure 28. O<sub>2</sub> Concentrations vs. Depth for Different Cover Materials**

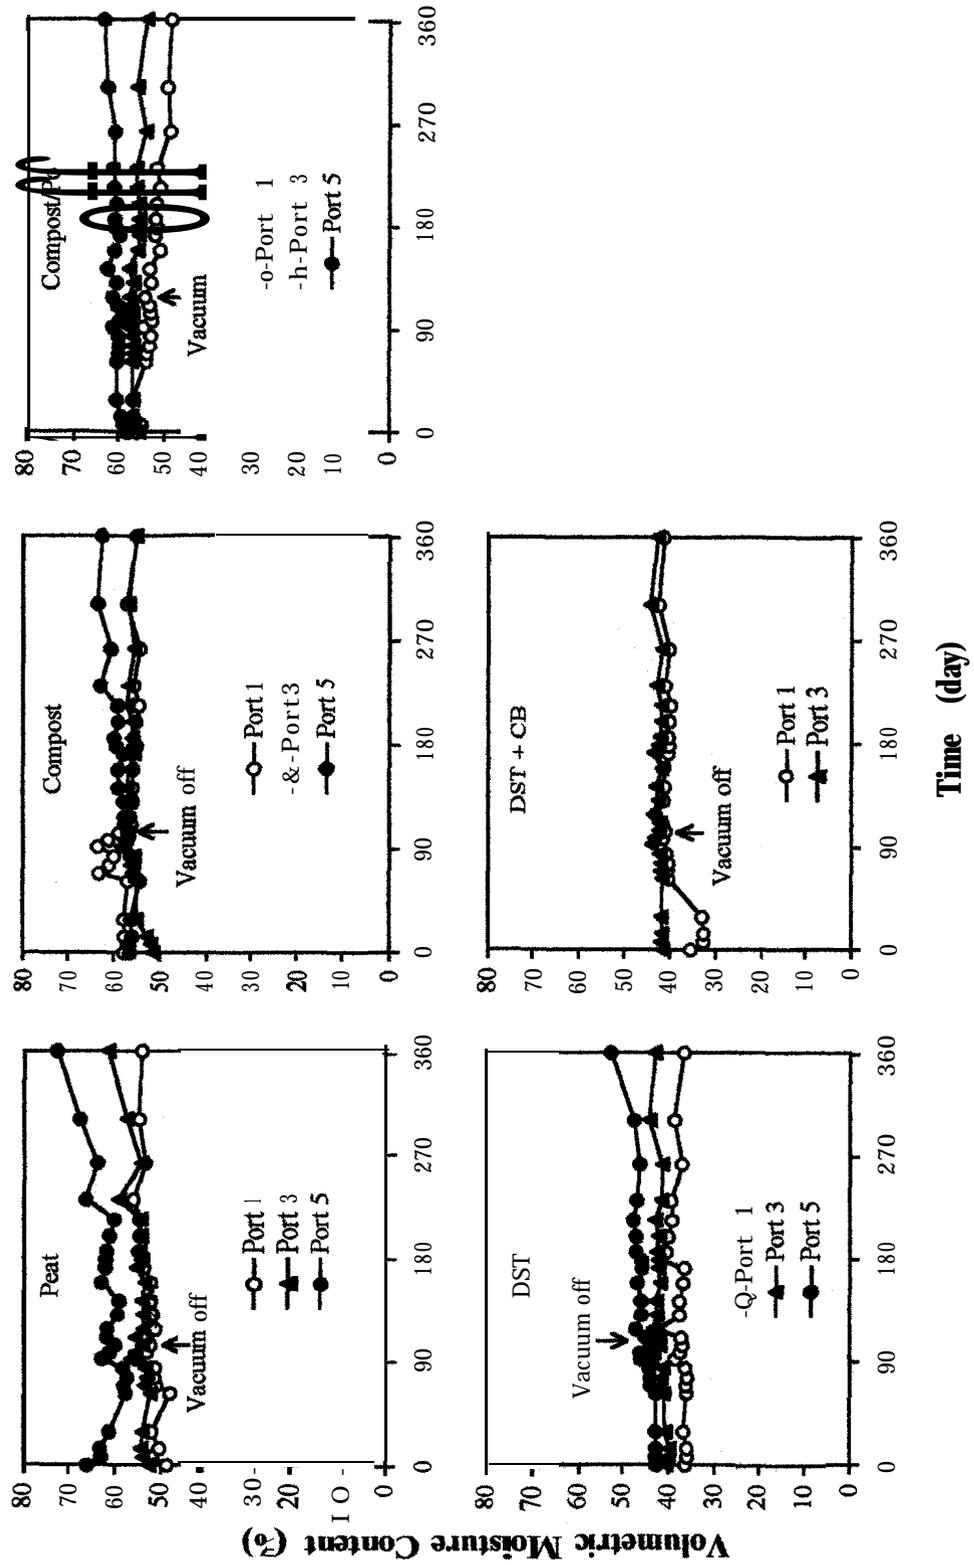
**Figure 29. Volumetric Moisture Content by TDR vs. Time for Different Cover Materials**

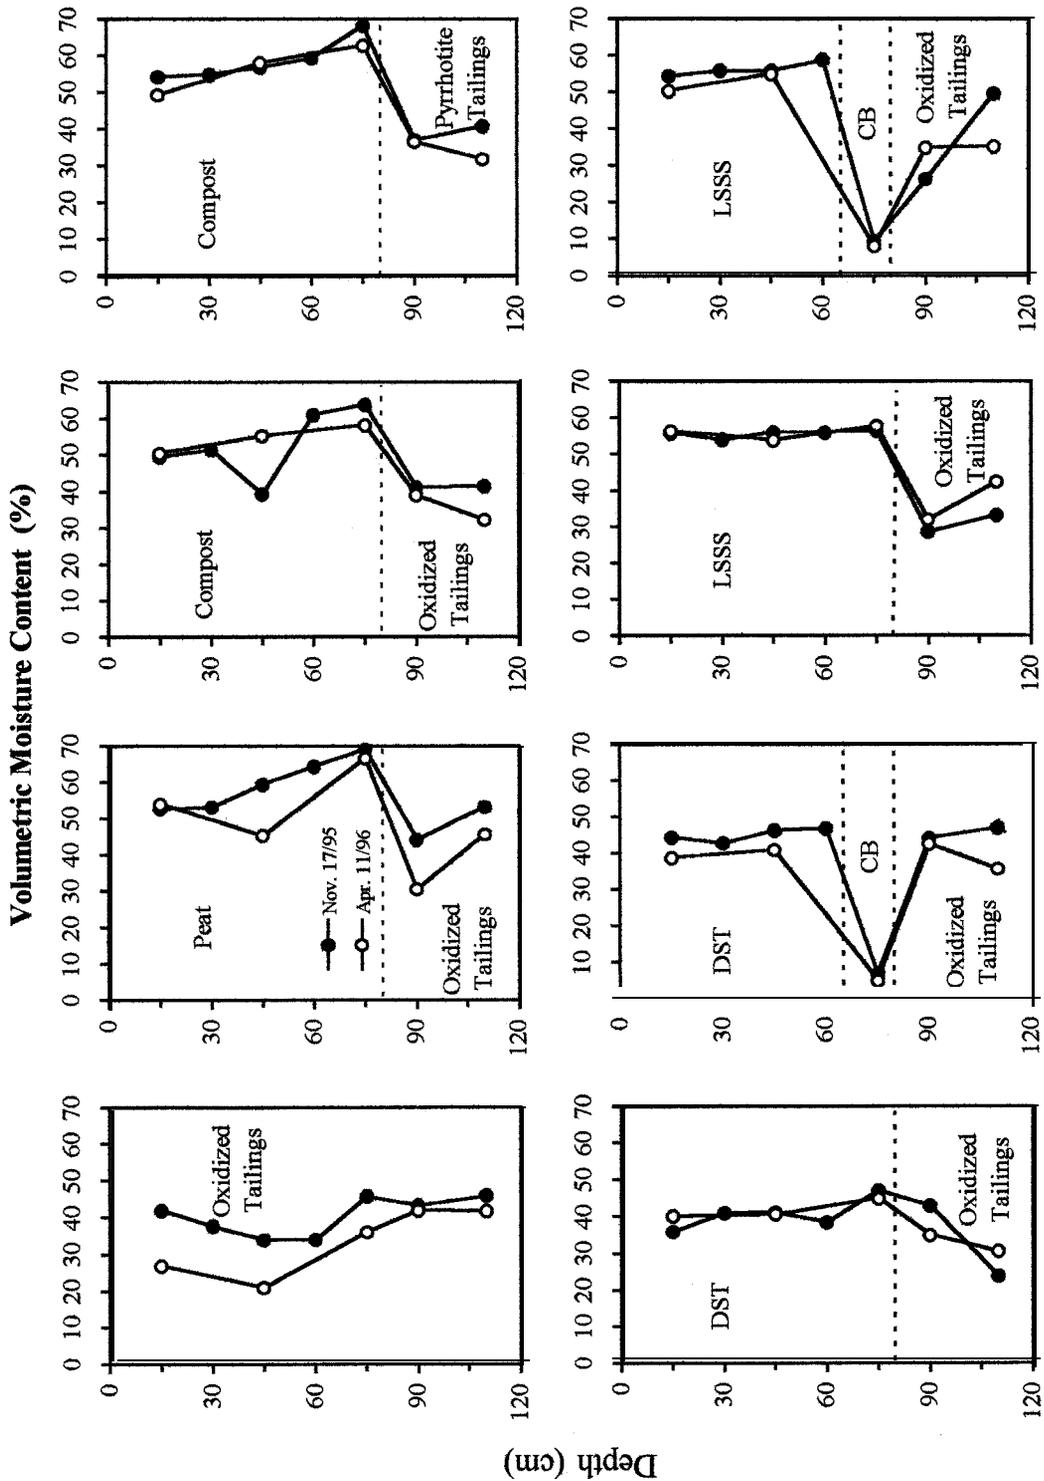
**Figure 30. In-situ Volumetric Moisture Content vs. Depth for Different Cover Materials**

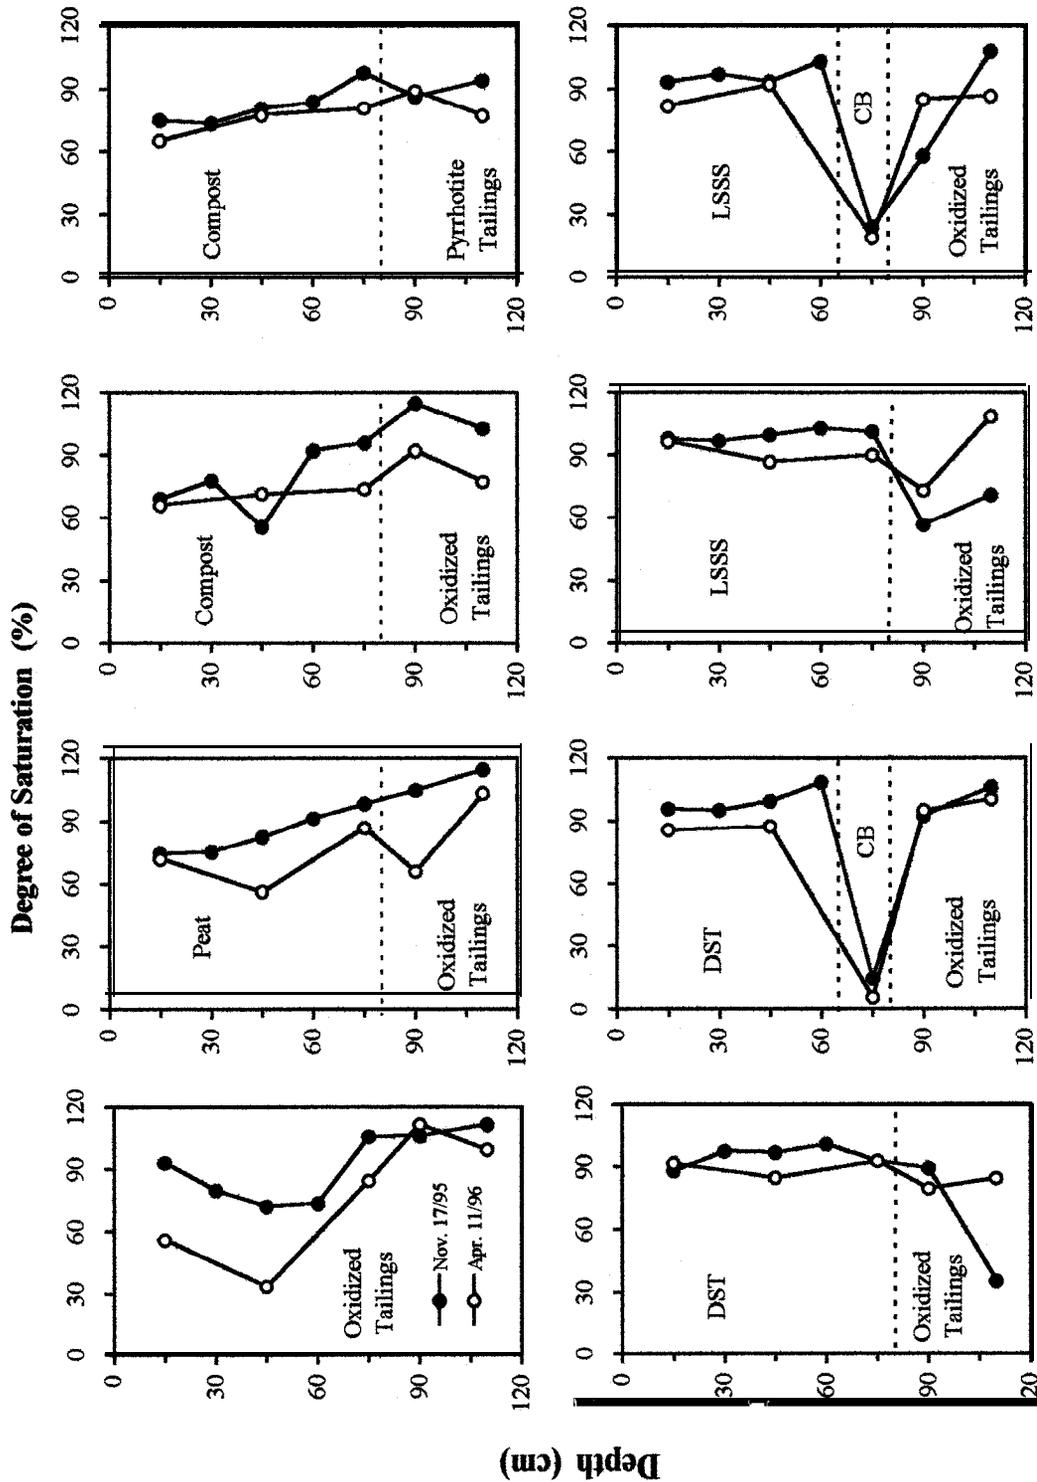
**Figure 31. Degree of Saturation vs. Depth for Different Cover Materials**
