**EVALUATION OF THE USE OF  
COVERS FOR REDUCING ACID  
GENERATION FROM  
STRATHCONA TAILINGS**

**MEND Project 2.25.3**

**EVALUATION OF THE USE OF COVERS  
FOR REDUCING ACID GENERATION  
FROM STRATHCONA TAILINGS  
7777-112  
MEND Project 2.25.3**

Final Report

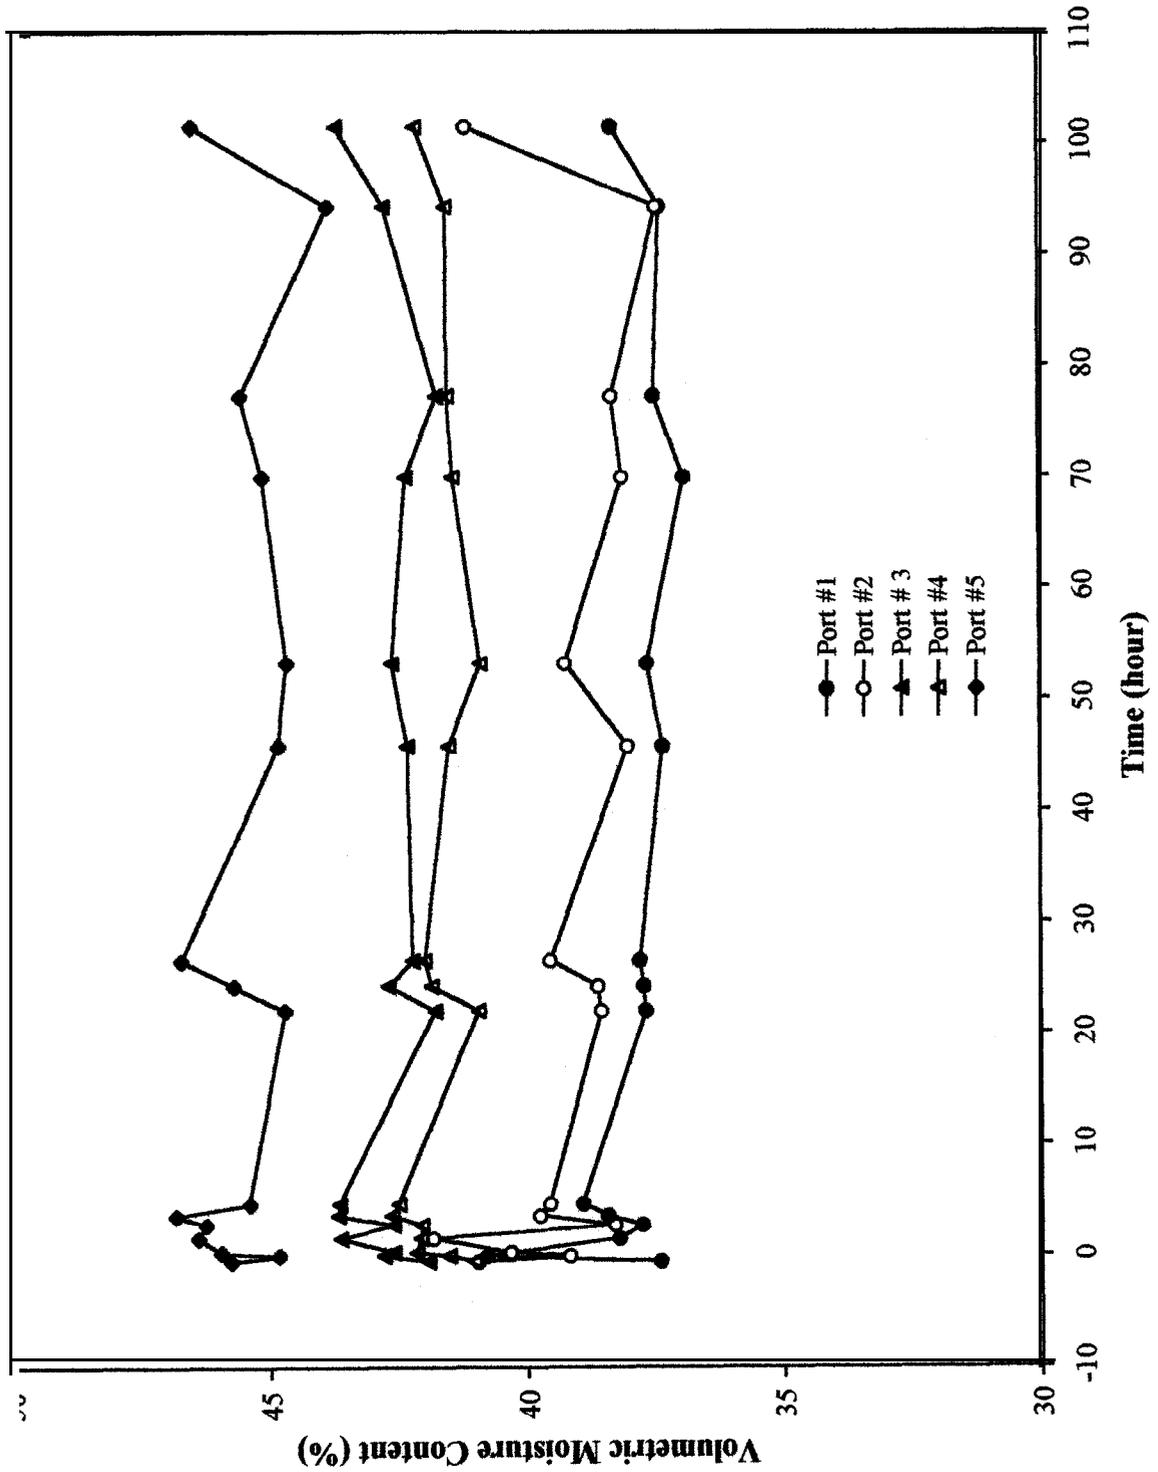
**Figure 32. Volumetric Moisture Content Before and After Rainfall at Different Sample Ports in Strathcona Pilot Cell #3 (DST over Oxidized Tailings)**

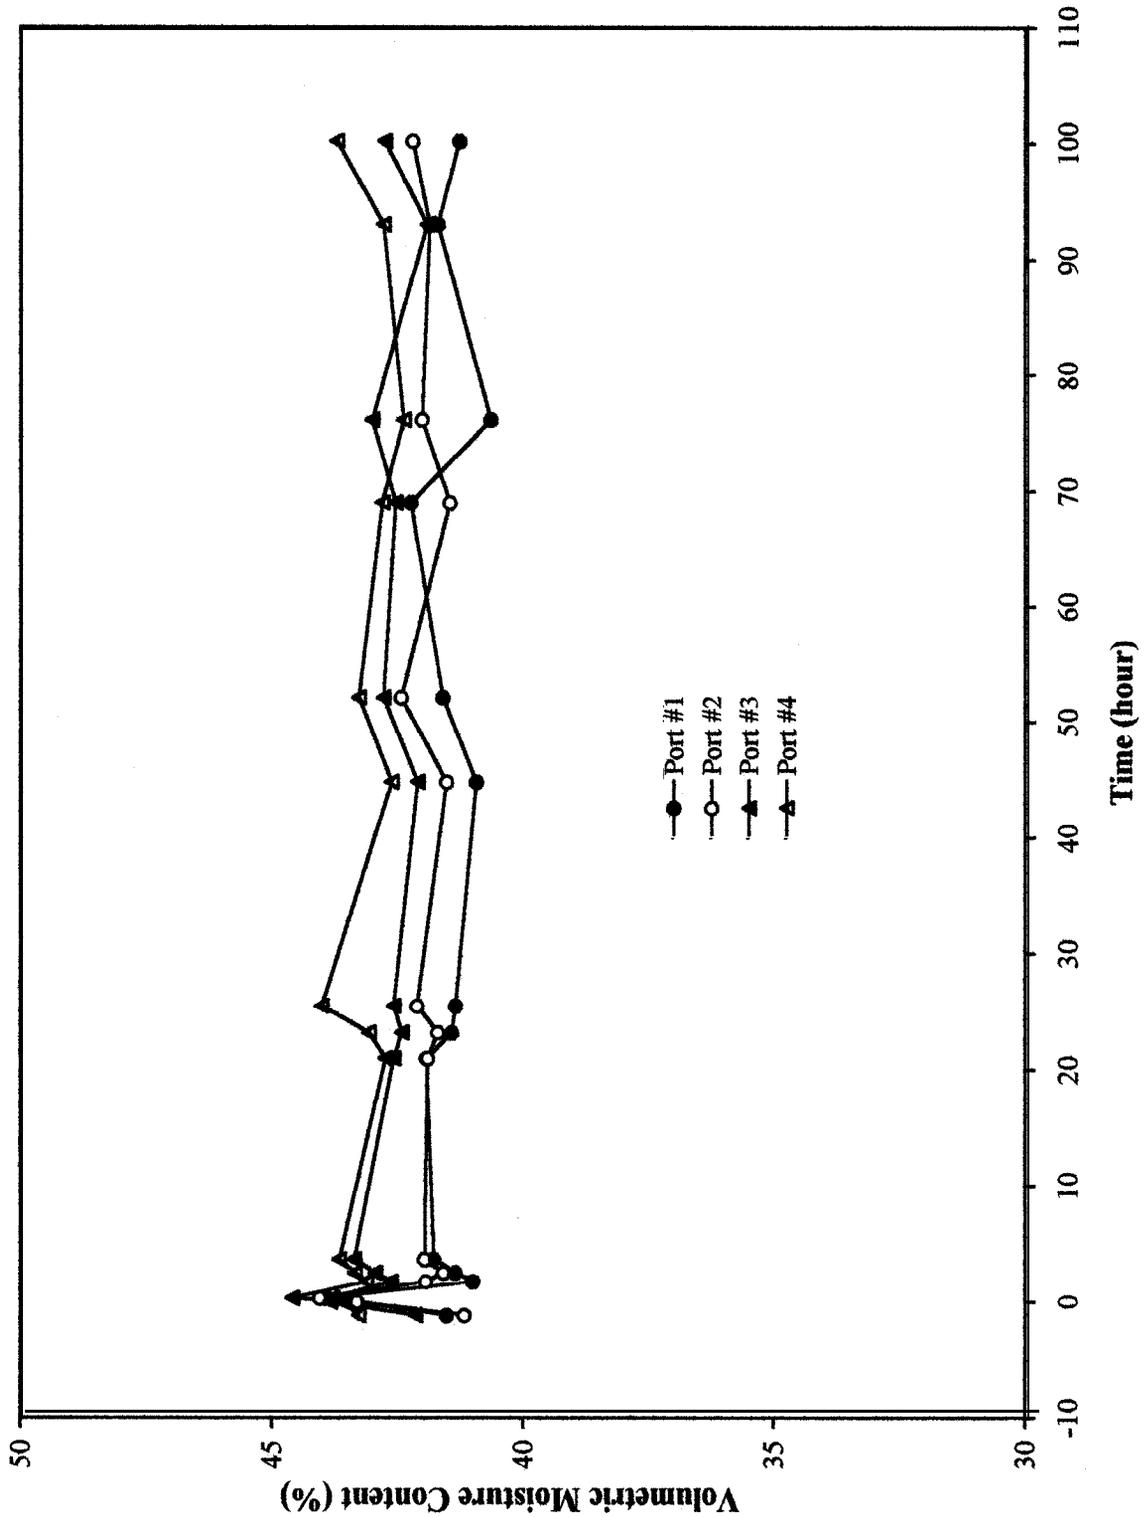
Figure 33. Volumetric Moisture Content Before and After Rainfall at Different Sample Ports in Strathcona Pilot Cell #6 (DST+CB over Oxidized Tailings)

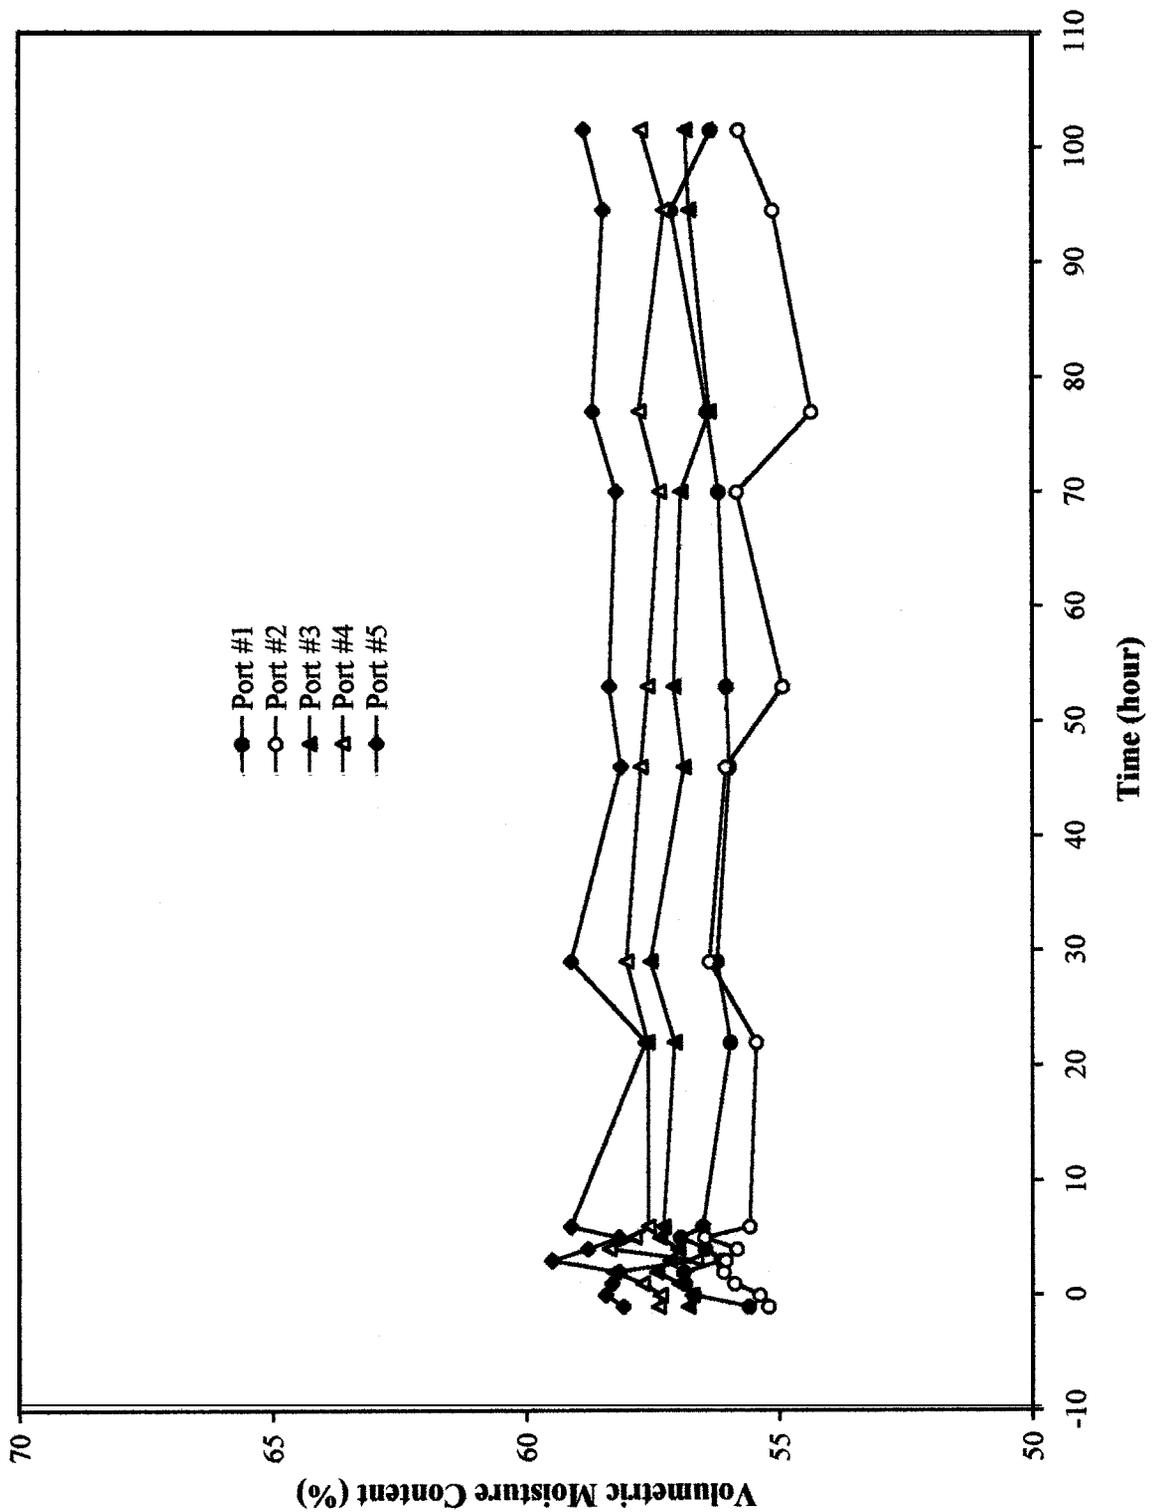
**Figure 34. Volumetric Moisture Content Before and After Rainfall at Different Sample Ports in Strathcona Pilot Cell #4 (Compost over Oxidized Tailings)**

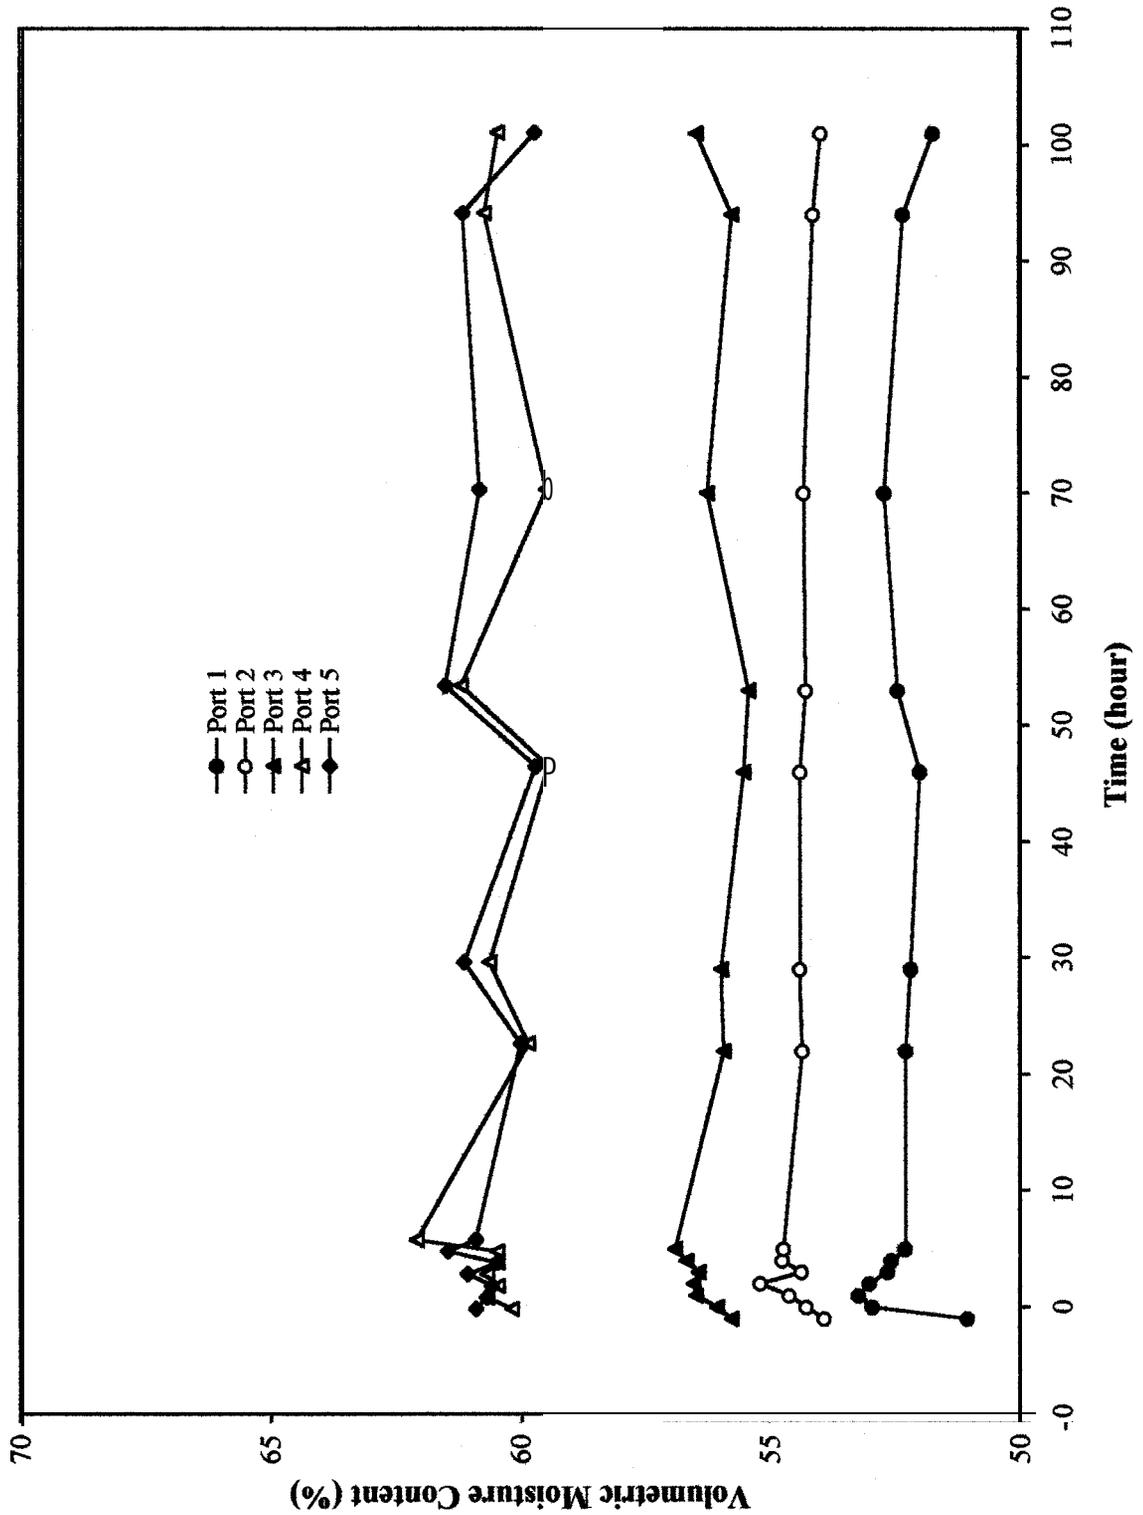
Figure 35, Volumetric Moisture Content Before and After Rainfall at Different Sample Ports in Strathcona Pilot Cell #8 (Compost over Pyrrhotite Tailings)

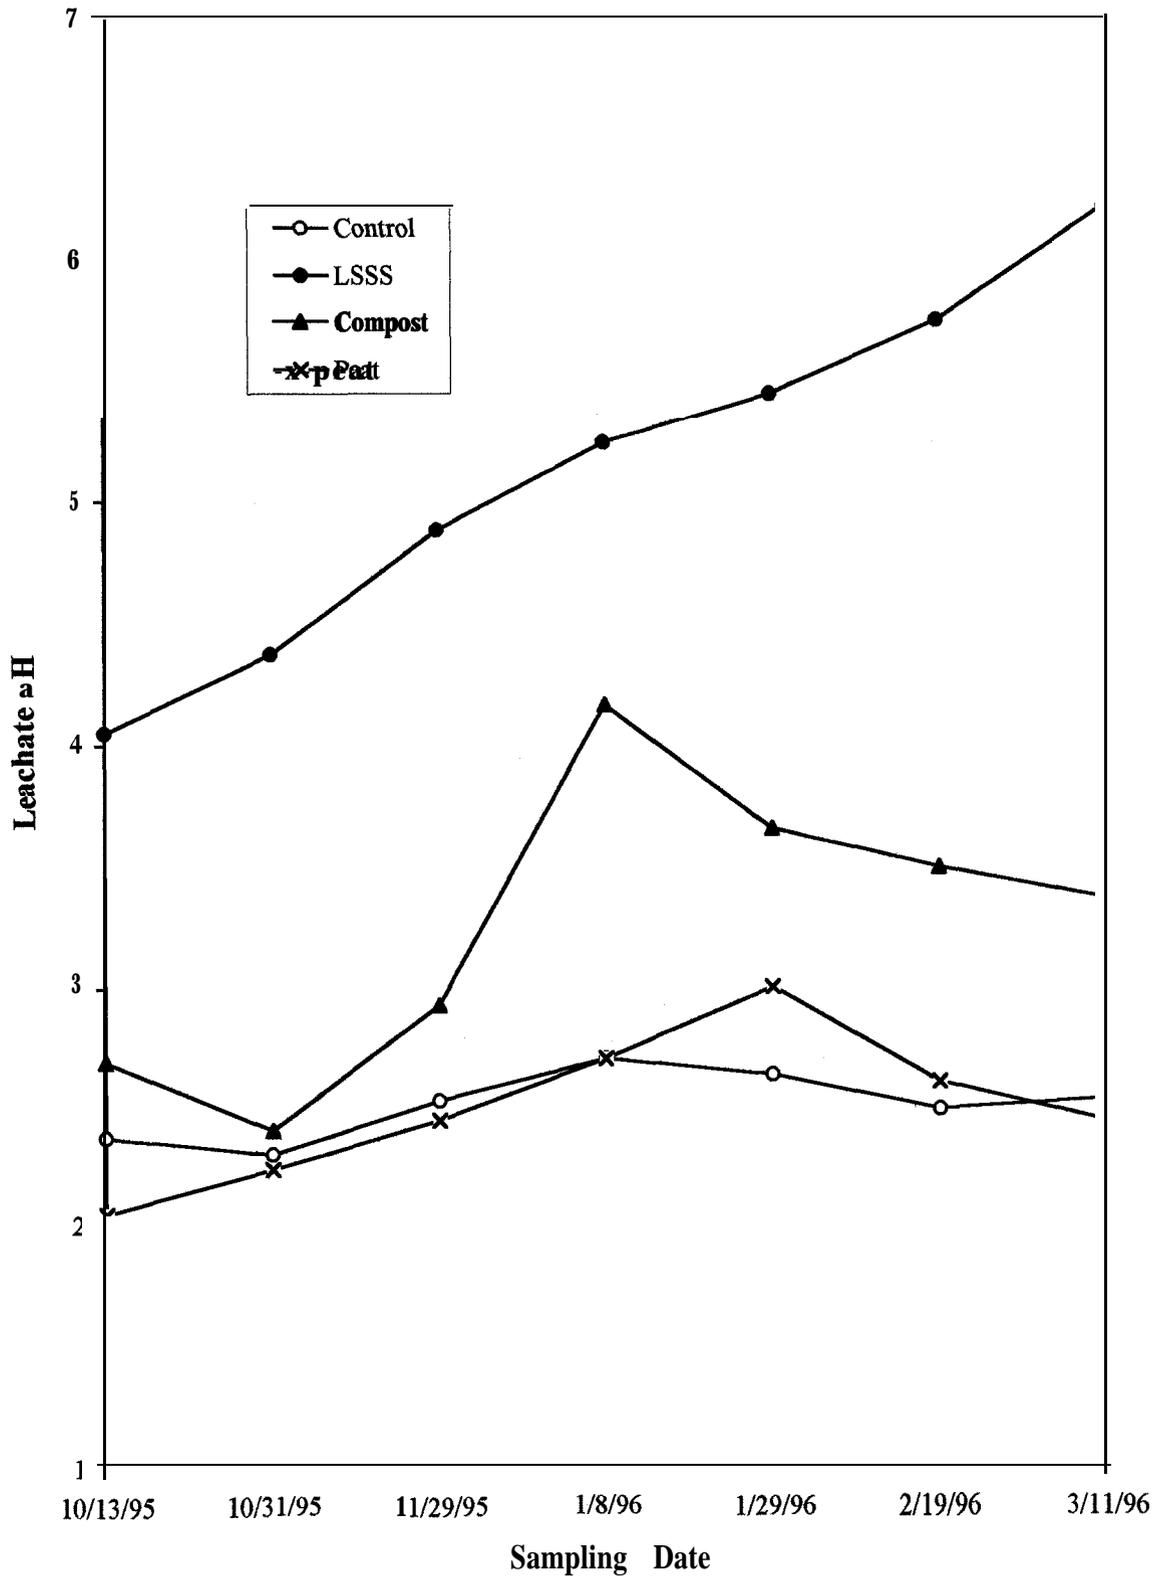
Figure 36. Leachate pH Changes in the Control Cell and in the Cover Cells

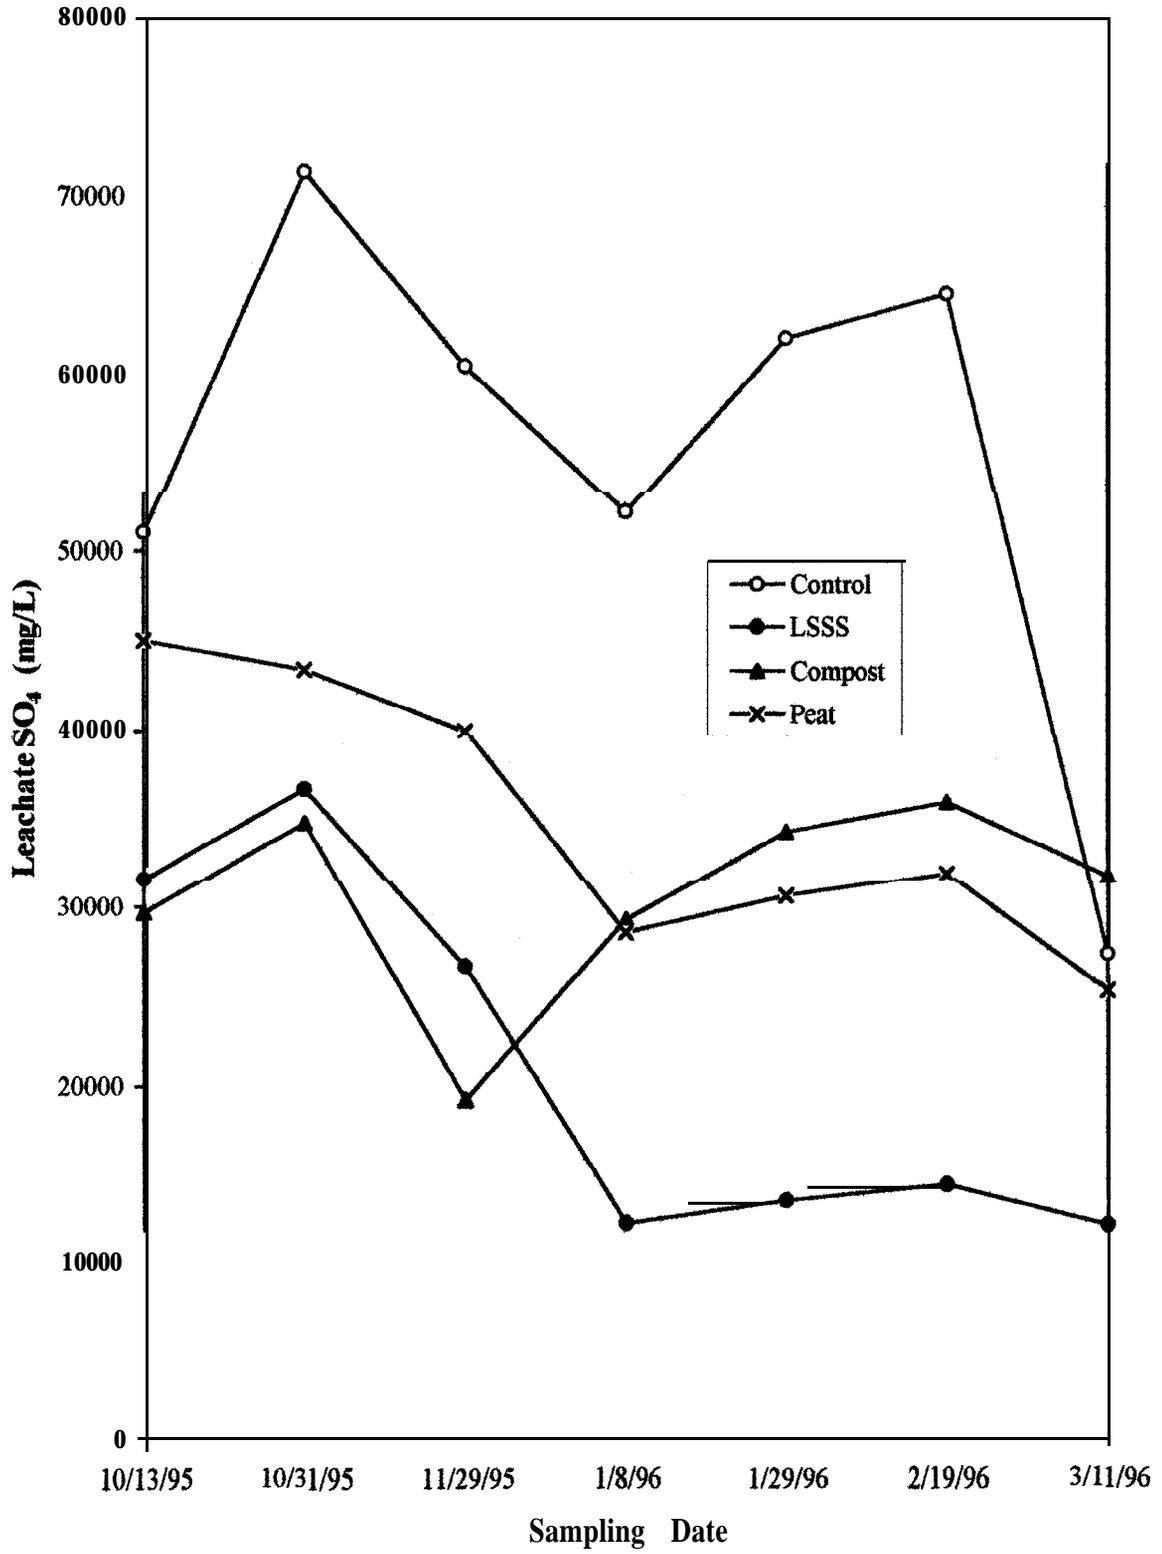
Figure 37. Leachate SO<sub>4</sub> Changes in the Control Cell and in the Cover Cells

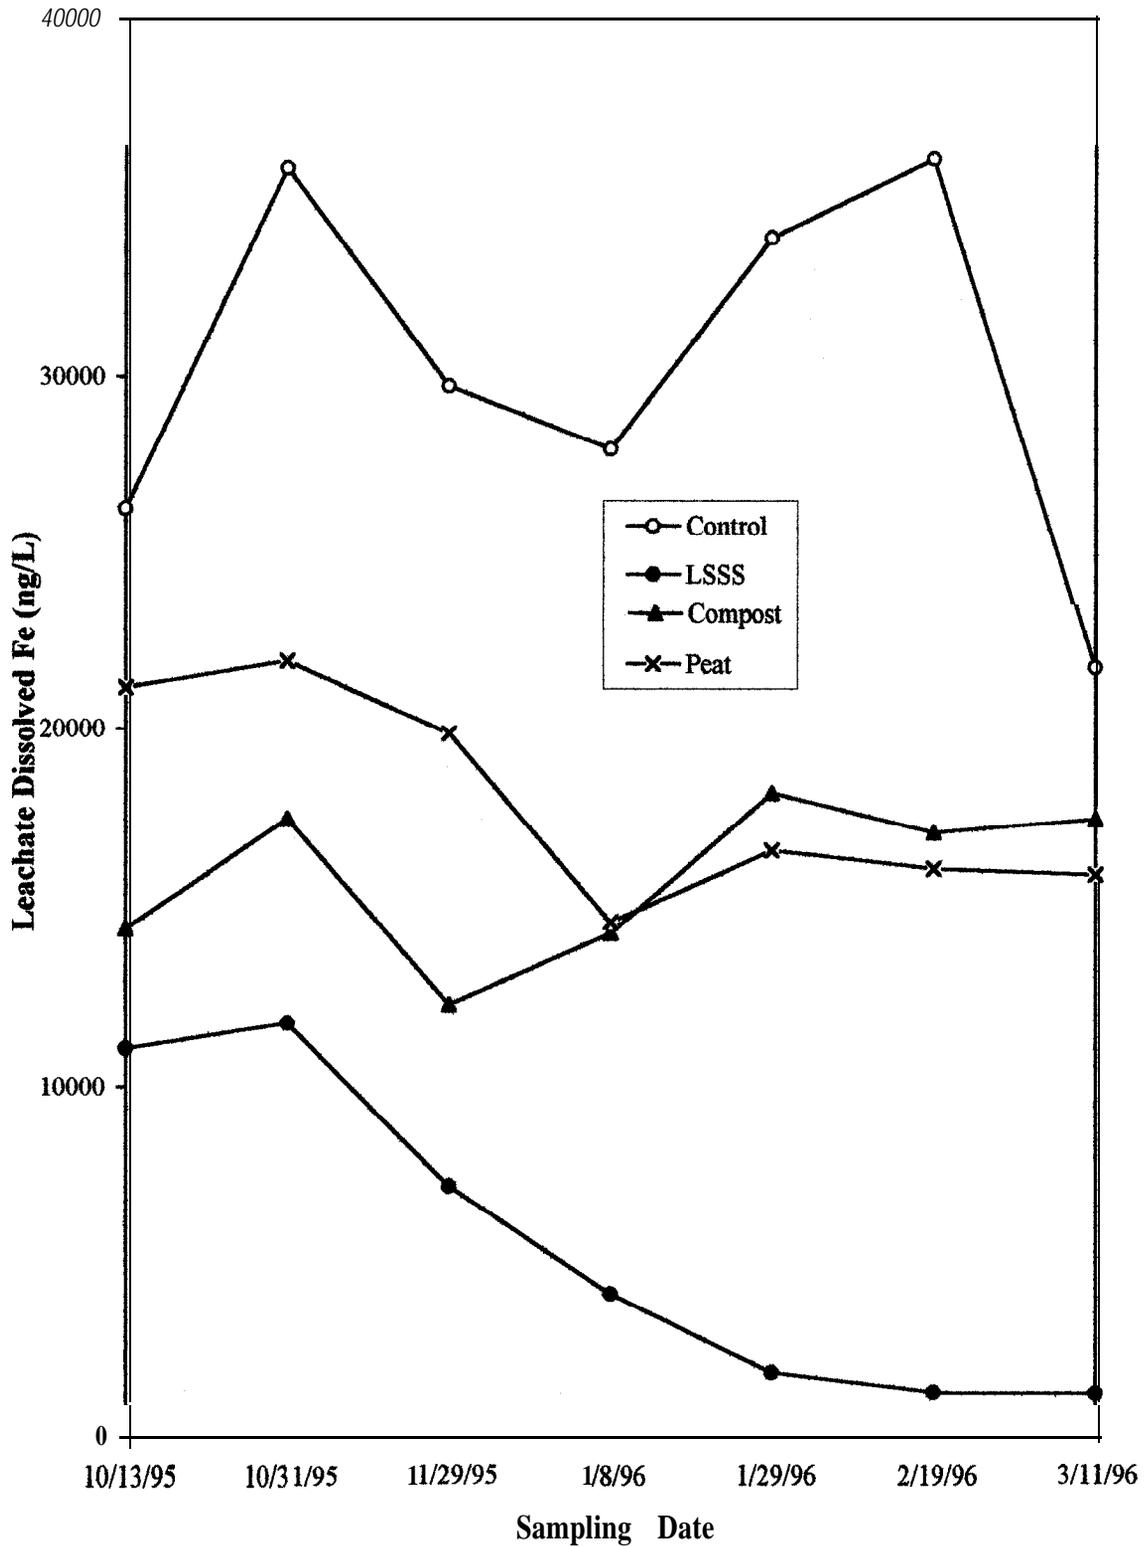
Figure 38. Changes in **Leachate Dissolved Fe Concentrations** in the Control Cell and in the Cover Cells

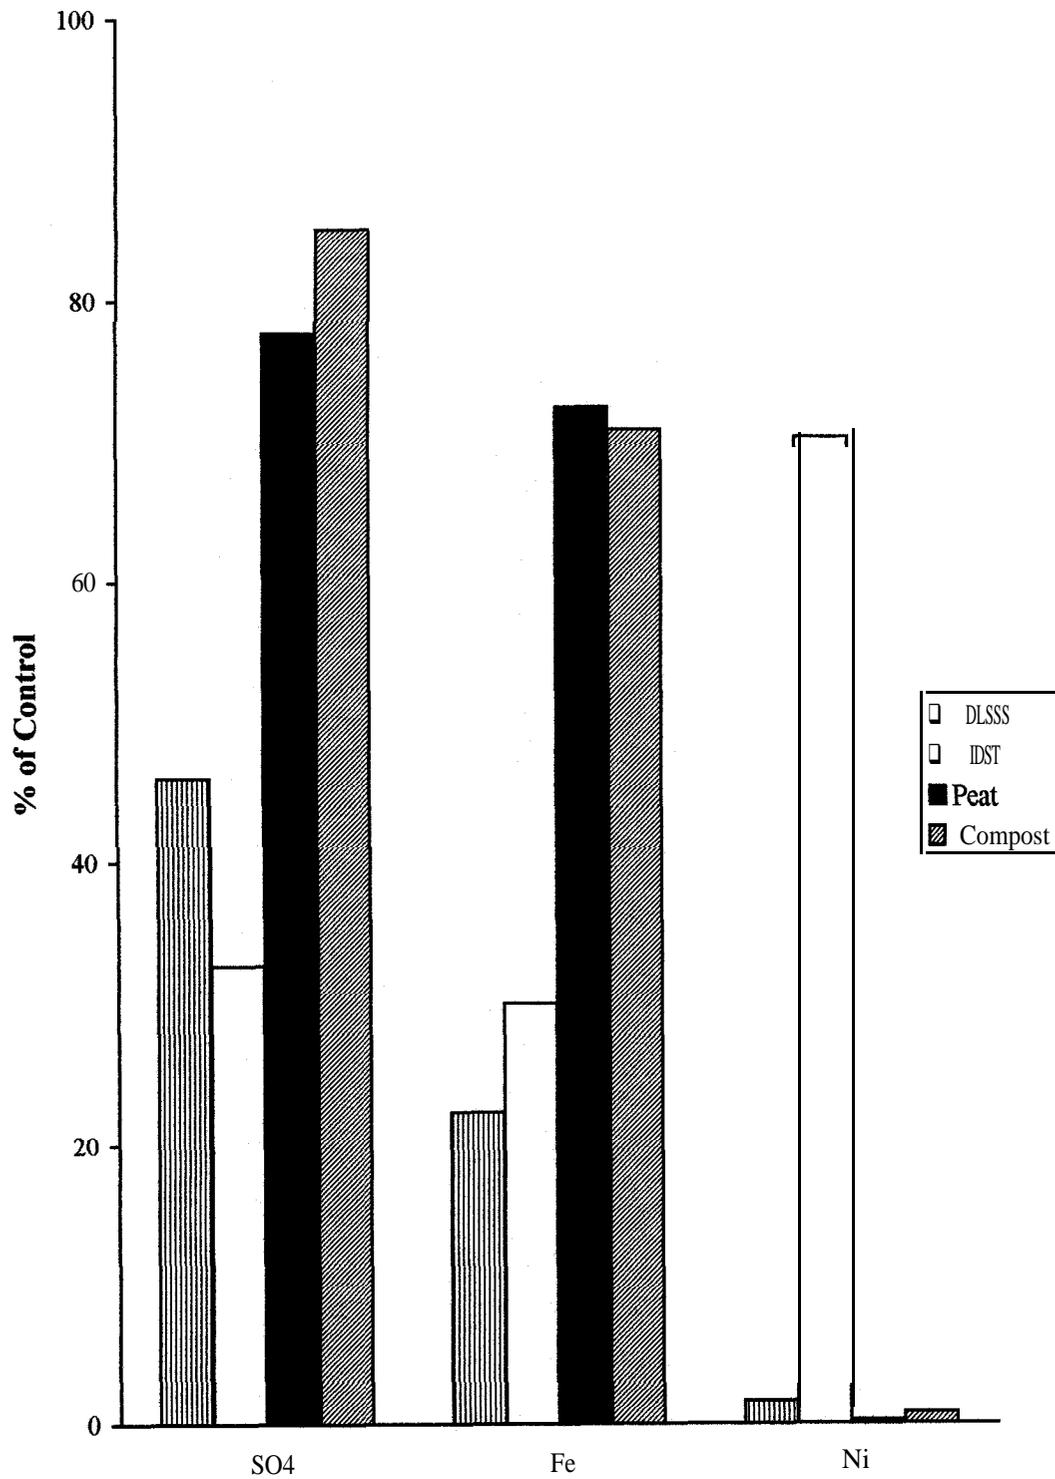
**Figure 39. Sulphate, Iron and Nickel Loading Relative to the Control Cell**

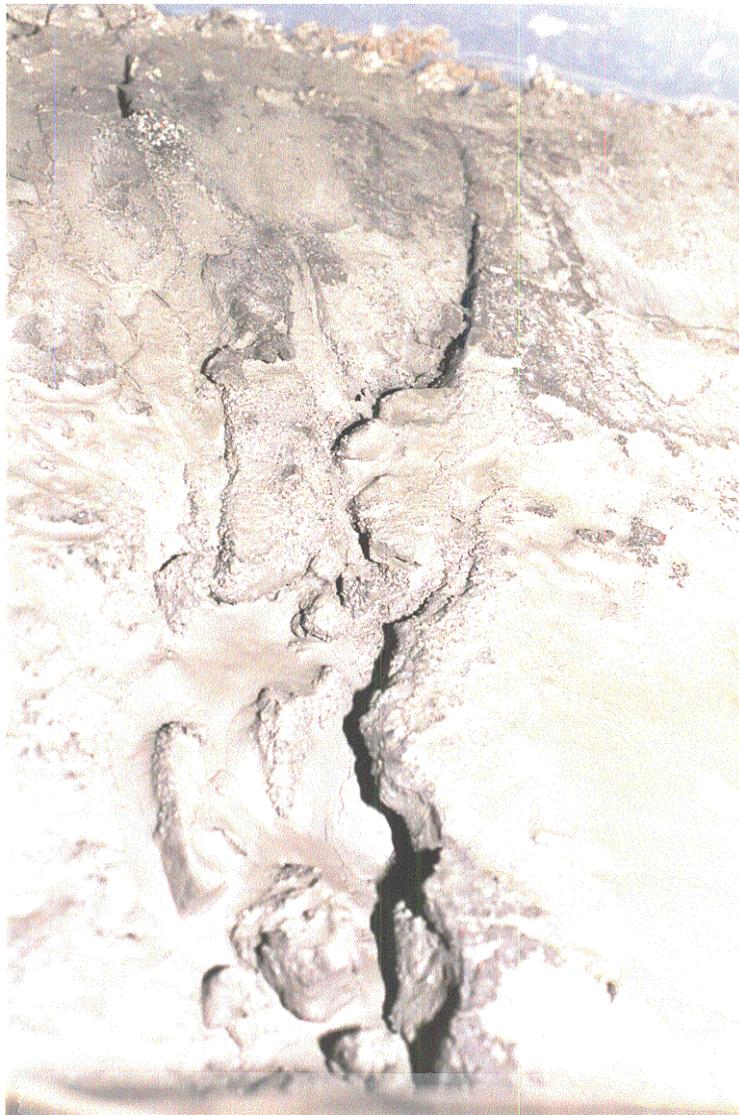
**Plate #8:**

**Surface Crack in Control Pilot Cell, July 1995**

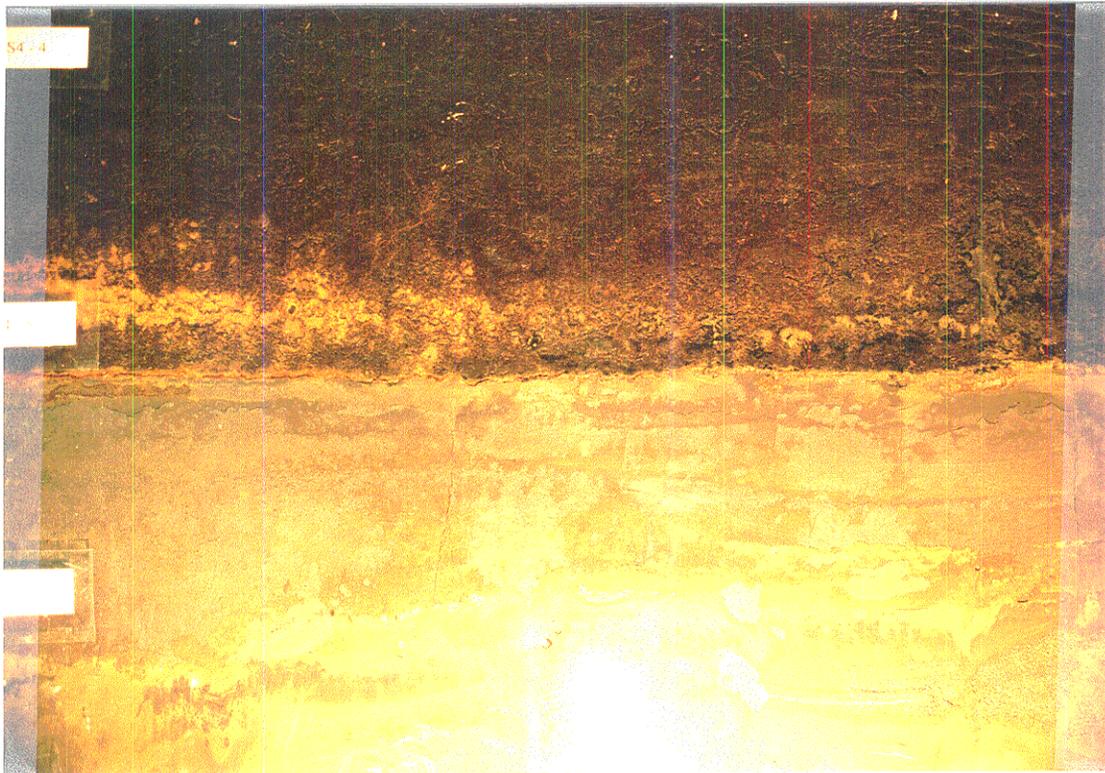
Plate #9:

Surface Crack in Desulphurized Tailings Cover, July 95

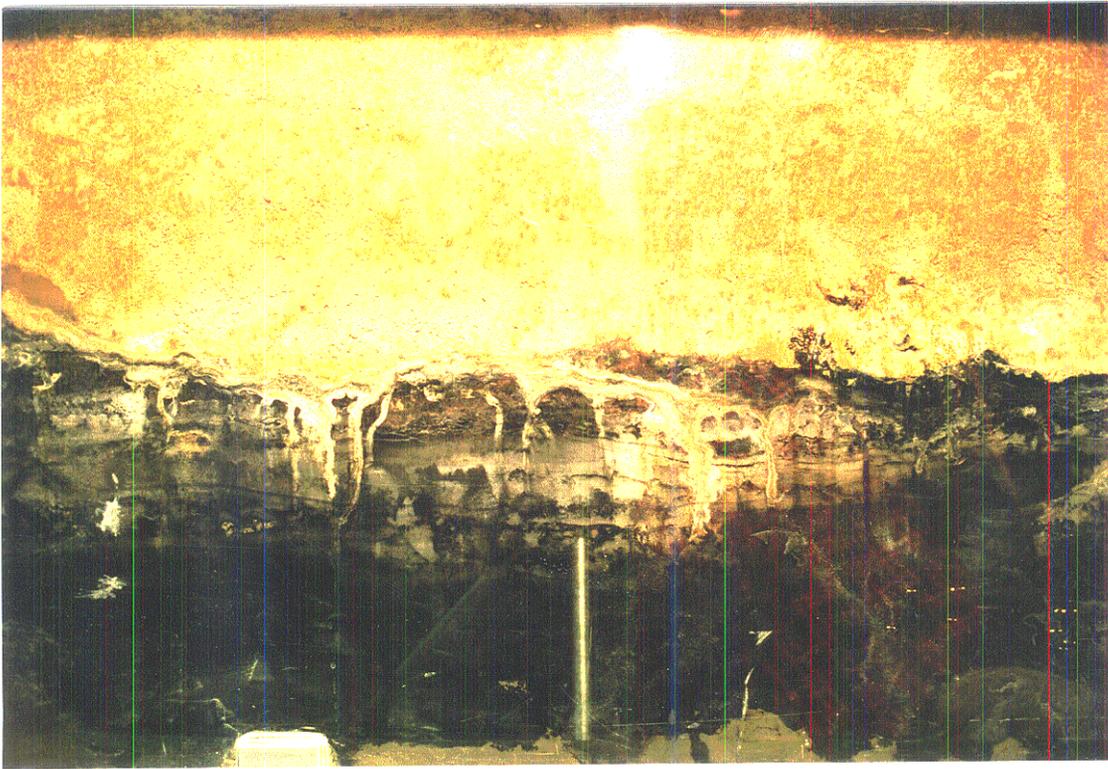
Plate #11:                    Interface Between Peat Cover and Oxidized Tailings November 1995

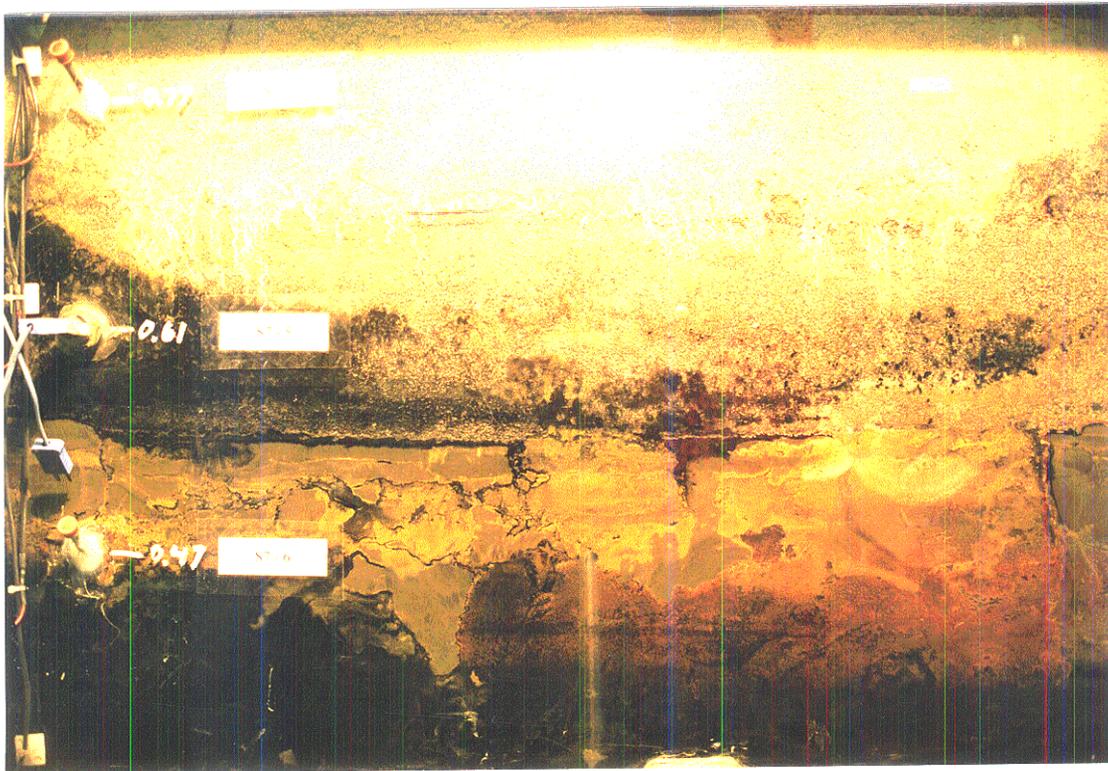
**Plate #12:**                    **Interface Between Lime Stabilized Sewage Sludge Cover and Oxidized Tailings, November 1995**

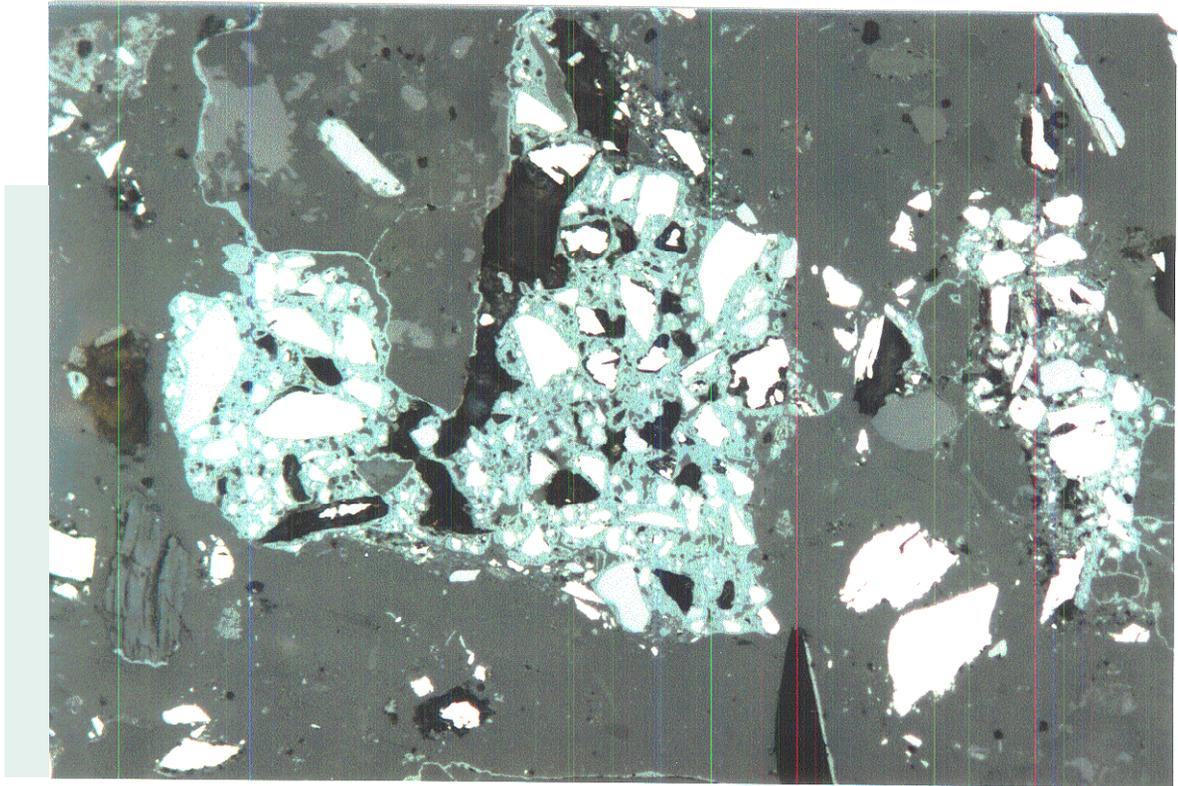
**Illustration #2**  
**Sample 1-0**

Photomicrograph of a representative limonite cemented 'clump' or aggregate. Limonite cementation is fairly compact, and occurs around both pyrrhotite (white) and silicates (dark-grey) alike. The occurrence of limonite around both sulphide and non-sulphide mineral components suggests local re-mobilization and precipitation of Fe-rich circulating fluids produced from active sulphide oxidation. Pyrrhotite within this cemented aggregate appears highly corroded and leached, and abundant cavities remain in the limonite (black holes).

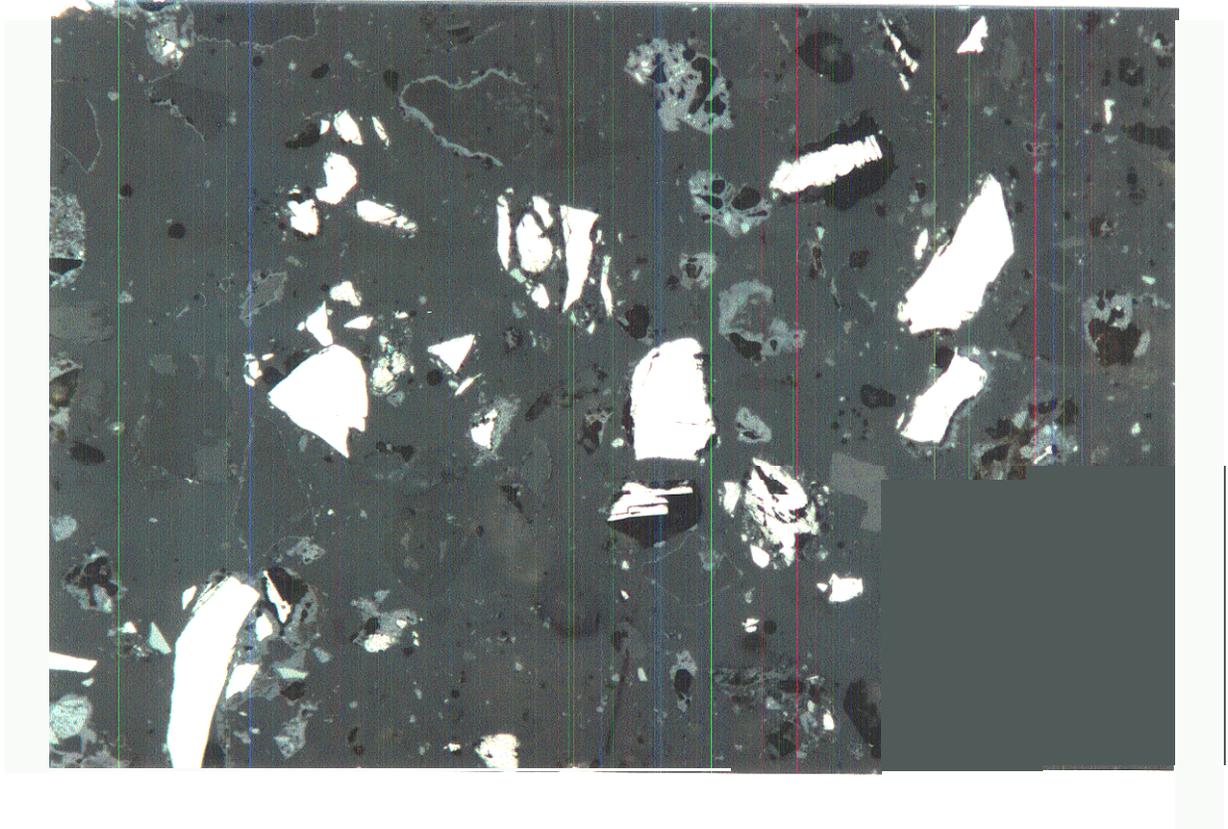
**Illustration #3**  
**Sample 1-U**

Photomicrograph of a representative highly compact limonite cemented aggregate. Note the pyrrhotite grains, ranging from relatively fresh (sharp grain boundaries) in appearance, to slightly oxidized (ragged margins), to highly corroded (leached grains within limonite 'clump'). Magnetite (light-grey) is also present within the limonite cements, and cements commonly form coatings around silicates.

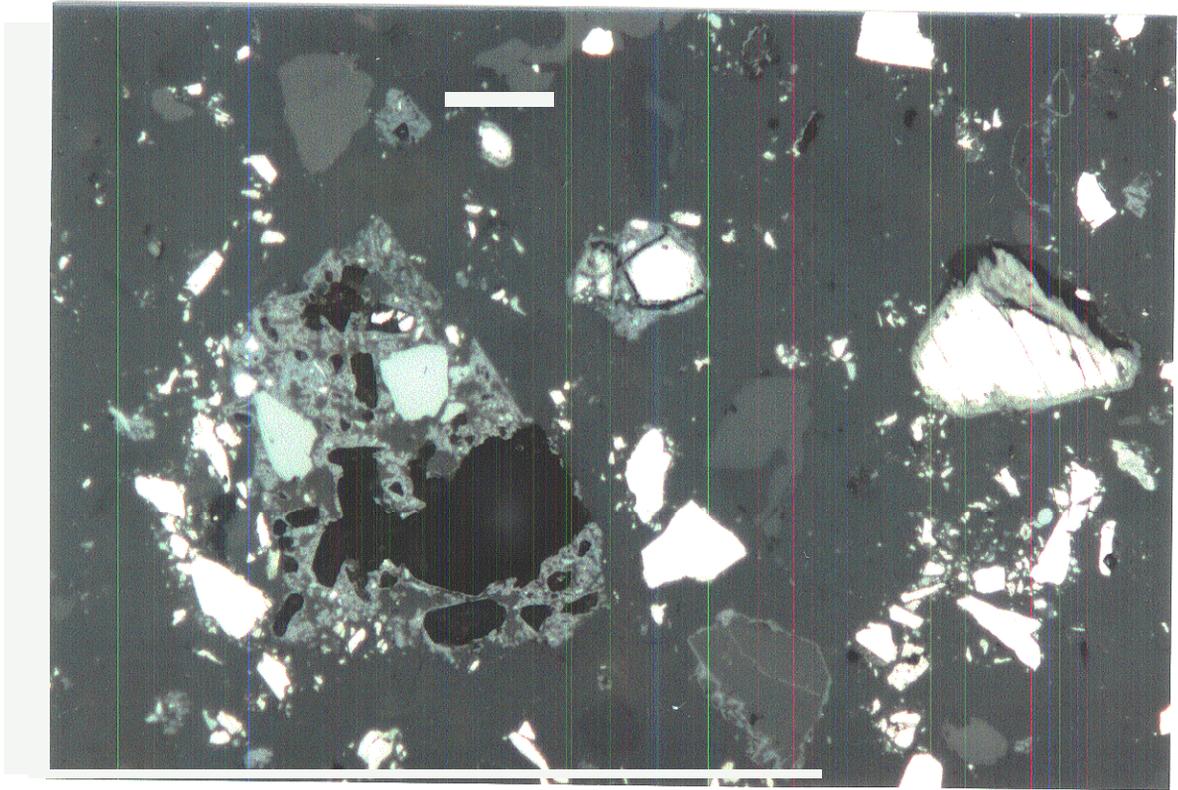
Illustration #5 Magnification 200x Incident Light  
Sample 1-6 PS 5760

Photomicrograph of representative pyrrhotite grains. showing initial breakdown along the crystallographic grain boundaries, indicative of incipient oxidation. Note abundant finer material surrounding a few pyrrhotite grains. and limonite (bluish-grey) rims.

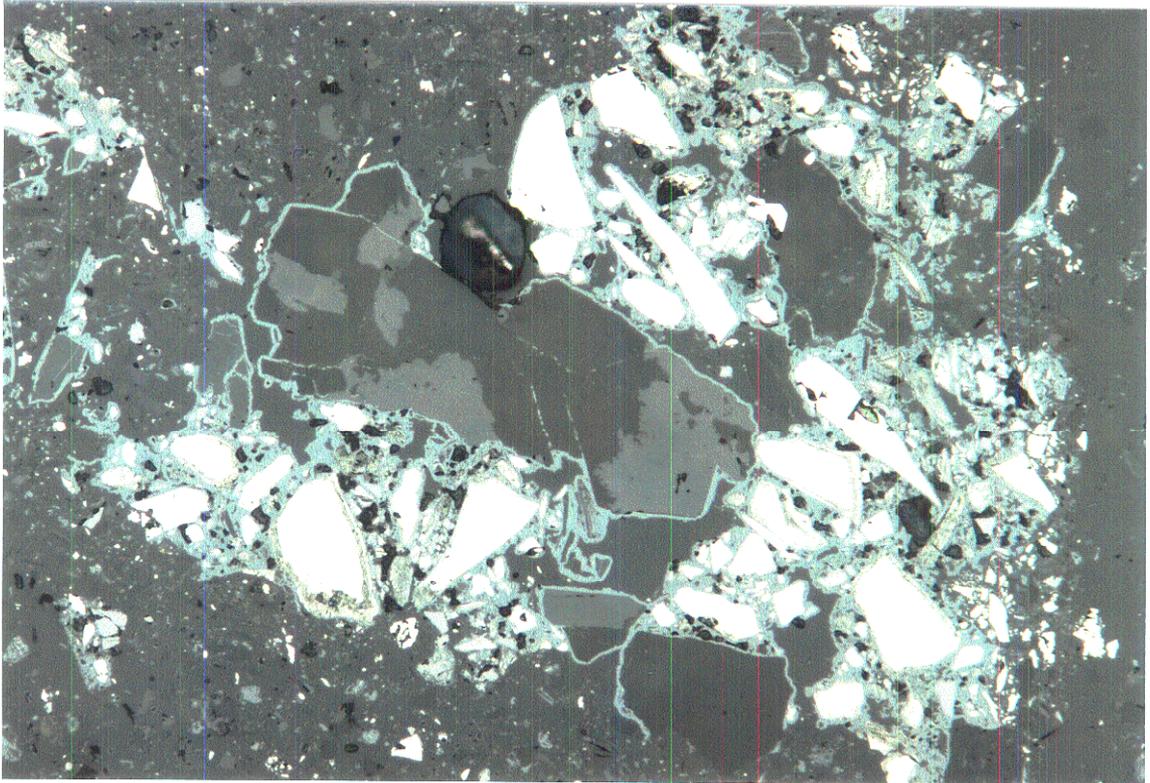
**Illustration #7**  
**Sample 2-6**

Photomicrograph of a representative limonite cemented 'clump'. Note almost all pyrrhotite grains occur within the cements. The majority of grains within the limonite cements show incipient effects of oxidation. Pyrrhotite within this cemented aggregate shows minor effects of oxidation with breakdown at the rims to an Fe-oxyhydroxide.

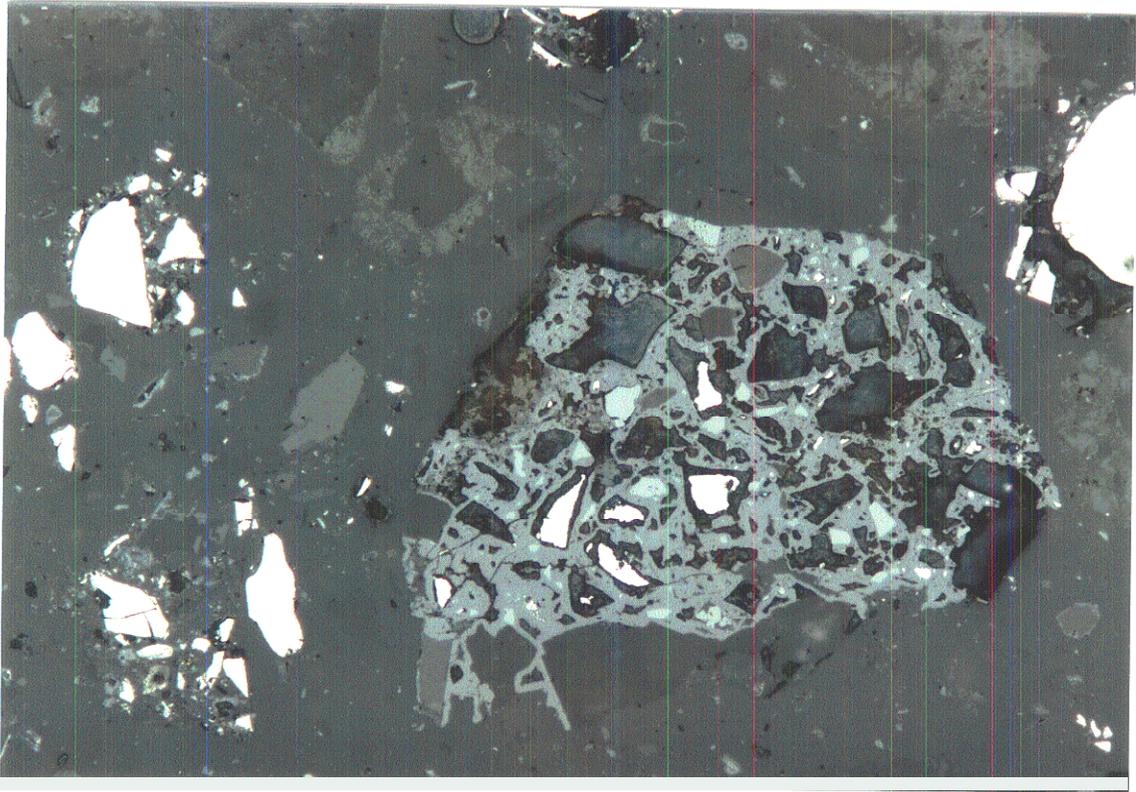
**Illustration #9**  
**Sample 3-6**

Photomicrograph of representative liberated pyrrhotite grains. The majority of pyrrhotite occurs within loose to compact limonite cemented 'clumps'. Pyrrhotite in this photomicrograph appears to be leached around its margins.
