**EVALUATION OF THE USE OF  
COVERS FOR REDUCING ACID  
GENERATION FROM  
STRATHCONA TAILINGS**

**MEND Project 2.25.3**

**EVALUATION OF THE USE OF COVERS  
FOR REDUCING ACID GENERATION  
FROM STRATHCONA TAILINGS  
7777-112  
MEND Project 2.25.3**

Final Report

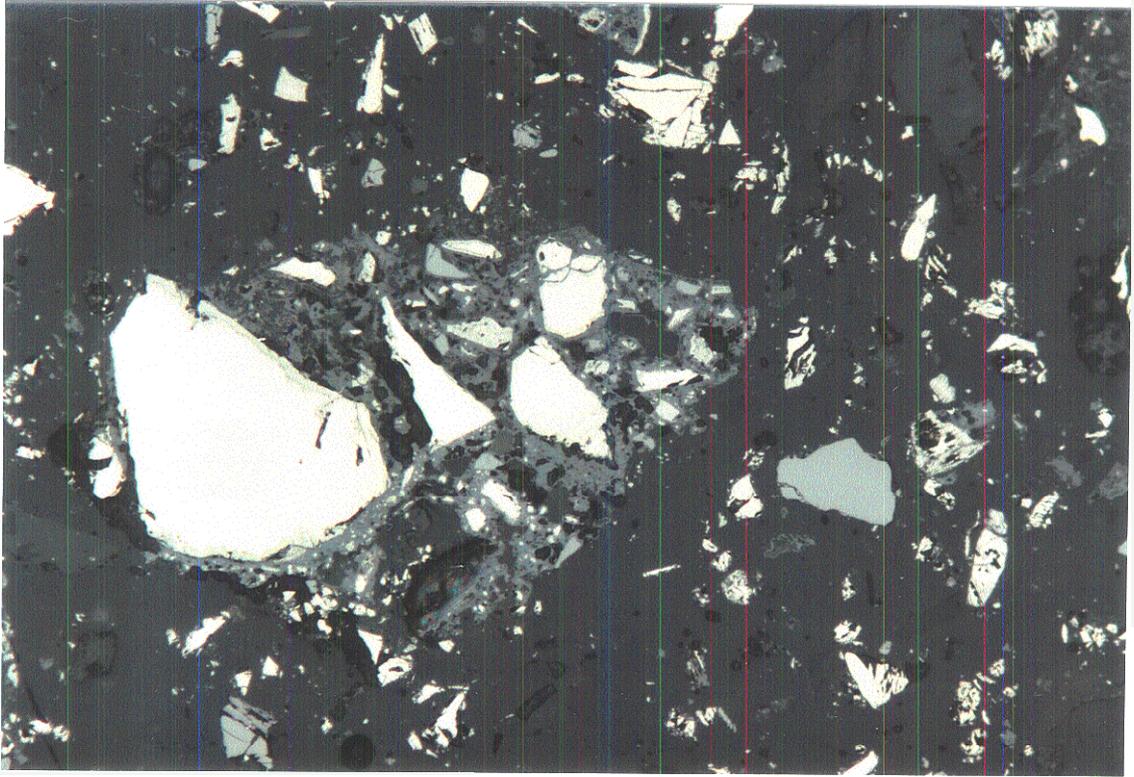
**Illustration #11**  
**Sample 4-6**

Photomicrograph of representative pyrrhotite grains. The majority of pyrrhotite occurs as liberated grains, which show evidence of incipient oxidation in the form of cracked and ragged grain boundaries. A minor proportion show alteration to an Fe-oxyhydroxide.

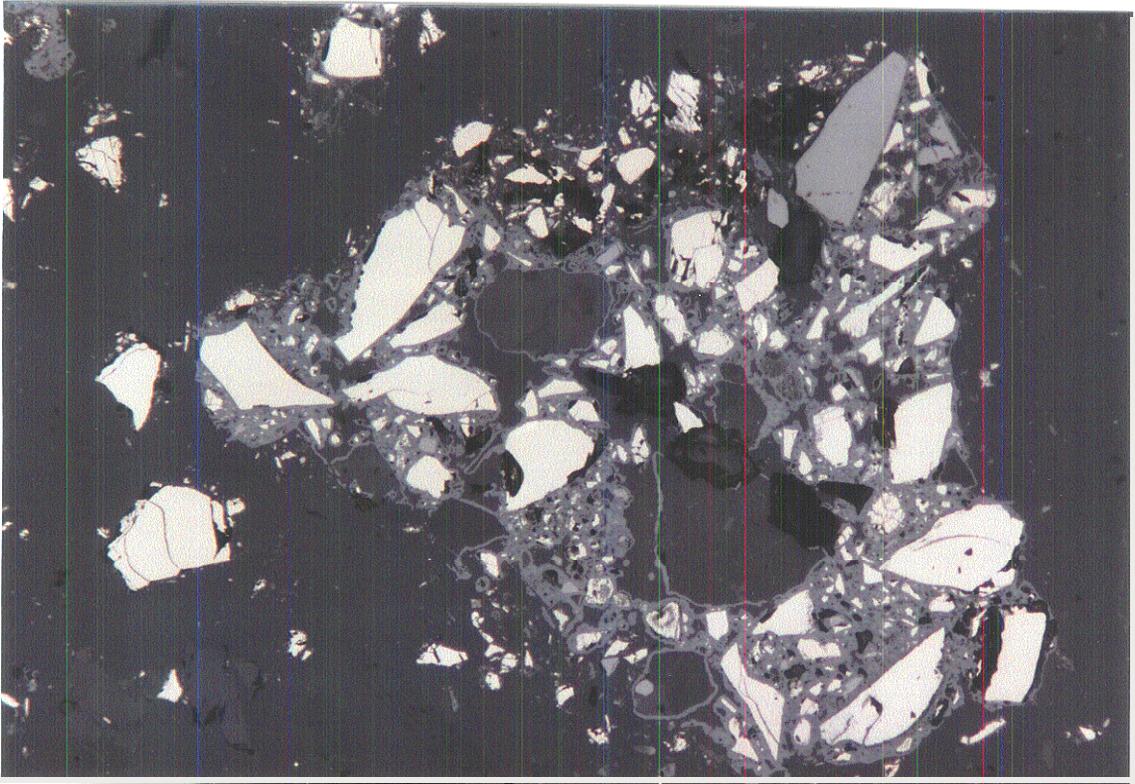
Illustration #13  
Sample 5-6

Photomicrograph of representative pyrrhotite grains (creamy white). The majority of pyrrhotite occurs as liberated grains, which show evidence of incipient oxidation in the form of cracked and ragged grain boundaries. A minor proportion show alteration to an Fe-oxyhydroxide (centre-left, and top-centre). Magnetite is rare to absent in this sample (< 1% of total sample).

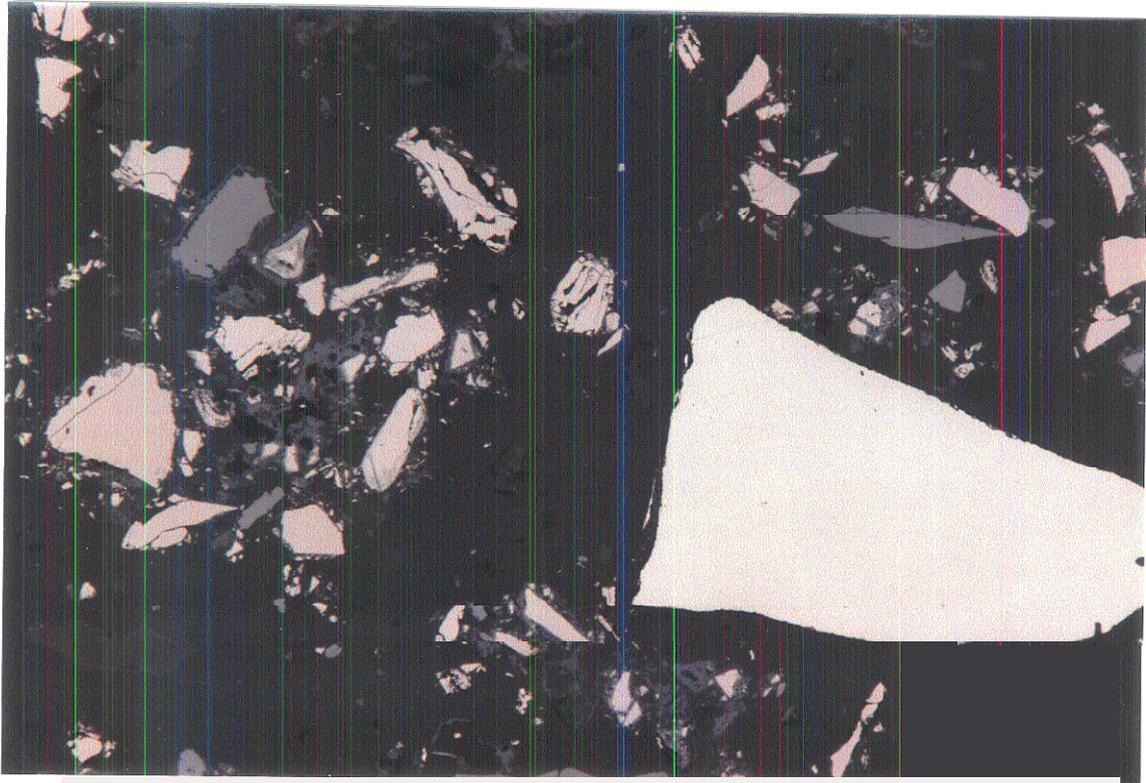
**Illustration #15**  
**Sample 6-6**

Photomicrograph of a loosely cemented limonite aggregate. Note the relatively fresh appearance of pyrrhotite grains in this photomicrograph, and the abundance of pyrrhotite fines ( $< 30 \mu\text{m}$ ). A minor proportion of pyrrhotite shows incipient breakdown in the form of ragged grain margins.

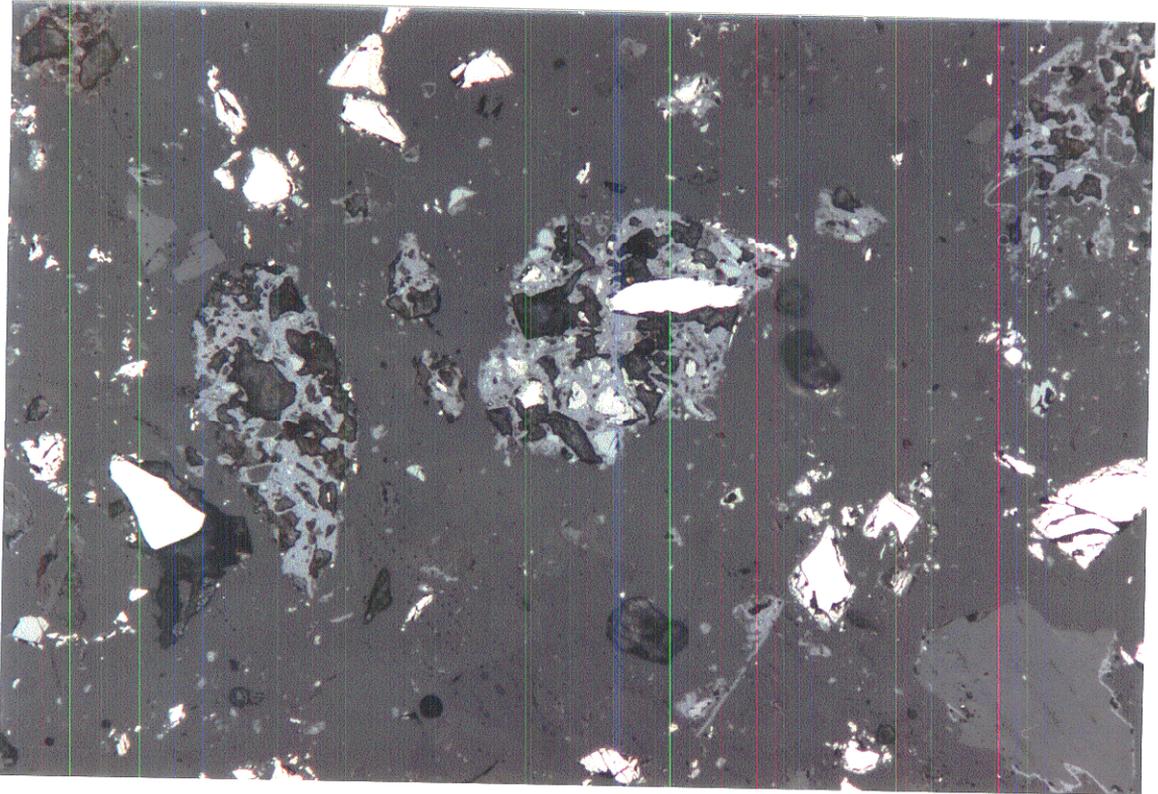
Illustration #17  
Sample 7-6

Photomicrograph of representative pyrrhotite grains. The majority of pyrrhotite occurs within limonite cemented 'clumps' (left-centre), and a minor proportion occurs as liberated grains (right-bottom, and right-centre). Almost all pyrrhotite enclosed by limonite cements are moderately oxidized with rims of Fe-oxyhydroxide or leached margins. Liberated pyrrhotite grains show incipient to moderate effects of oxidation (ragged margins and rims of Fe-oxyhydroxide).
