**ACID ROCK DRAINAGE  
REMEDATION MEASURES  
AT FOUR NORWEGIAN MINES**

**MEND Report 2.33.1**

**November 1991**

**STEFFEN, ROBERTSON AND KIRSTEN (B.C.) INC.  
Suite 800 - 580 Hornby Street  
Vancouver, British Columbia  
Canada, V6C 3B6**

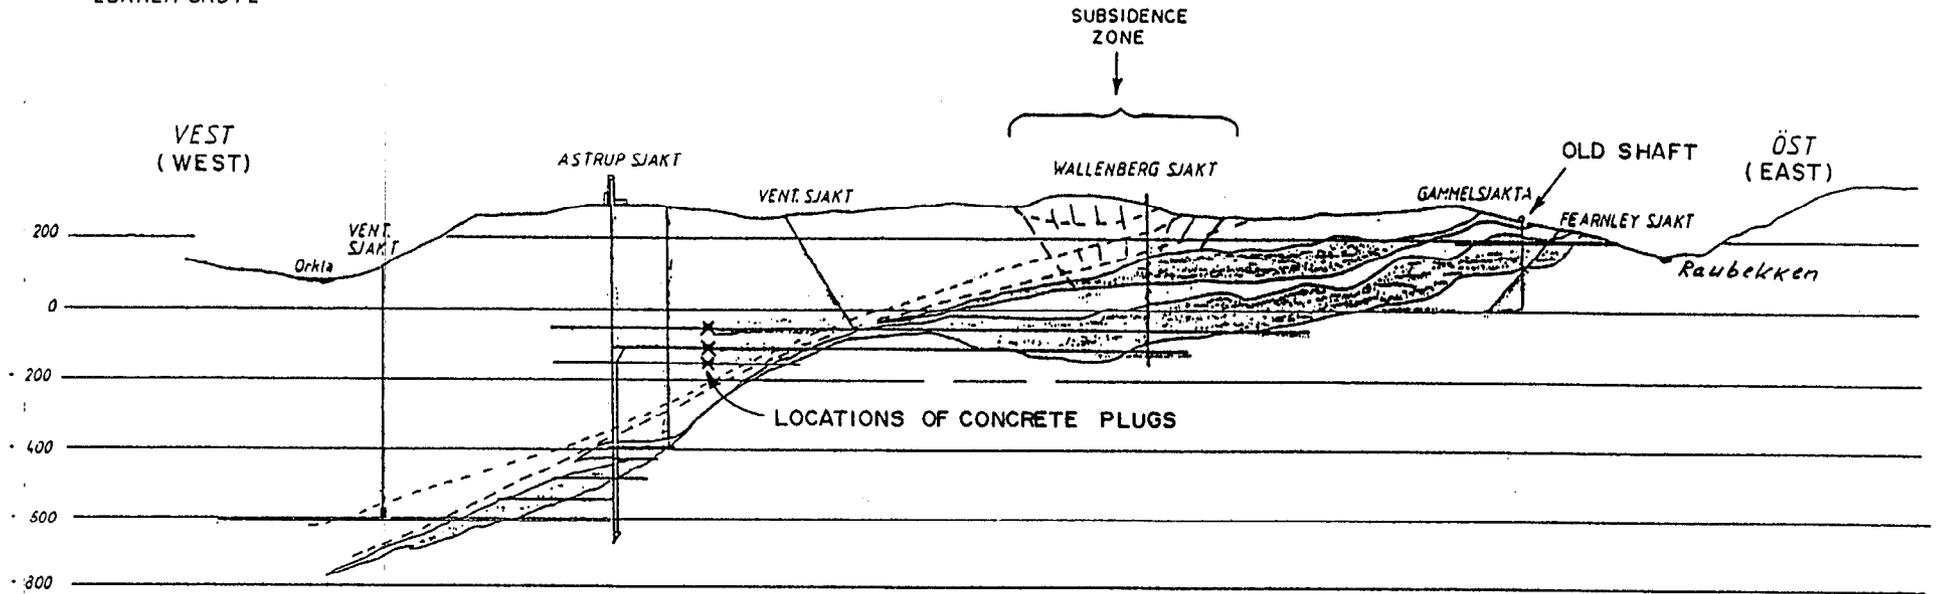
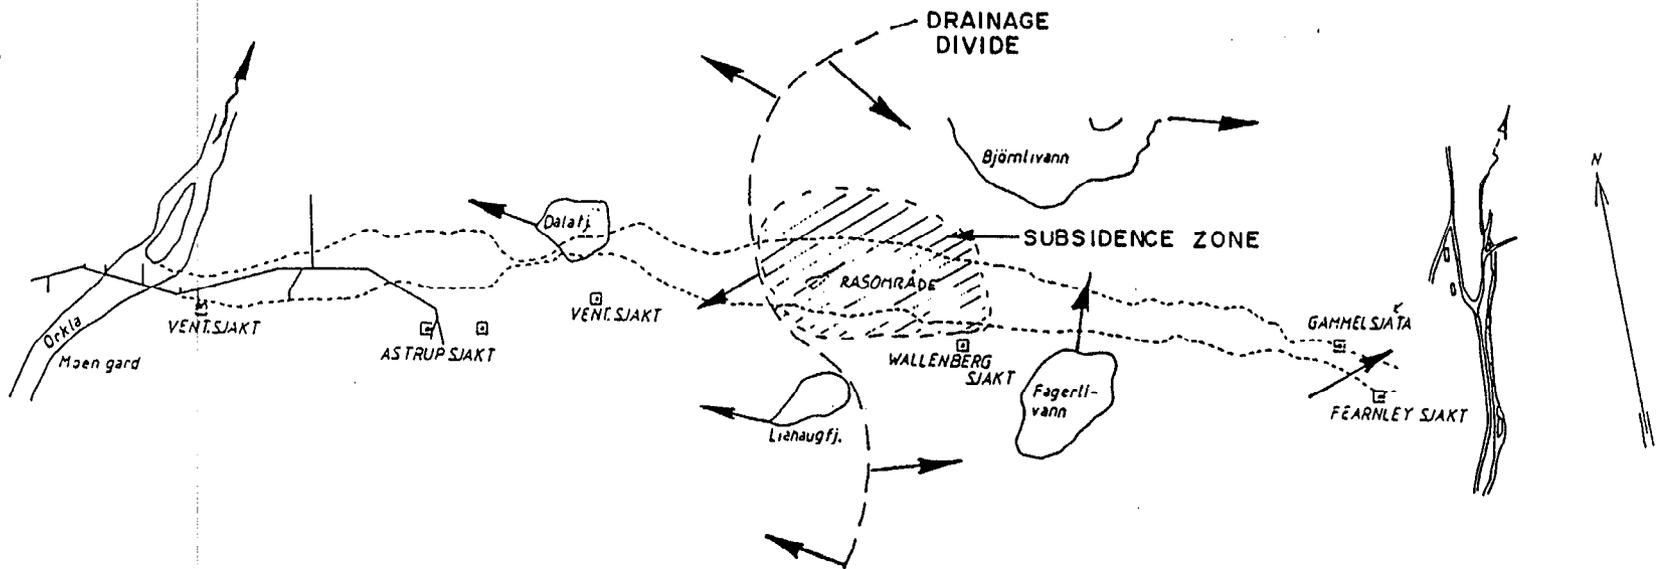
FIGURE 1 LØKKEN MINE - CROSS-SECTION AND PLAN OF UNDERGROUND MINE  
ARROWS SHOW GENERAL DRAINAGE DIRECTION

A cross section of the mine workings is illustrated in Figure 1. The underground mine workings are accessed by four shafts. Three of the shafts were sunk in this century. The Fearnley shaft was sunk in 1911, the Wallenberg shaft in 1916 and the Astrup shaft in 1972. Mining methods included sub-level stoping with long hole drilling, and room and pillar methods. Løkken ore is a very hard, fine grained pyritic material, and generally roof conditions are good. In the older section of the mine wood was used as a roof support medium. Wood consumption in the underground workings during the 1950's and the 1960's ranged between 100 and 300 m<sup>3</sup> per year. The wood was preserved using conventional arsenic compound impregnation techniques.

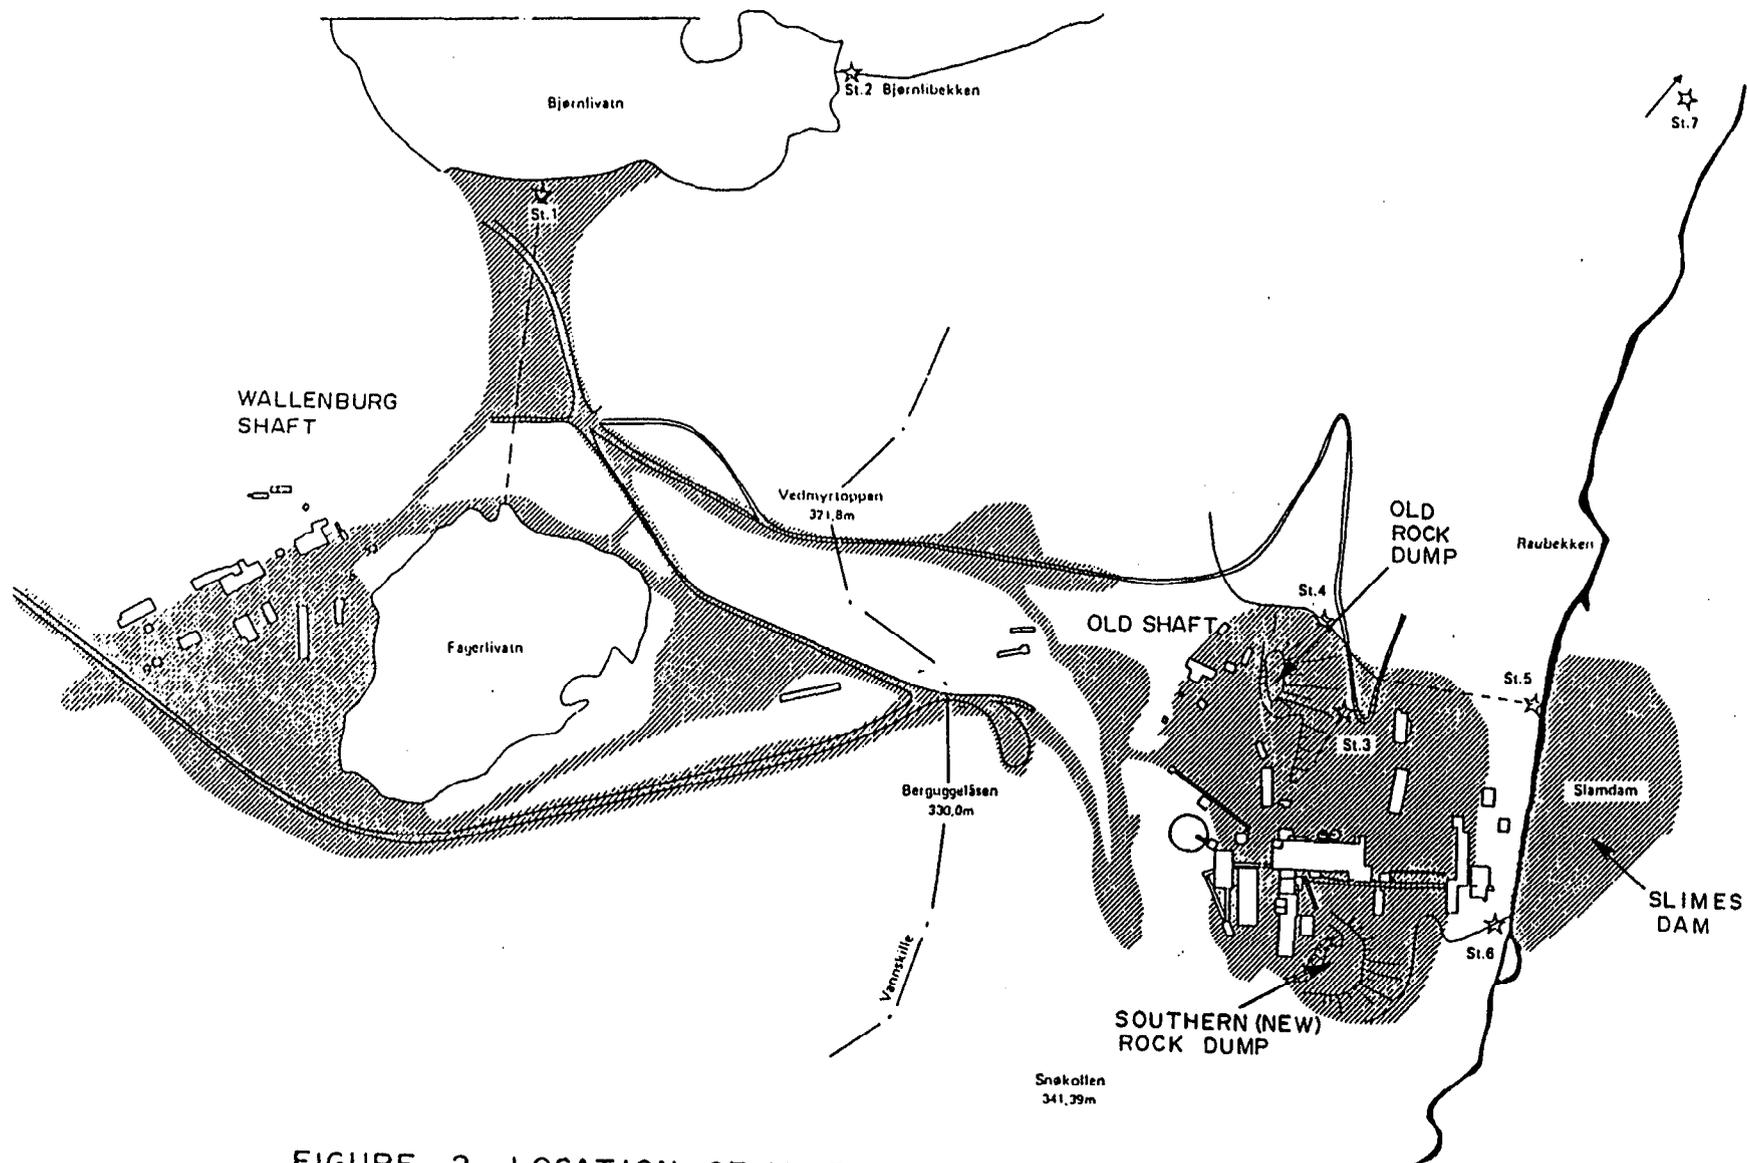
FIGURE 2 LOCATION OF MINE WASTES AND TAILINGS  
 AT LØKKEN VERK (NEW TAILINGS DAM NOT SHOWN)  
 SHADED AREAS SHOW LOCATIONS OF MINE WASTES

The locations of mine rock and tailings are illustrated in Figure 2 (mine wastes are indicated by shaded areas). Mine rock has been placed at various locations on the mine site, with the majority of the mine rock piles dating to pre 1920. The total mine rock placed is estimated at 2 000 000 tonnes. The copper

Although this has not been a complete solution, some improvement of the water quality has been observed. The water quality in the Raubekken, as measured at Station No. 7 - Figure 2, monitored from 1975 to 1986, is summarised in Table 1.

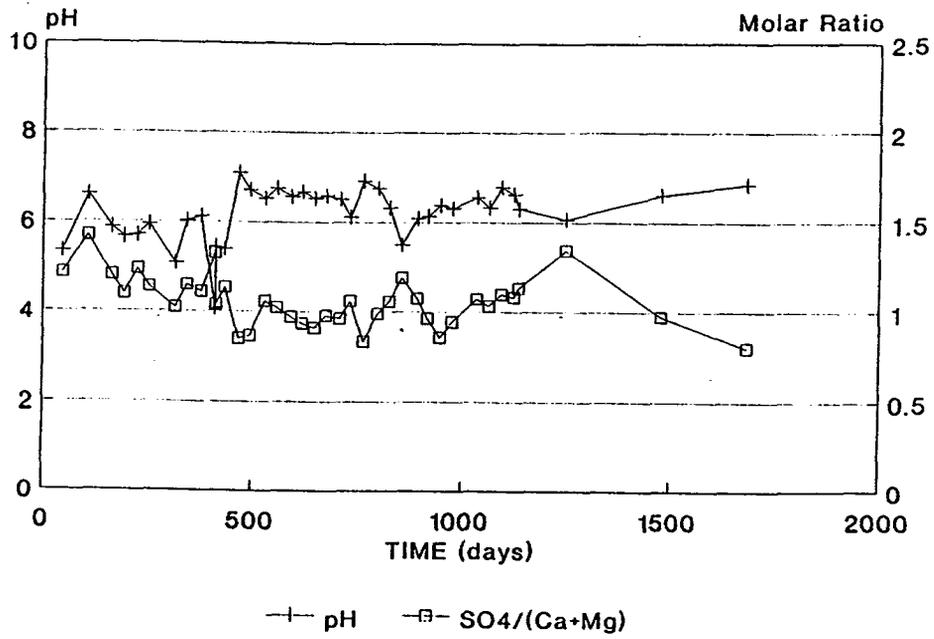
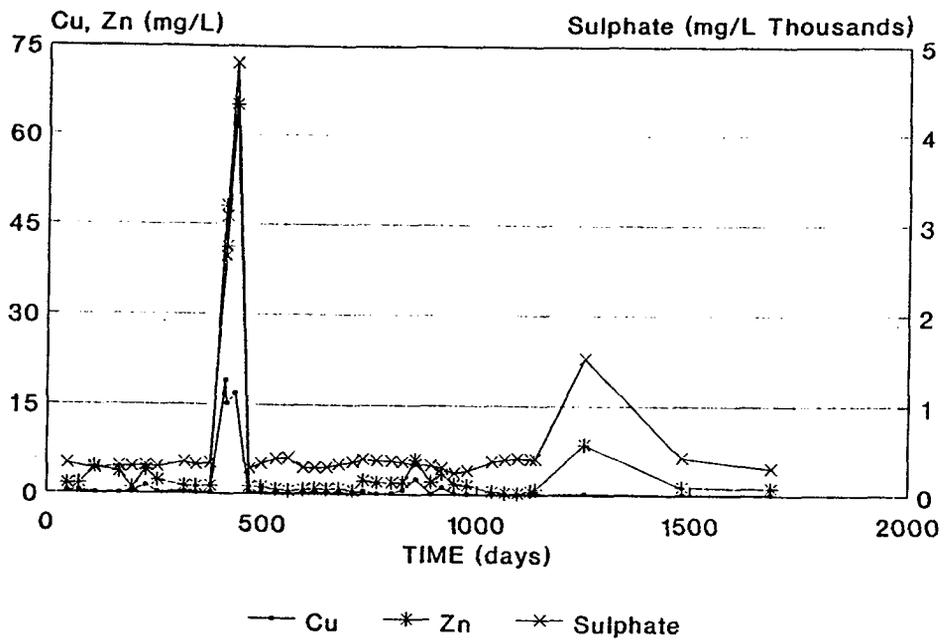
FIGURE 3

The surface water quality is illustrated in Figures 3 and 4 (day 500 on the time scale corresponds to Jan. 1988). Two significant increases in the sulphate and metal contents of the surface water of the column were observed at the end of 1987 and early 1990. The water level at the location of these marked increases coincided with the intersections of the main mine tunnels at the 300 m and 200 m levels. These increases in the concentrations are likely as a result of the 'washing' action of the water entering the connecting portals from the main body of the mine, resulting in the solubilization of stored oxidation products in the tunnels, and transport into the Wallenberg Shaft.

LØKKEN WATER MONITORING  
SURFACE

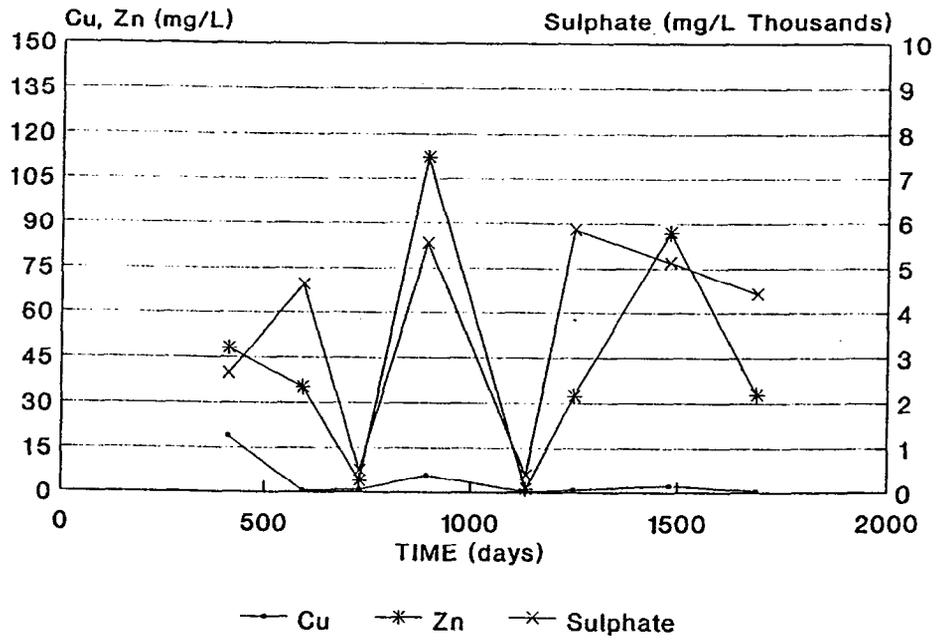
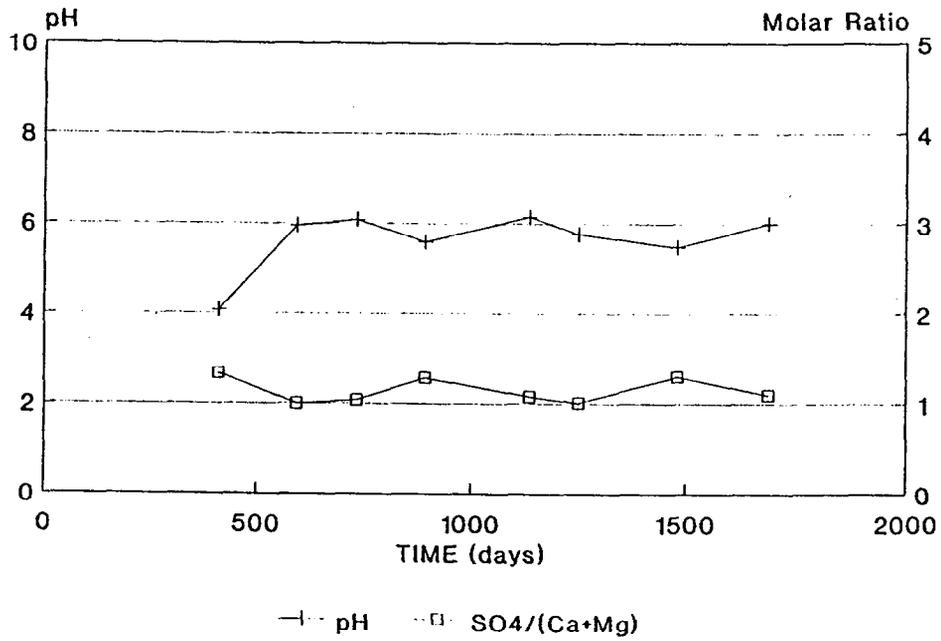
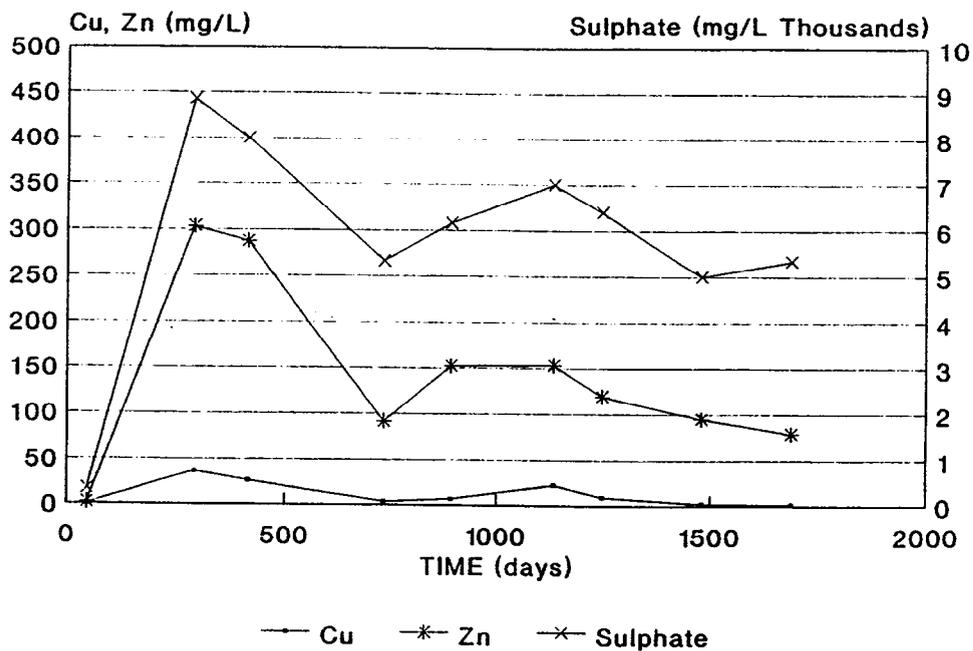
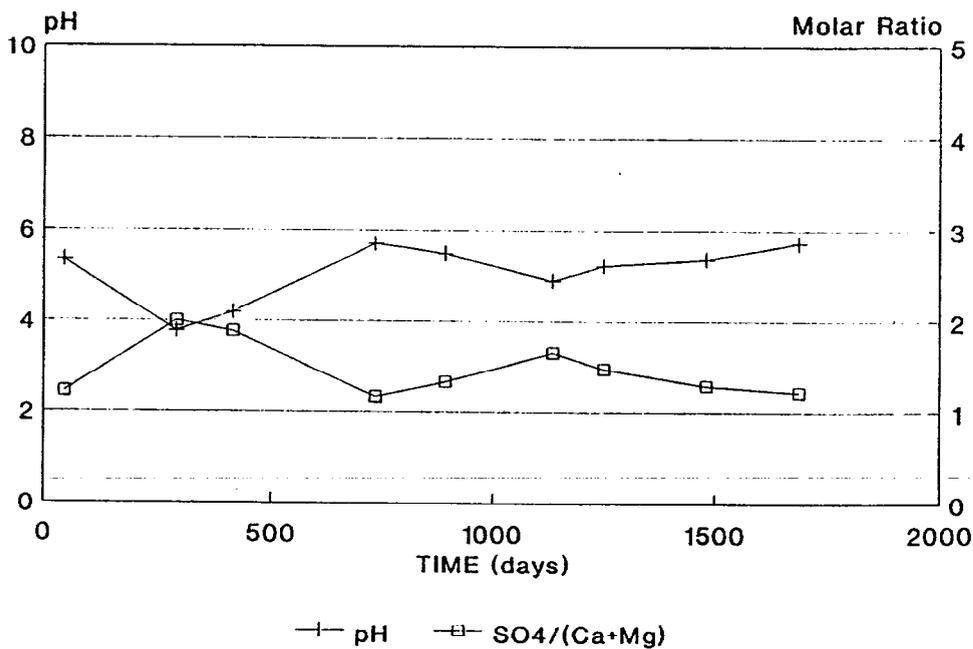
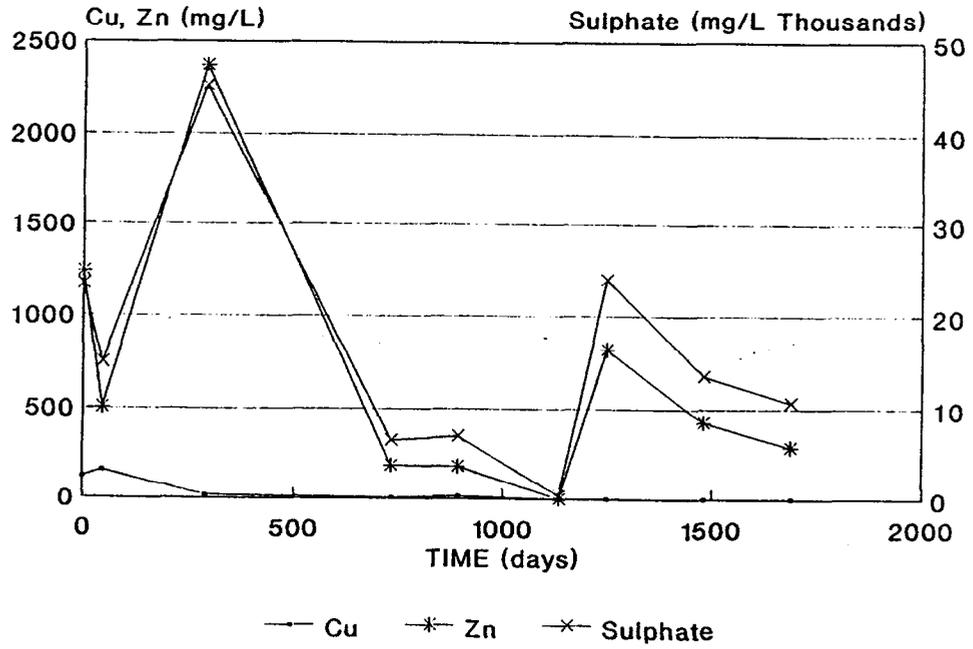
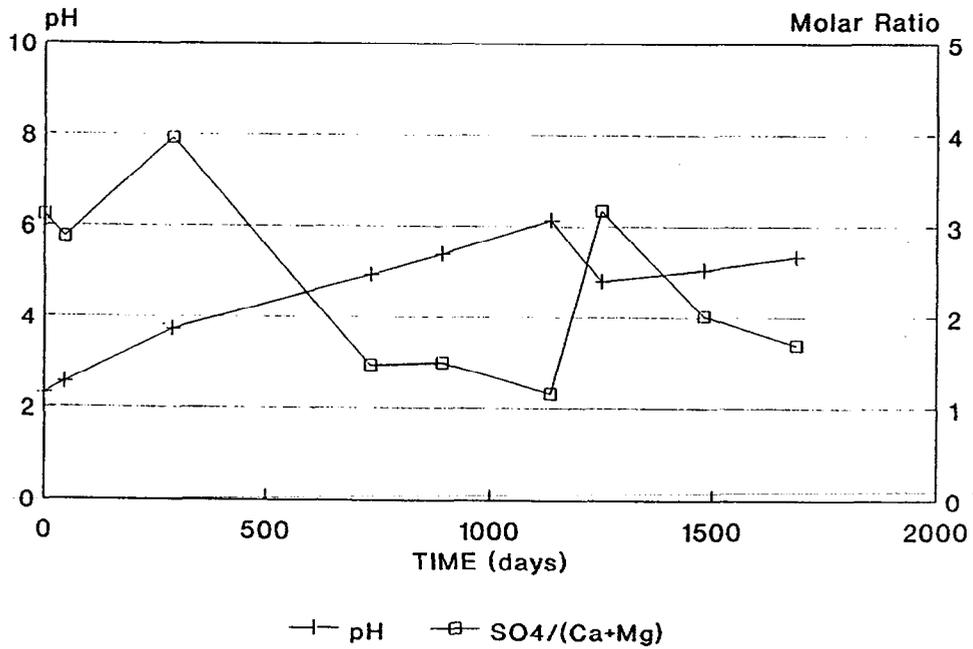
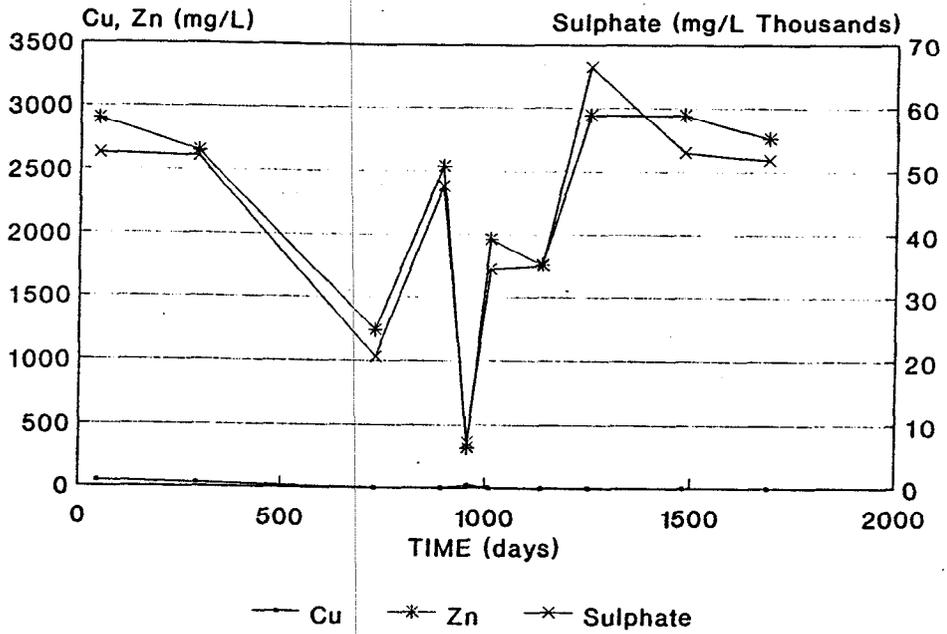
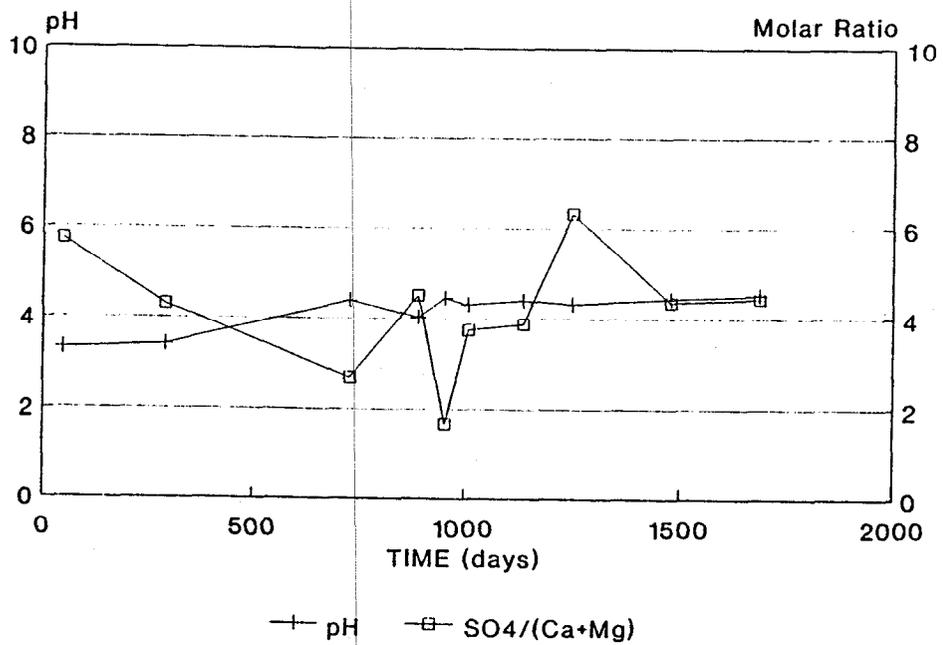
illustrated in Figures 13 and 14. Similarly, the water quality data for the 430, 380, 340 and 300 levels are illustrated in Figures 5 to 12. With the exception of one data point the 490 level displays relatively stable curves, confirming the relative isolation of this section of the mine. The large deviation of the single exception, suggests a sampling or possibly an analytical error. Therefore, it may be fair to assume that there are no external impacts on the water quality for the level 490 location.

Neither the copper nor the zinc concentrations will be affected by pH at the prevailing conditions (i.e. through the precipitation of hydroxides). However, for the initial period of monitoring a slow reduction in the sulphate concentration is observed. For the more recent data the rate of reduction is observed to increase. A similar trend is observed for the zinc concentration.

If diffusion of the ionic species was the predominant mechanism for the reduction in the sulphate and zinc concentrations, the concentration profiles would show a rapid initial rate of decrease (at the time of the highest concentration differential and thus the greatest driving force). In time this rate will steadily decrease and approach zero as equilibrium in the water column is reached. Therefore a diffusion mechanism will result in rates of change opposite to that observed.

Similarly, if neutralisation (reaction with alkaline minerals) is the primary mechanism, the greatest change in the pH and concentration profiles will be observed at the time of the highest concentrations. The same be said for the uptake of metals by organic matter. A high initial rate when concentrations are high, would be observed, decreasing as saturation is approached.

However, a lag phase is observed prior to the change in the concentration for the water quality profiles. When this is considered in conjunction with the isolation of sulphate reducing bacteria at this level, it is evident that sulphate reduction through the activity of sulphate reducing bacteria may be the principal mechanism present. The initial lag phase observed may be due to the time required to:

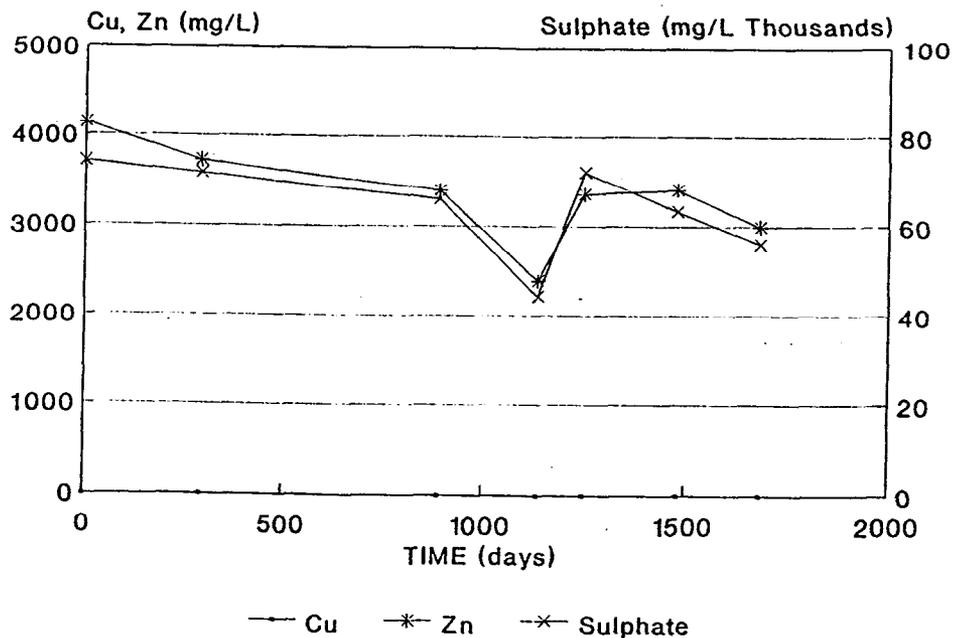
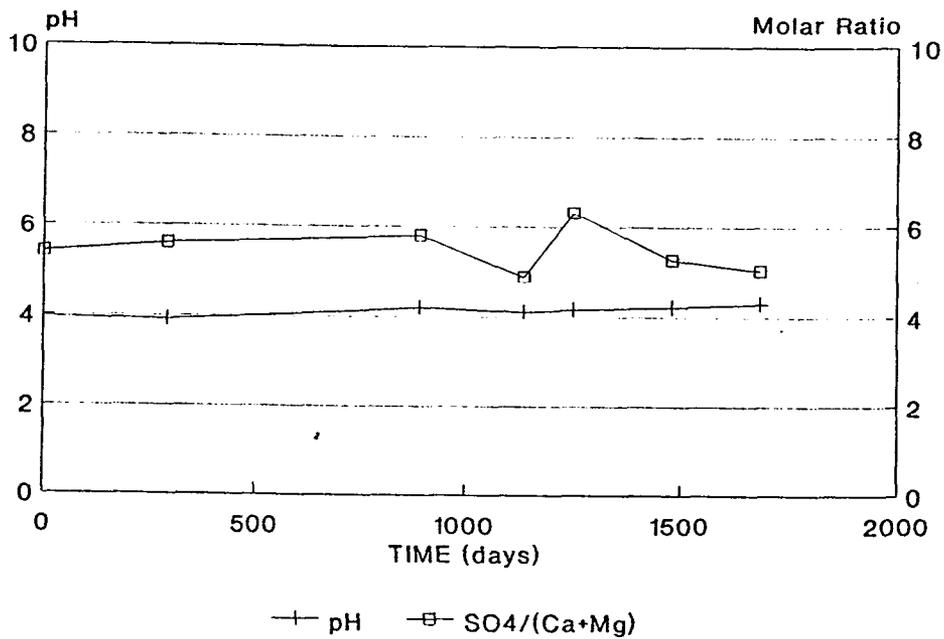
On the basis previously discussed, the water at depth (490 level) is expected to remain stagnant, provided there are no external forces to cause a turnover in the water column. It is recognised that diffusion will provide a mechanism for the reduction in the chemical gradient of the water column, but in the case of the 490 level, this mechanism is expected to be insignificant. The water quality data for the 490 level is

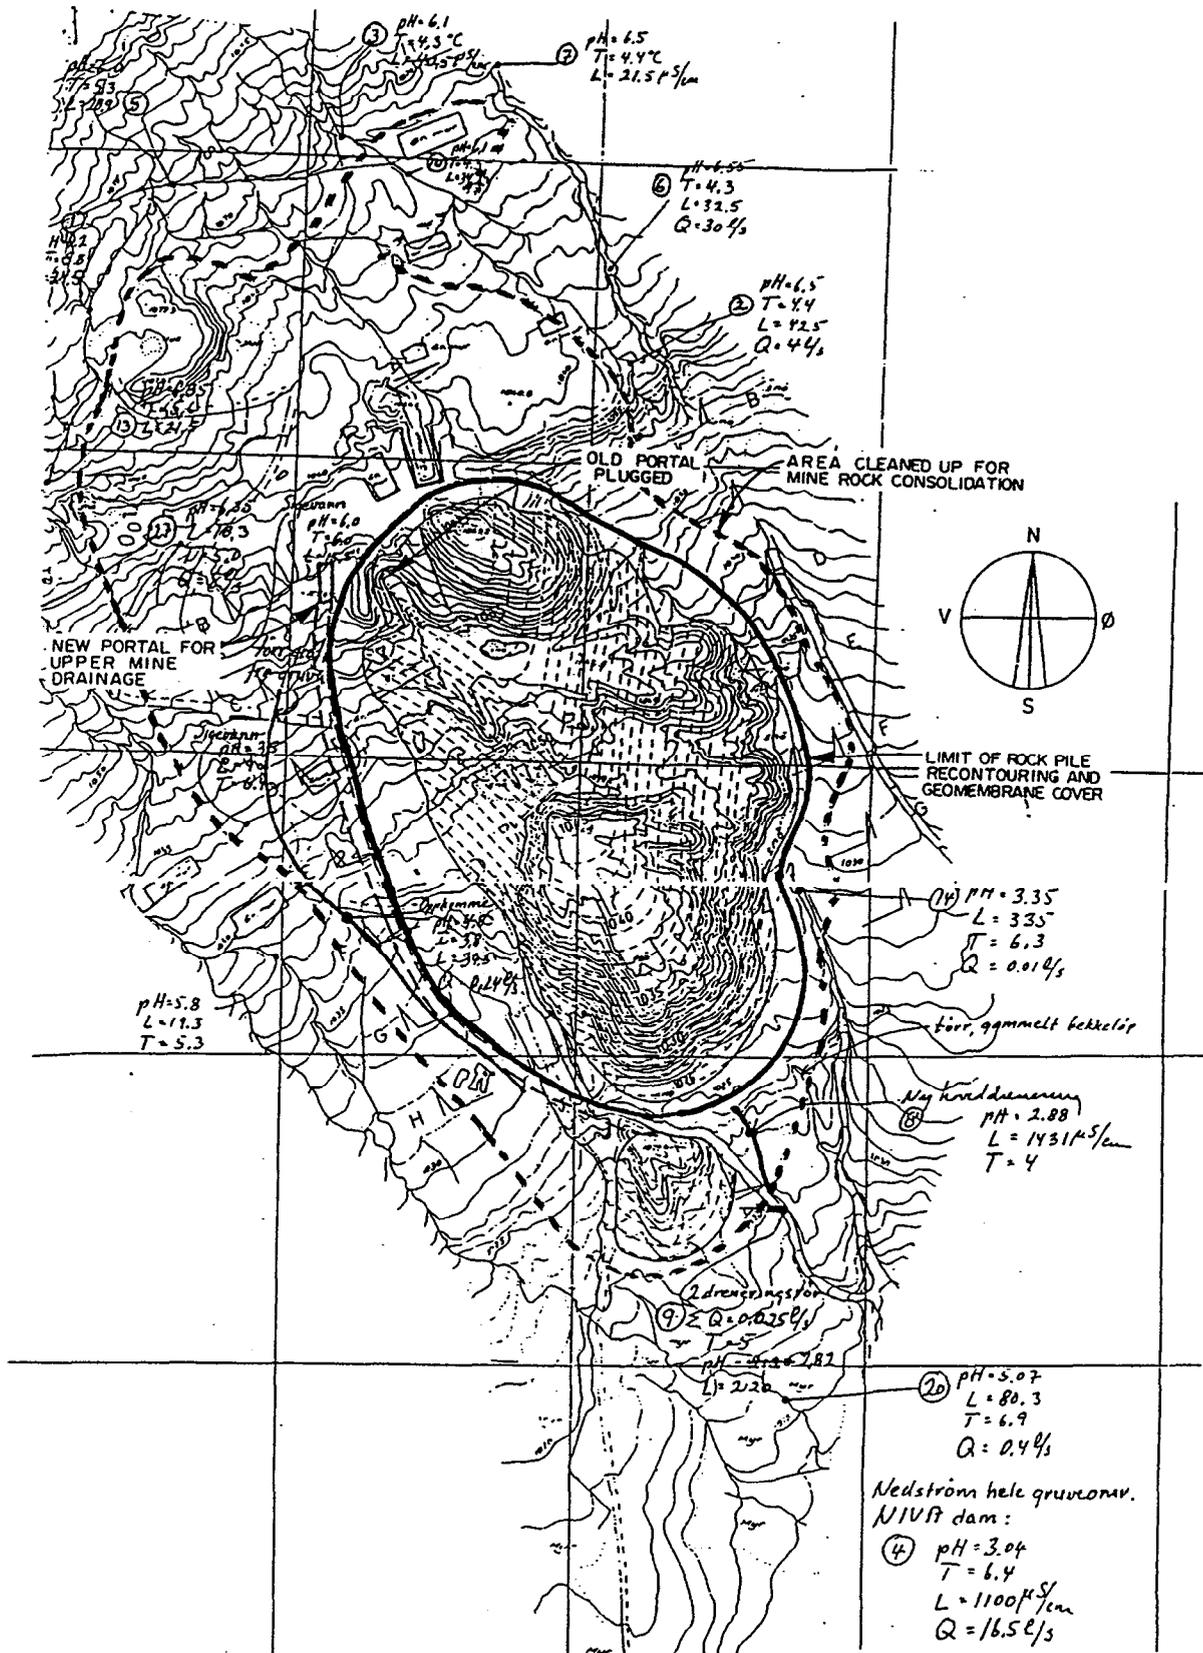
FIGURE 16 KJØLI ROCK PILE REMEDIATION DURING 1989 PROGRAM ; SEEP SURVEY RESULTS FOR SEPT. 20/90

The results of a seep survey in the vicinity of the pile in 1988 is shown on Figure 15. The pH measurements clearly indicate the pile as the major source of ARD. Note that the drainage in the ditch leading from the mine portal is at pH 3.5 while the drainage from the southern end of the rock pile is at pH 2.2 (see Table 3 for metals transport).

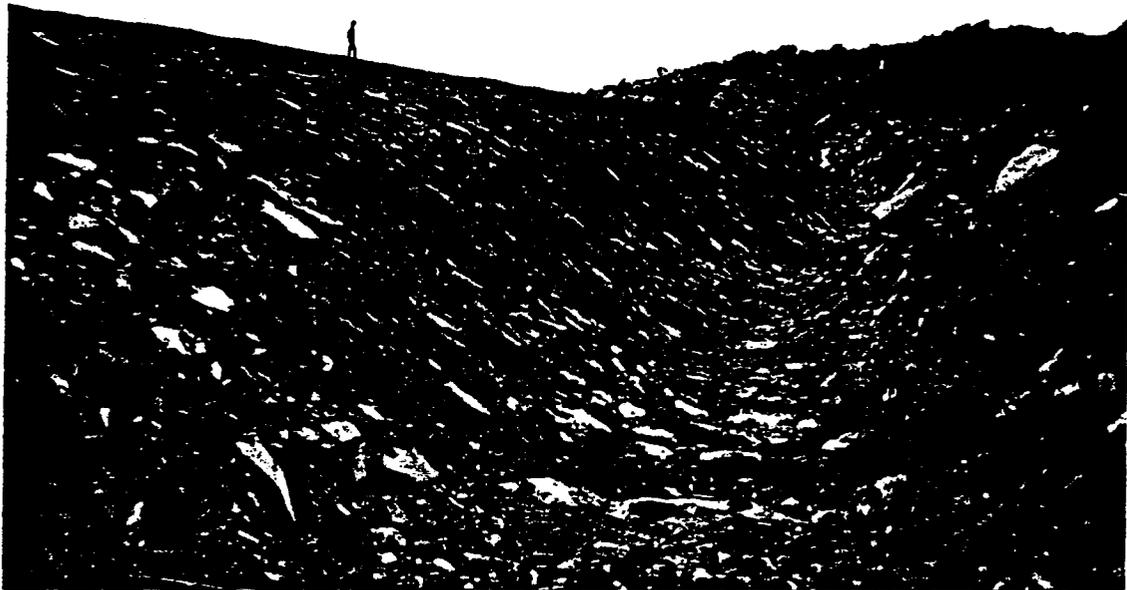
Plate 5: Kjølvi - Ditch at edge of rock pile into which geomembrane cover was sealed

A ditch was blasted into bedrock around the mine rock pile to a depth of approximately 2.0 m to allow the geomembrane cover to be sealed into bedrock (Plate 5). Before placing the liner, since no bedding layer was placed between the mine rock and the HDPE liner, the mine rock was compacted with a vibrating roller to smooth out the surfaces in order to minimise potential damage to the geomembrane (Plate 5). A geofabric layer was placed between the mine rock and the geomembrane (Plate 6). The colour of the liner was selected to be white as this would show up damage during placement.

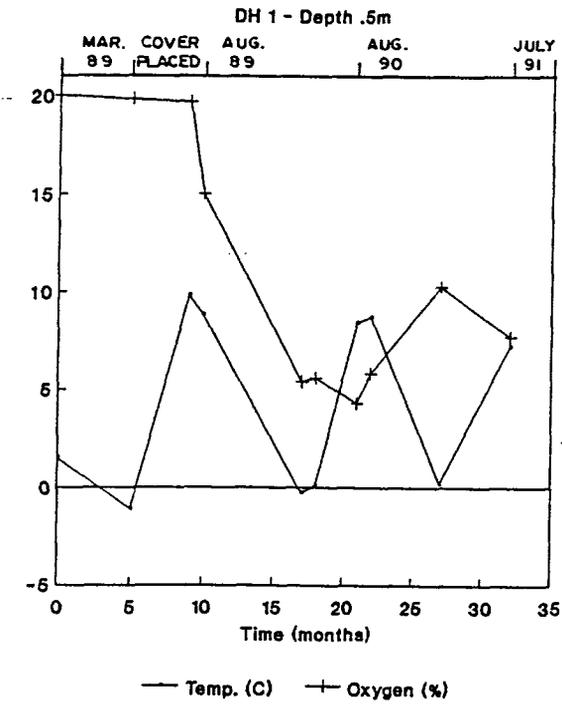
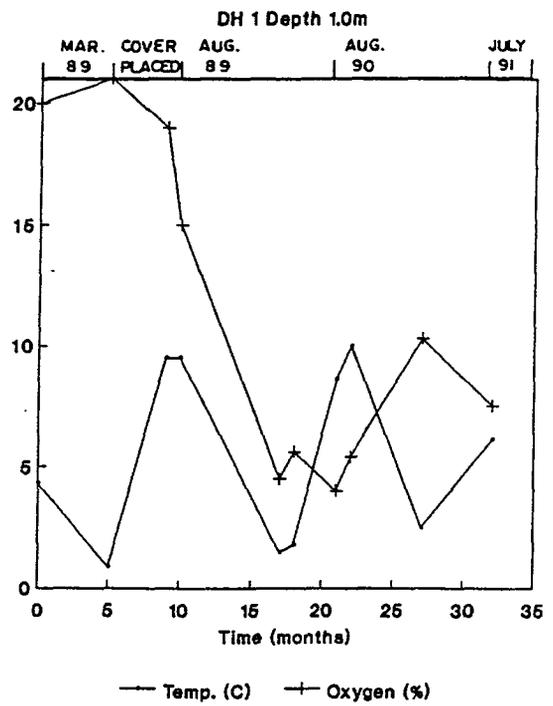
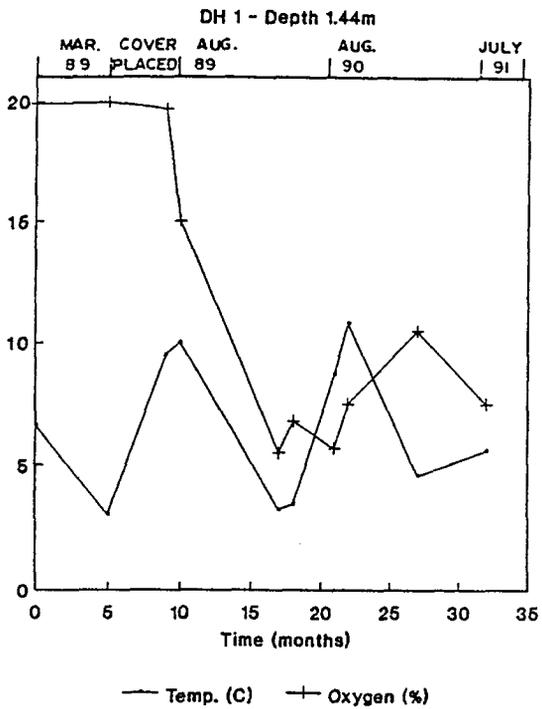
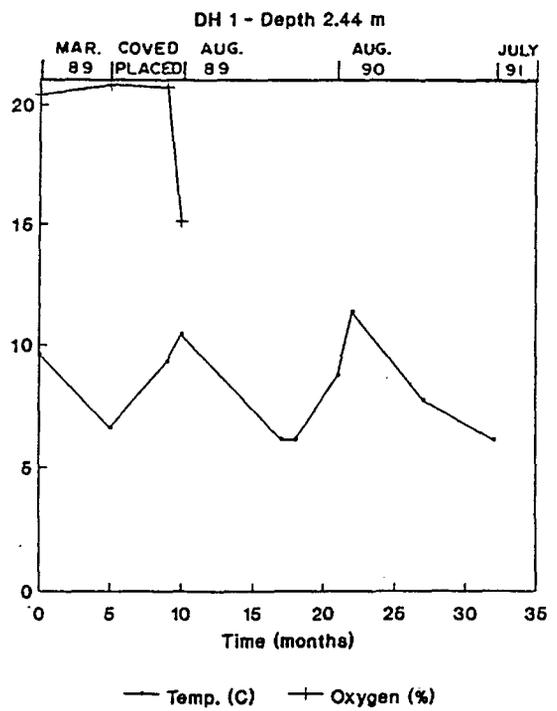
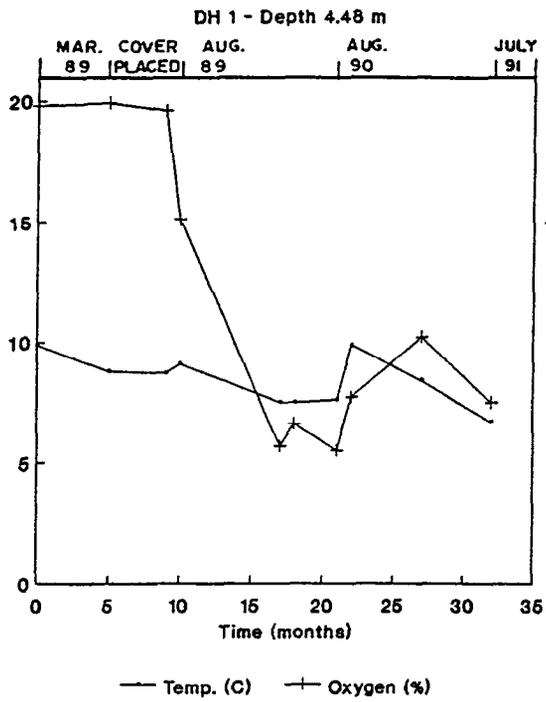
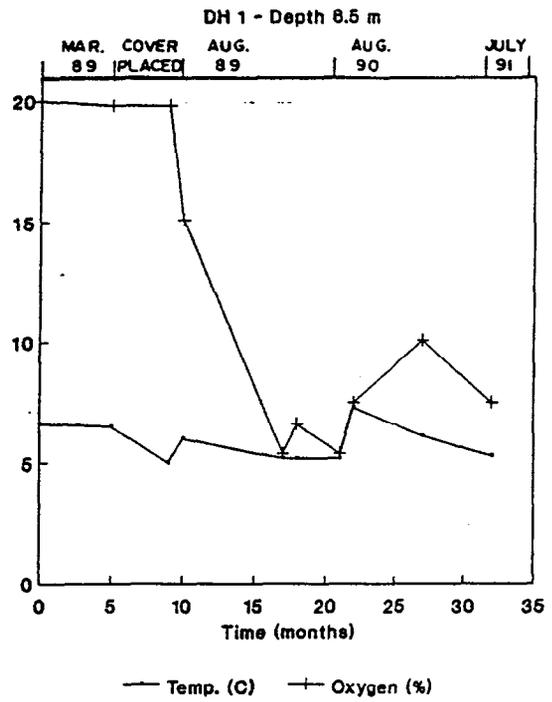
The temperature profile for the mine rock close to the surface to a depth of approximately 3.0 m accurately reflects the seasonal temperature variation. At depths in excess of 4.0 m the temperature profiles are less affected by the seasonal variation. The relatively high temperatures observed at depth indicate continued oxidation. In general a downward trend in all the temperature profiles are observed

at depth since the placement of the cover. This trend is well illustrated by the drill hole 3 location at a depth of 6.45 m. It is concluded that the rate of oxidation in the rock pile has been significantly reduced as a result of the cover placement.

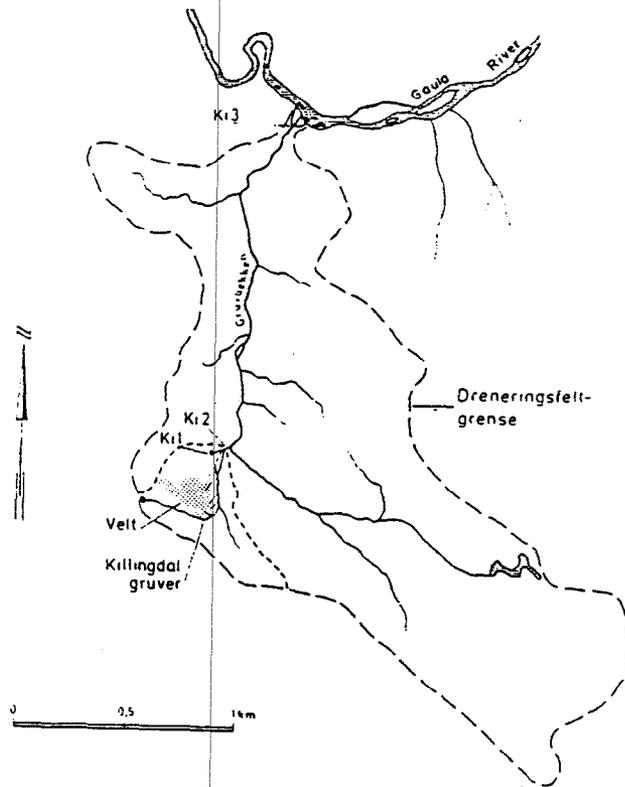
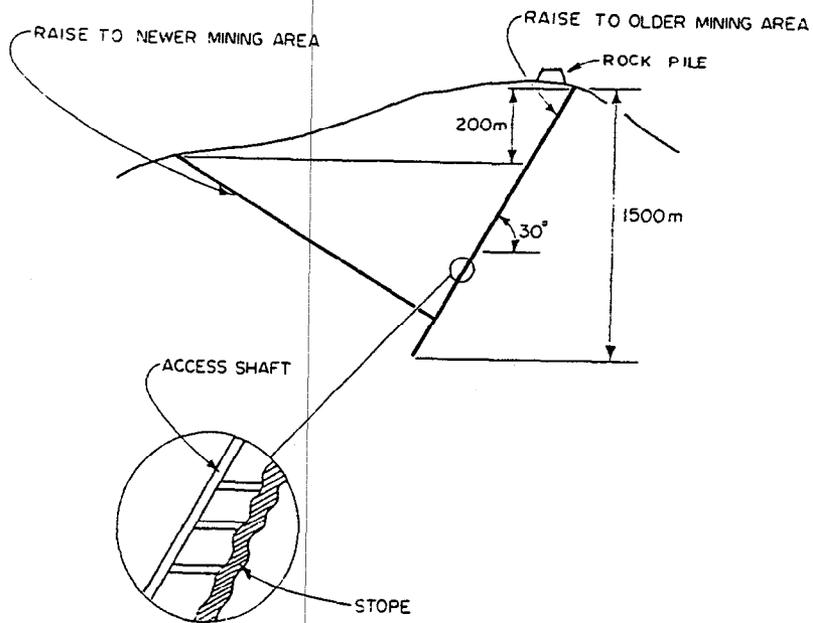
FIGURE 36 KILLINGDAL MINE

The primary source for ARD from the site is from the rock piles placed at the upper mine entry (Plate 9). This source is responsible for approximately two thirds of the total copper transported from the site. The mine rock varies considerably in nature, including coarse and fine rock in discrete piles, burned or roasted rock and newer coarse mine rock.

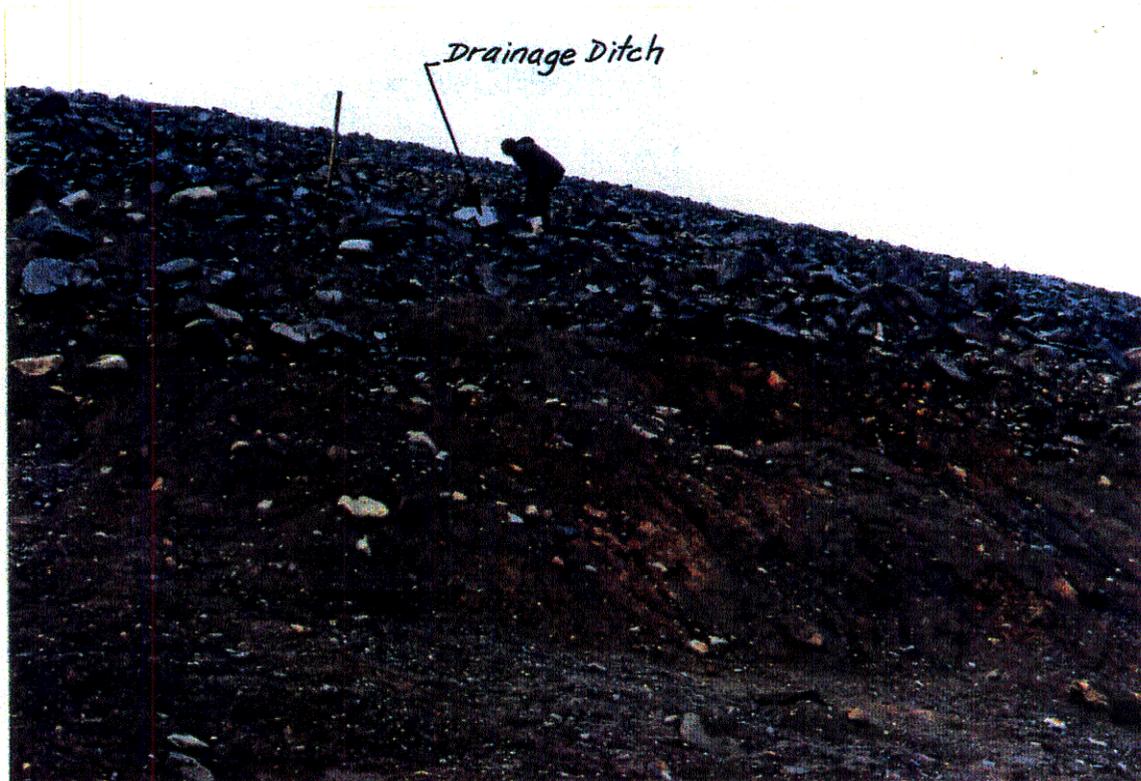
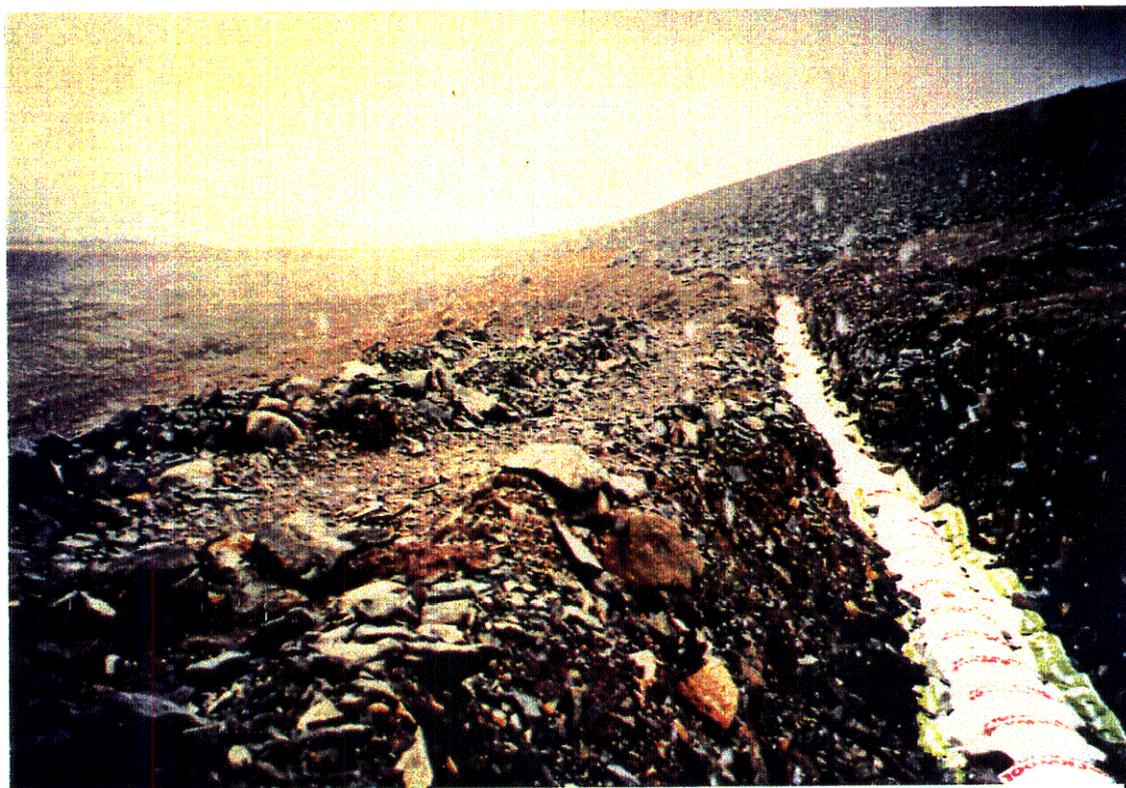
To achieve this, a collection ditch was designed at the toe of the mine rock pile, equipped with a drainage collection pipe. The location and nature of the collection ditch is illustrated in Plates 11 and 12.

Plate 11: Killingdal - Covered rock pile showing location of drainage ditch

Plate 12: Killingdal - Portion of drainage ditch with drain pipes still to be completed

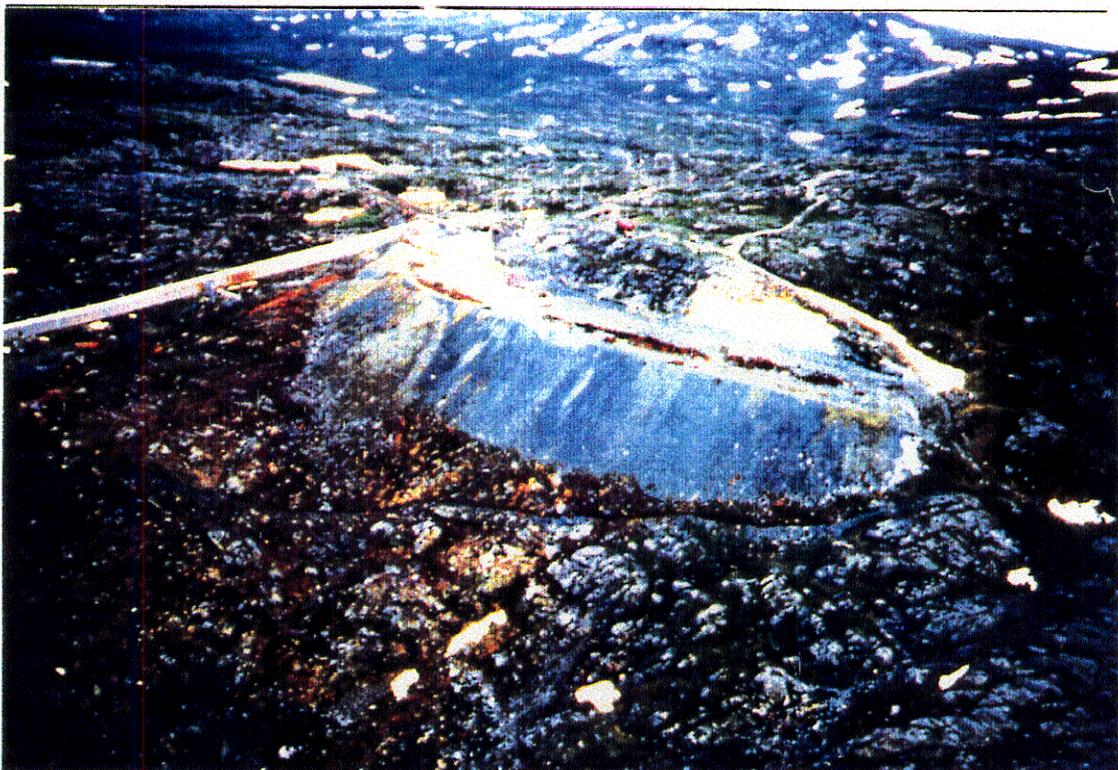
Plate 13: Skorovas - General view of mine rock prior to removal

During the late 1800s' and up to 1940 a number of surveys and test mining operations had been conducted at the site. The disturbances created by these test operations further contributed to the ARD originating from the site. Mine production at a rate of 500 tonnes per day from an underground operation started in 1952. The ore contained an average of 37% sulphur, 1.1 % copper and 2.2% zinc. The mine produced a pyrite concentrate for acid production until 1976. Subsequently copper and zinc concentrates were produced until the ore deposit was depleted in 1984. Approximately 1.5 million tonnes of tailings were deposited directly into the Dausjøen during this period. A mine rock pile of approximately 160 000 m<sup>3</sup> was developed on the side of the mine adjacent to the mine entrance at this time (Plate 13).
