**ACID ROCK DRAINAGE  
REMEDATION MEASURES  
AT FOUR NORWEGIAN MINES**

**MEND Report 2.33.1**

**November 1991**

**STEFFEN, ROBERTSON AND KIRSTEN (B.C.) INC.  
Suite 800 - 580 Hornby Street  
Vancouver, British Columbia  
Canada, V6C 3B6**

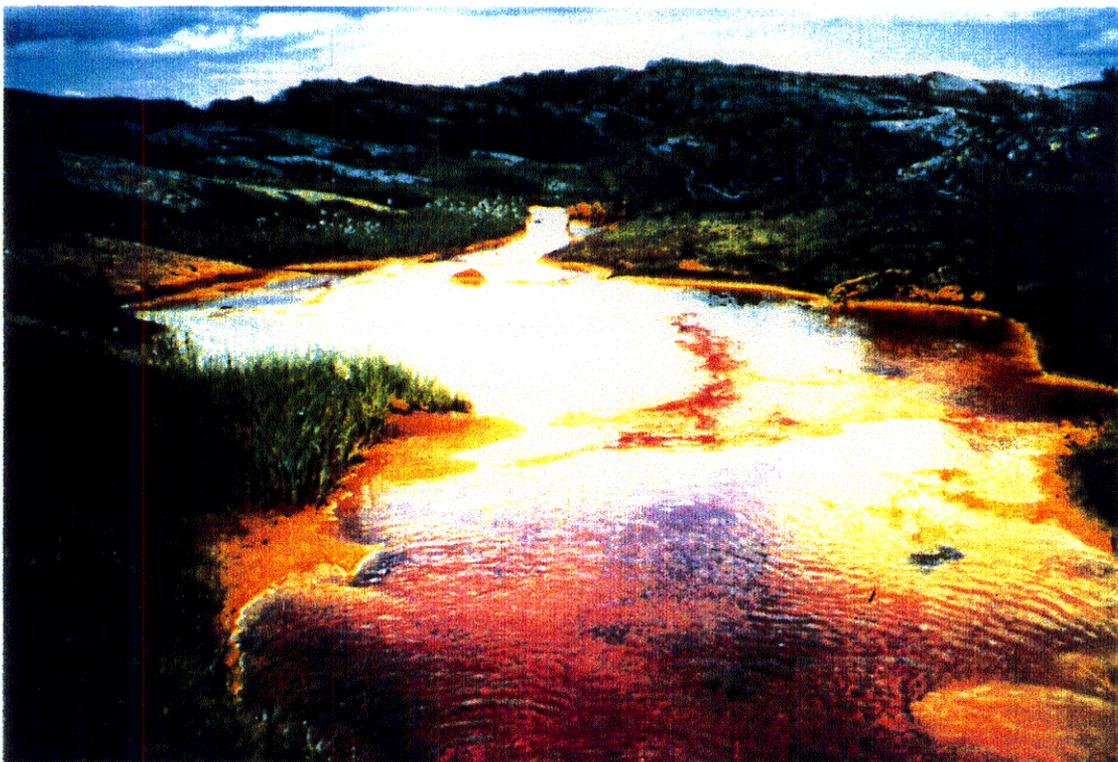
Plate 14: Skorovas - Metal hydroxide accumulation in grassy flood plain of Dausjøen Creek upstream of Store Skorovatn

As a consequence of mine development and operation a significant drop in the pH of the drainage from Dausjøen was observed, resulting in an increased metal transport from Dausjøen. The following abatement measures were applied in an attempt to reduce the metal transport:

- The acidic seepage from the mine rock pile and water from Gruvebekken was diverted downstream of Dausjøen, and
- a liming station was installed in Dausjøen creek. The pH of the water flowing from Dausjøen was monitored on a continuous basis and milk of lime added directly to the stream flow on a proportional basis. Mixing and flocculation occurred in the stream flow with some resulting metal hydroxide precipitation accumulation in grassy shallows in the stream floodplain (Plate 14) or in lake Store Skorevatn. This lower lake is shallow and wind and wave action stirring of the sludge appears to have resulted in most of the hydroxides having been flushed through the lake. Approximately 400 tonnes of lime was consumed annually.

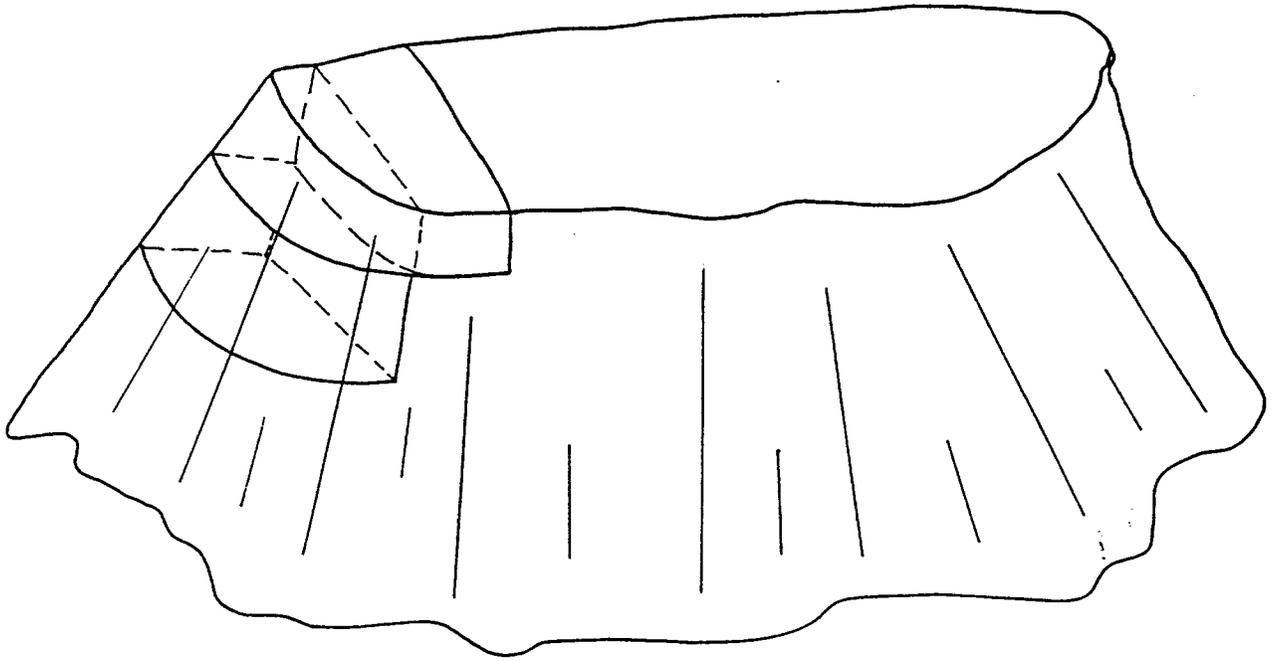
FIGURE 38 SKOROVAS- MINE ROCK  
PILE EXCAVATION

For the relocation of the mine rock, extensive construction of access roads to the mine rock pile and to the deposition site in Dausjøen, were required. The mine rock was excavated using of a backhoe and 6 to 8 dump trucks. Working two shifts per day, 3 months were required for the relocation of the mine rock. The mine rock was removed in lifts (Plate 15), starting at one end of the pile and gradually proceeding to the other side, working from the top down, to minimise the excavation area (see Figure 38), thus minimising the area exposed to rain. As foundation bedrock was exposed it was carefully and rapidly cleaned by hand (2 labourers) to remove residual mine rock. The resulting bedrock surface was remarkably clean (Plate 16).

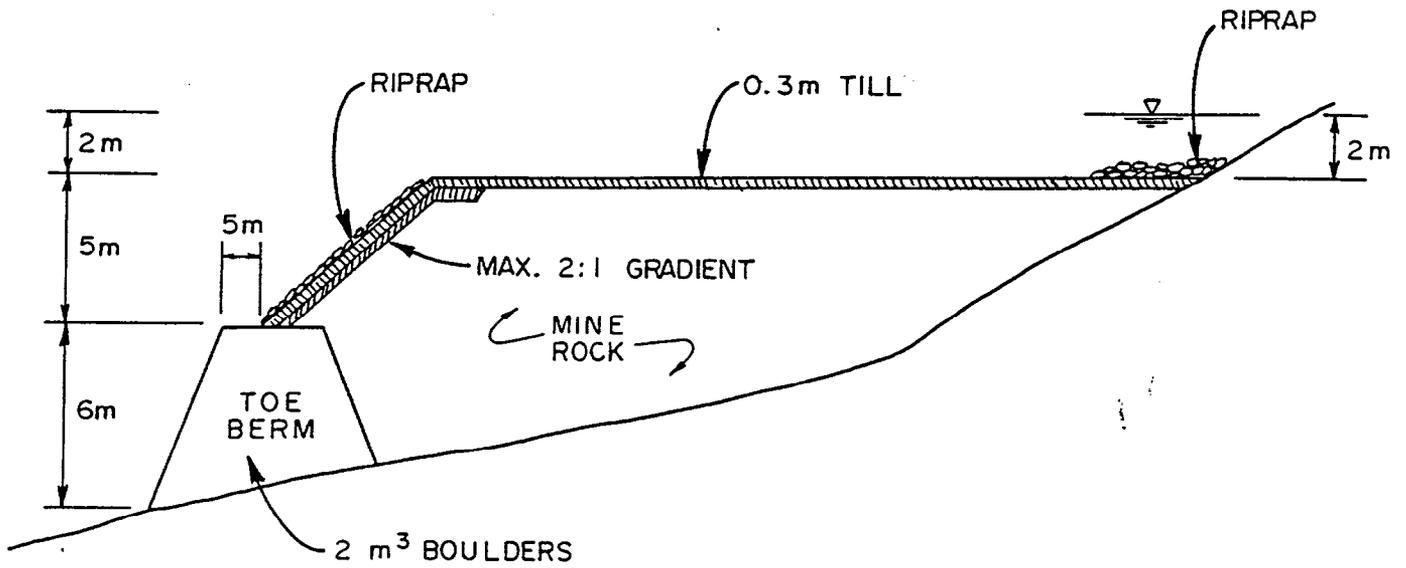
FIGURE 39 SKOROVAS - CROSS SECTION THROUGH CONSTRUCTED MINE ROCK PILE

A retaining berm was constructed along the planned perimeter of the mine rock deposition area in the Dausjøen to stabilize the toe of the final rock pile. This berm was constructed with 2 m diameter quarried rock boulders and explosives were used to consolidate and firmly imbed the rocks in the sediments. The relocated mine rock was placed in layers of approximately 2-3 m thick, and gradually expanded from the shore to the retention berm (Plate 17). The construction method is illustrated in Figure 39. After relocation, the mine rock was covered with 0.3 m of compacted till.

The till layer on the front face of the rock pile could not be compacted and is not continuous over either the mine rock or the berm. Rip rap was placed on the face of the mine rock slope and at the shore edge to minimise erosion due to wave action. The relocated mine rock pile was instrumented with sampling points within the mine rock at two locations for future monitoring.

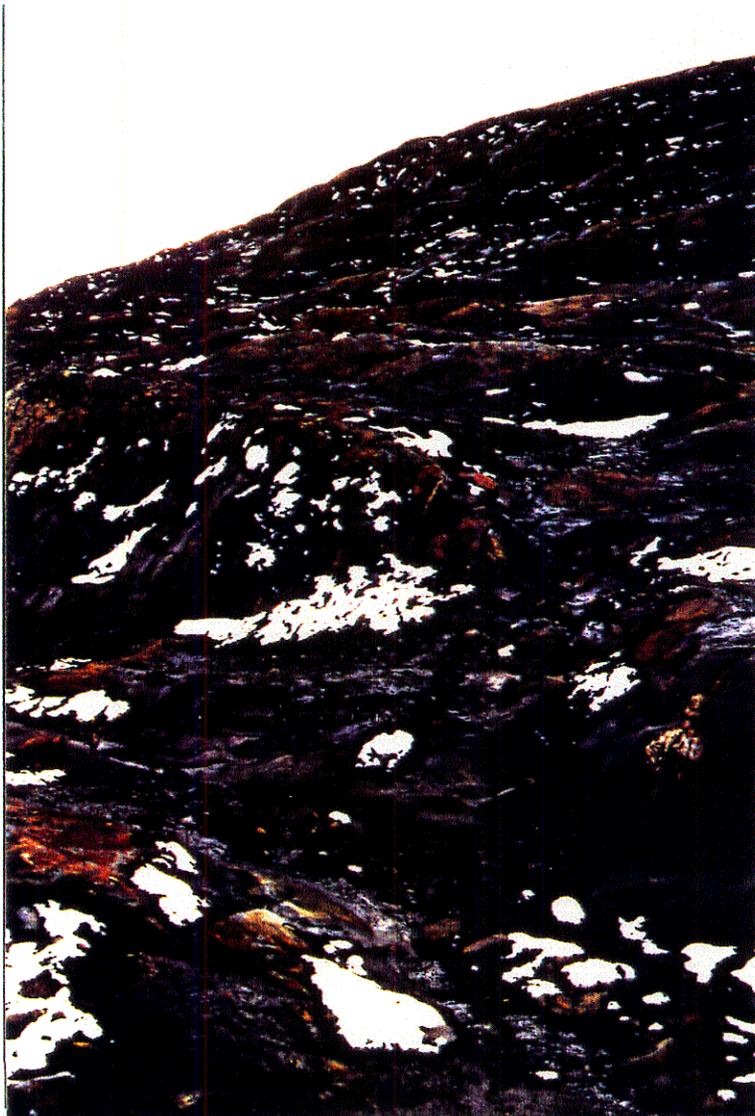
Plate 16: Skorovas - Bedrock after cleaning mine waste pile

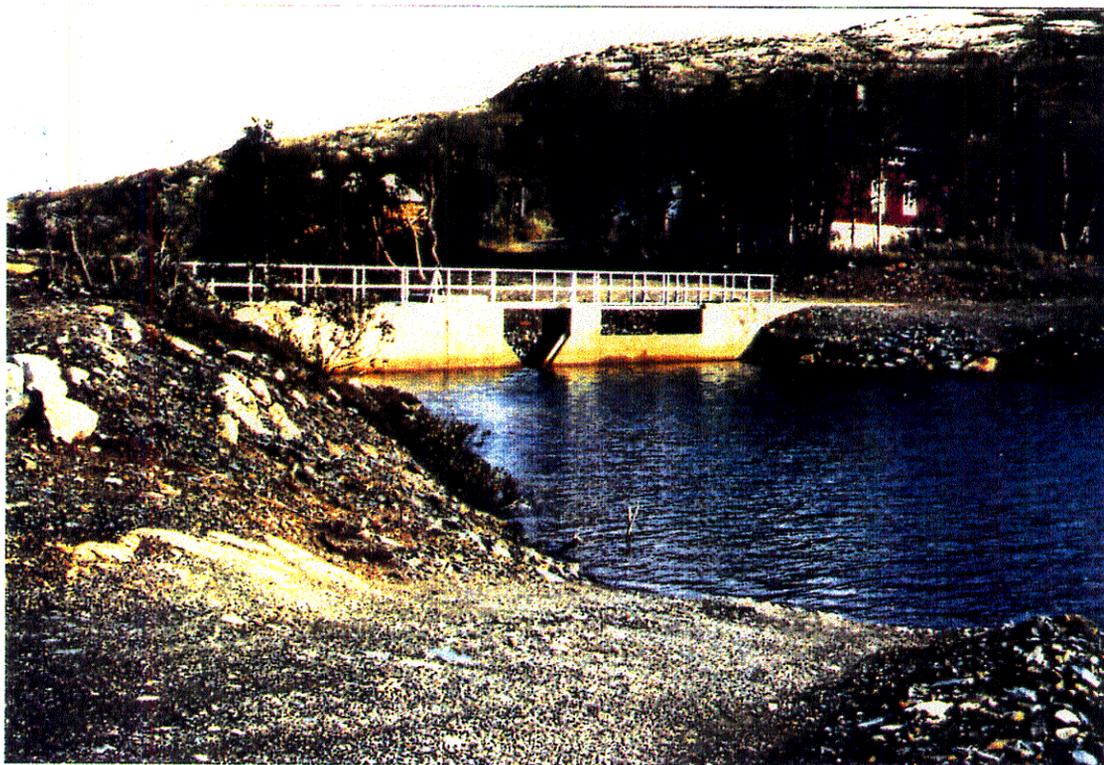
Plate 18: Skorovas - New dam at Dausjøen Lake outlet

A new dam wall was constructed at the overflow of the lake (Plate 18), equipped with a V-notch for flow measurement, raising the lake level by 2 m above the original level.

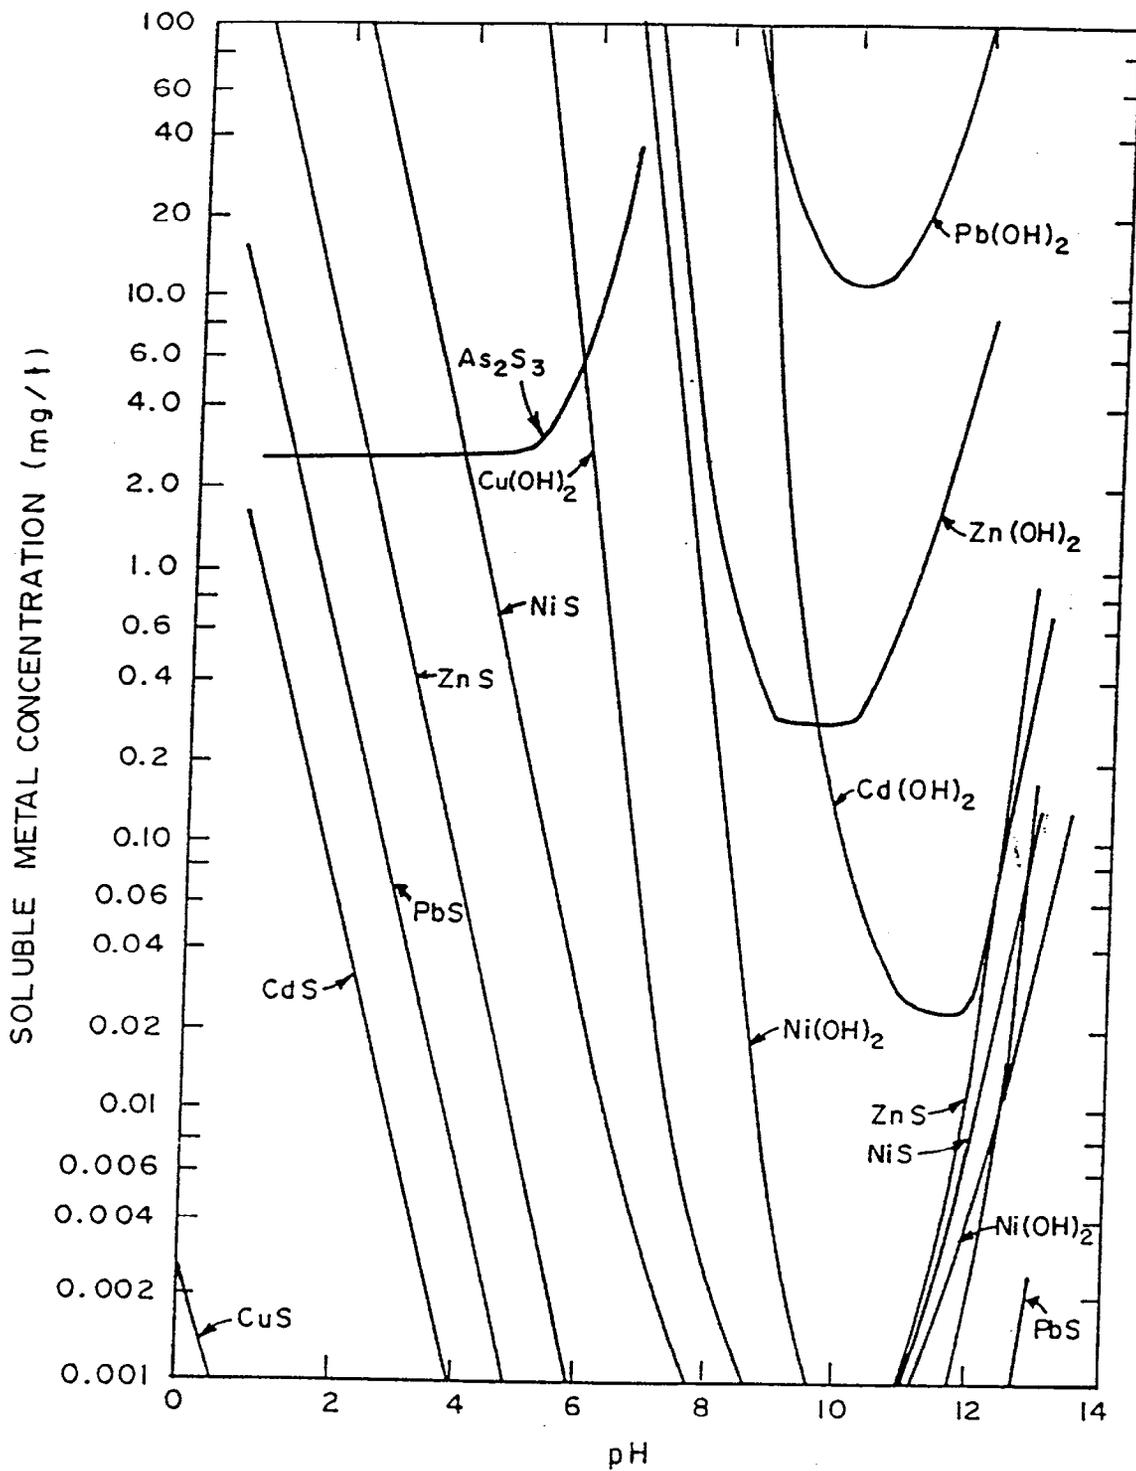
FIGURE A-1

Calculated Metal Sulphide and Hydroxide Solubilities  
(Bhattacharya Et Al 1981)

The activity of these sulphate reducing bacteria is important, not only due to the production of hydrogen sulphide, but also due to the subsequent metal interaction with the hydrogen sulphide. Hydrogen sulphide readily reacts with solubilised copper at low pH values to form the insoluble sulphide mineral. Similarly, the precipitation of zinc is possible, provided suitable conditions exist, for example a solution pH of greater than 3.5-4.0 is required (the theoretical solubility curves for various metal sulphides and hydroxides are provided in Appendix A - Figure A-1).

However, it should be noted that the cadmium concentration profiles decreased in phase with the copper concentration, and, since the electroplating of cadmium on metallic iron is less likely (total *e.m.f.* = +0.04V) than for copper, sulphide precipitation is more likely to have caused the concentration decrease (also note the solubility curves for cadmium and copper sulphides and hydroxides in Appendix A, Figure A-1).
