**EVALUATION OF FIELD-SCALE
APPLICATION OF A
SHOTCRETE COVER ON ACID
GENERATING ROCK**

MEND Project 2.34.1

**EVALUATION OF A FIELD-SCALE
APPLICATION OF A SHOTCRETE COVER
ON ACID GENERATING ROCK**

September 20, 1996

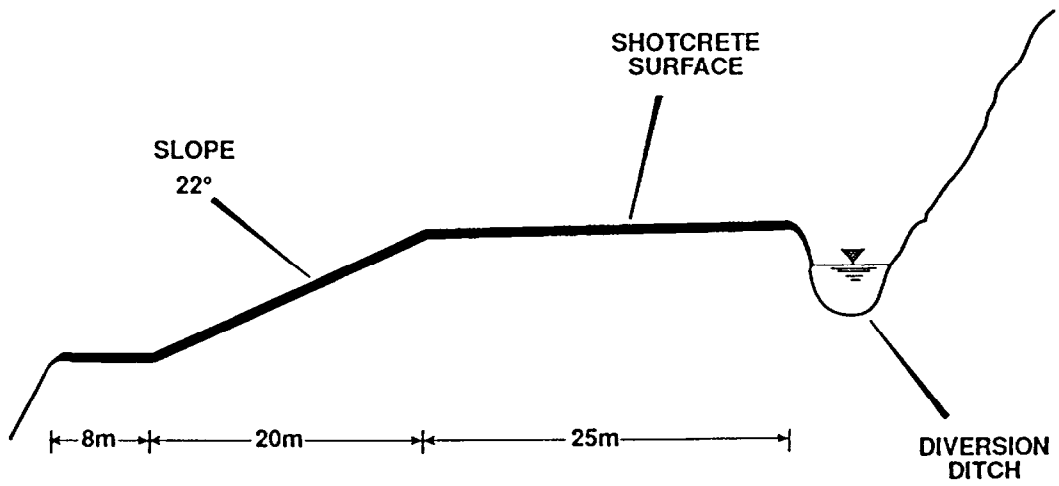
Figure 1. Schematic of large scale field application of shotcrete.

CROSS-SECTION

PLAN VIEW

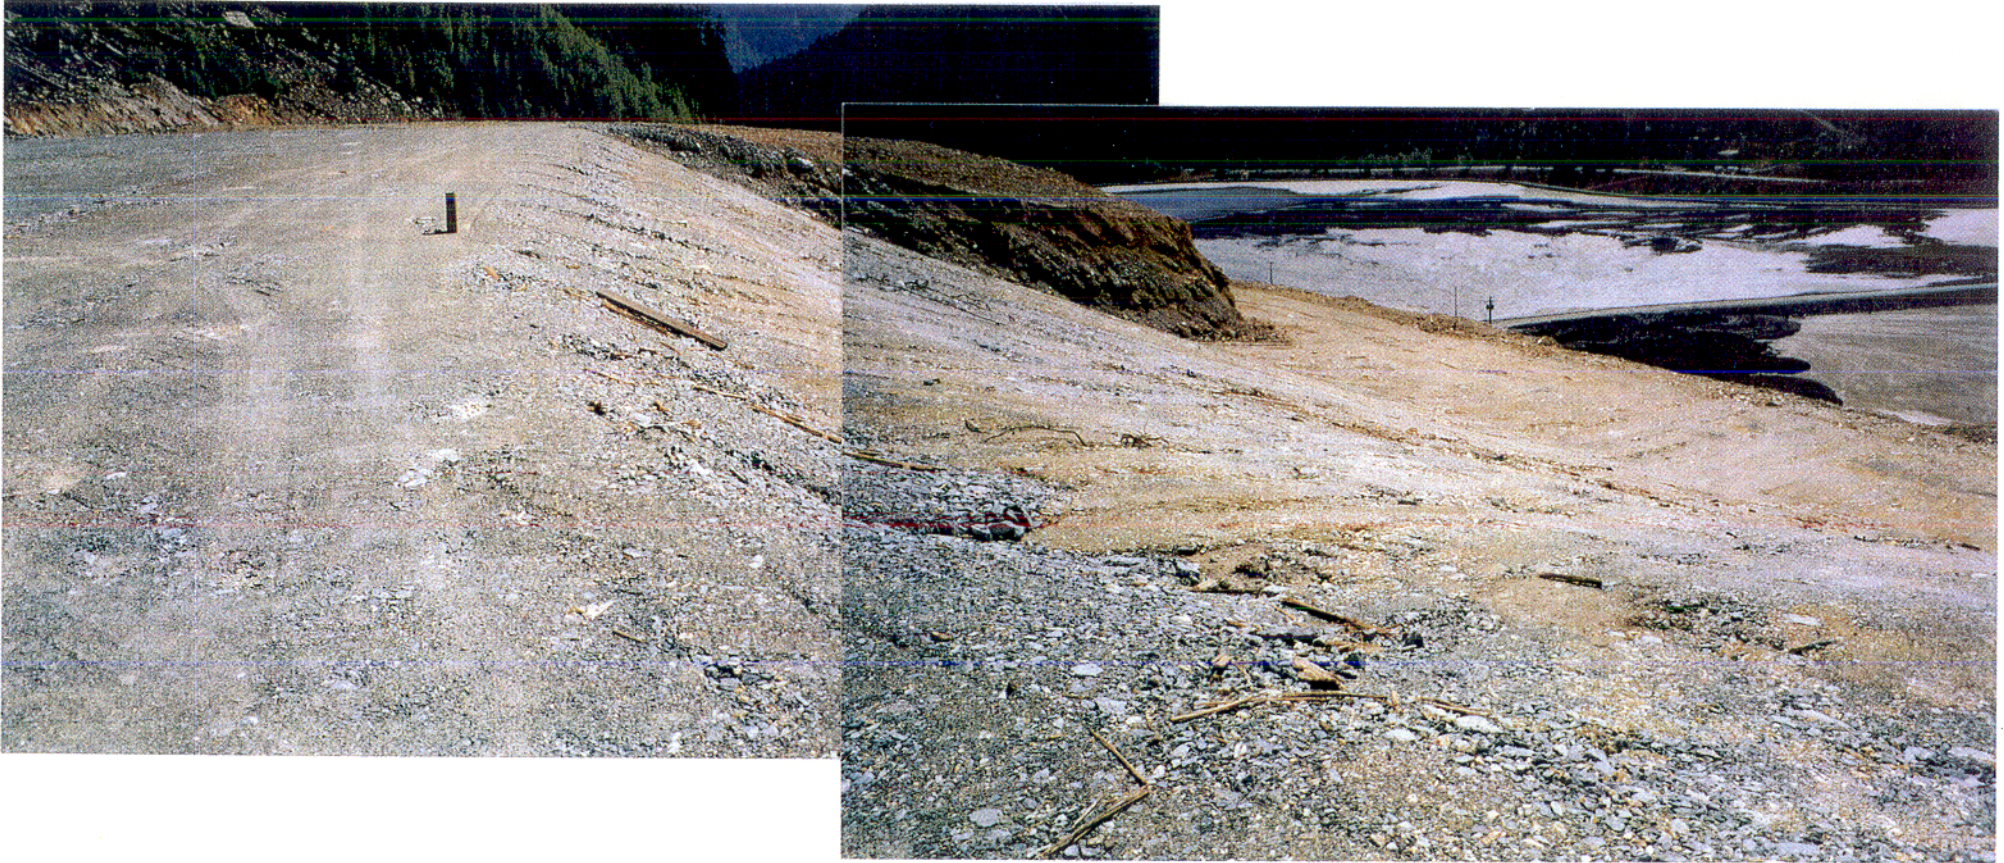
Photo 1 Test section after slope preparation and compaction

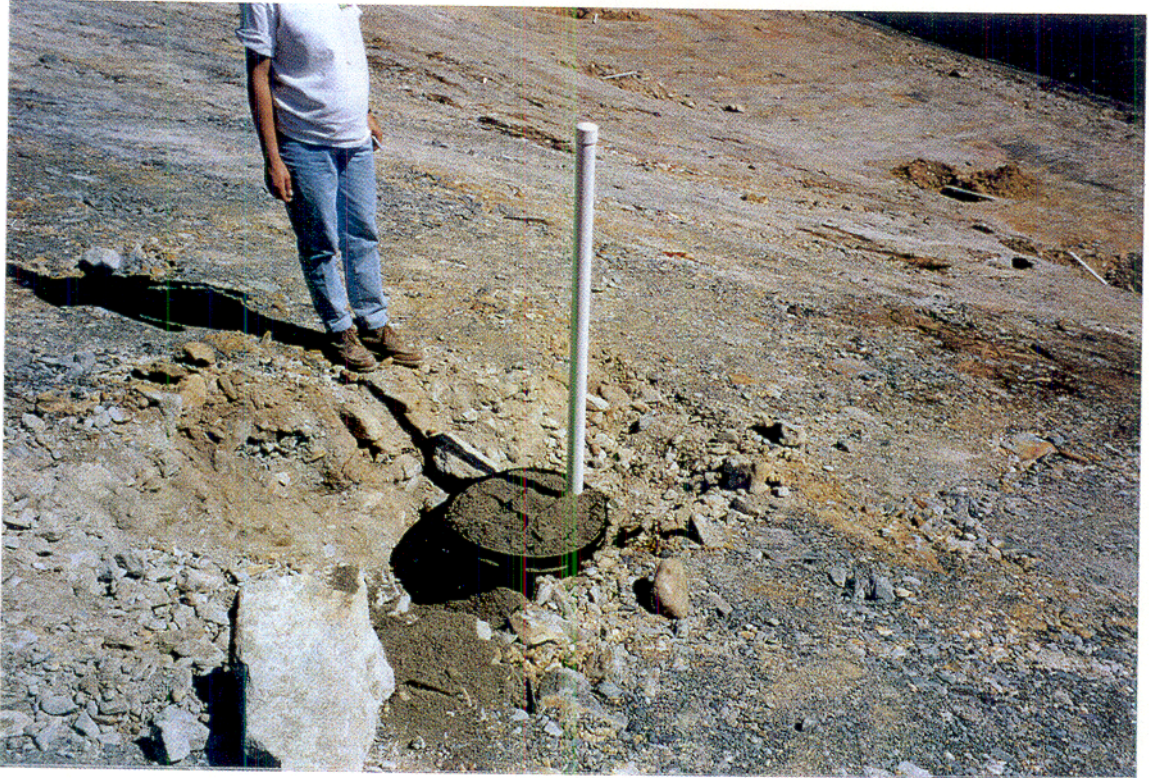
Photo 2 Infiltration boxes installed prior to shotcrete application

Prior to the application of the shotcrete, 13 infiltration boxes were installed to allow an assessment of water in the surface waste material of the dump. Holes were excavated into the dump to a depth of approximately 1 metre. Standpipes were placed in plastic barrels and located in the excavations. The barrels were filled with sand to the surface and the excavations backfilled and compacted (Photo 2). The standpipes were capped and after the shotcrete was applied the joint between the standpipe and shotcrete capping was sealed with a grout.

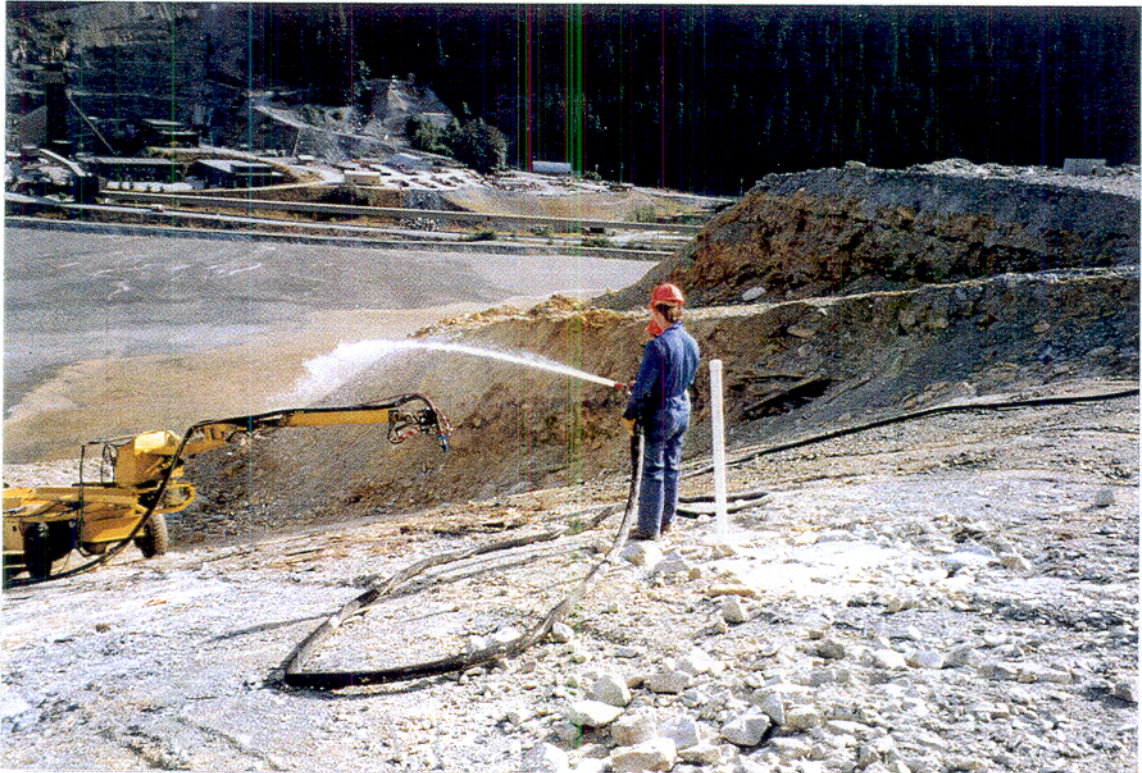
Photo 4 Water was sprayed on the waste dump before shotcreting

The crew consisted of one nozzleman, one helper, and one pumpman. The equipment did not require any major assembly and was mobilized in a few hours. Water was sprayed over the rock pile surface before applying shotcrete due to the hot and dry summer conditions (Photo 4).

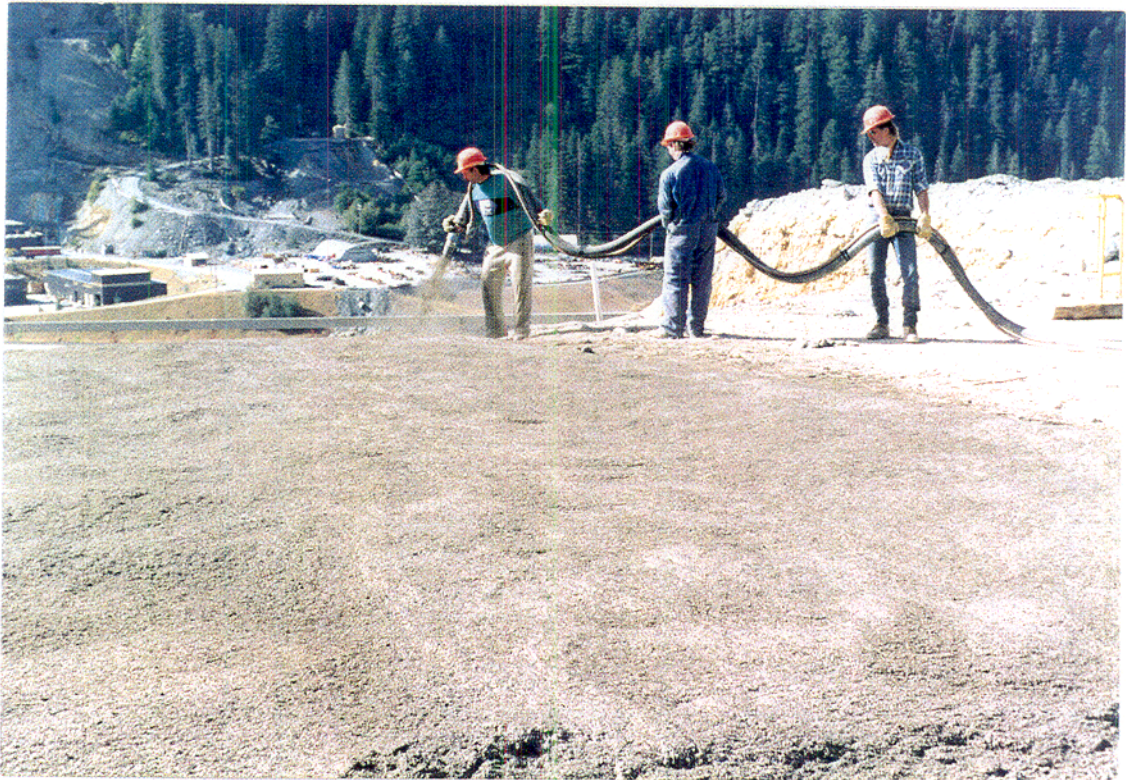
Photo 7 Nozzle was held manually where the robotic arm could not reach or when the robot was not working

A nominal thickness of 75 mm of shotcrete was chosen for this test. Approximately 80 m² to 90 m² were covered without having to move the vehicle. Owing to the relatively smooth surface produced by the compaction of the waste rock, the thickness of the shotcrete cover was quite uniform. During shotcreting of a small portion of the test panel, the nozzle was held manually because either the robotic arm could not reach the area or the apparatus experienced mechanical failure (Photo 7).

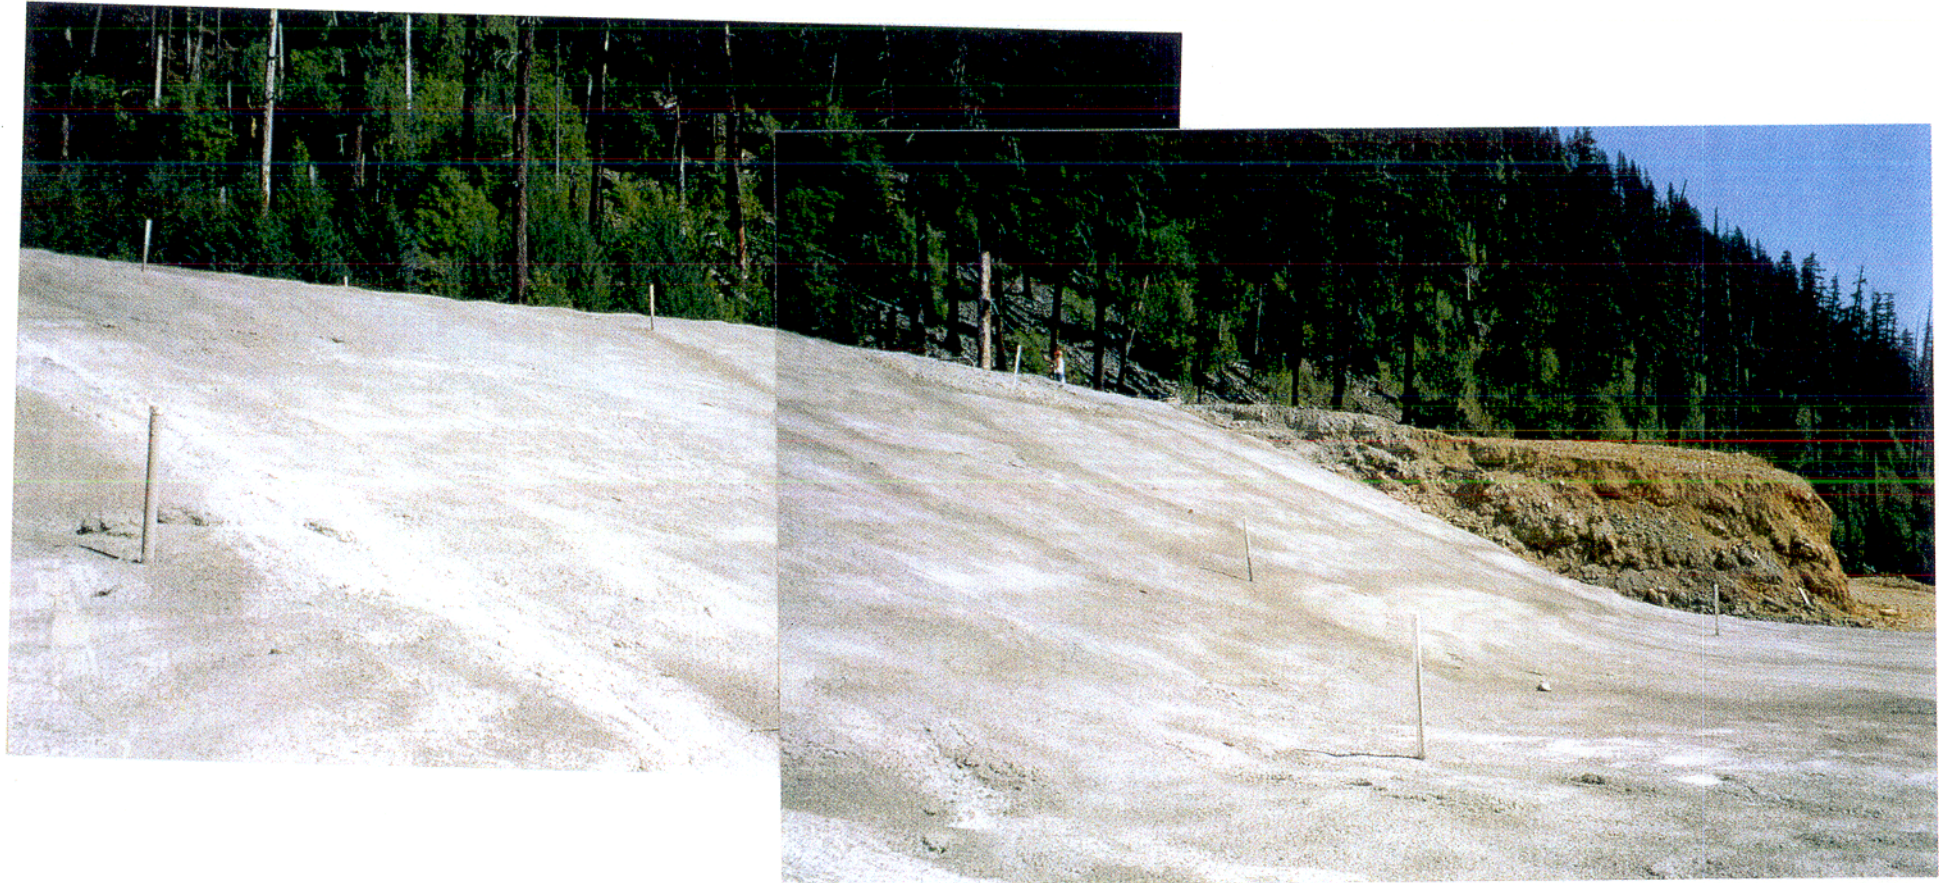
Photo 10 Completed shotcrete test panel - August 1992

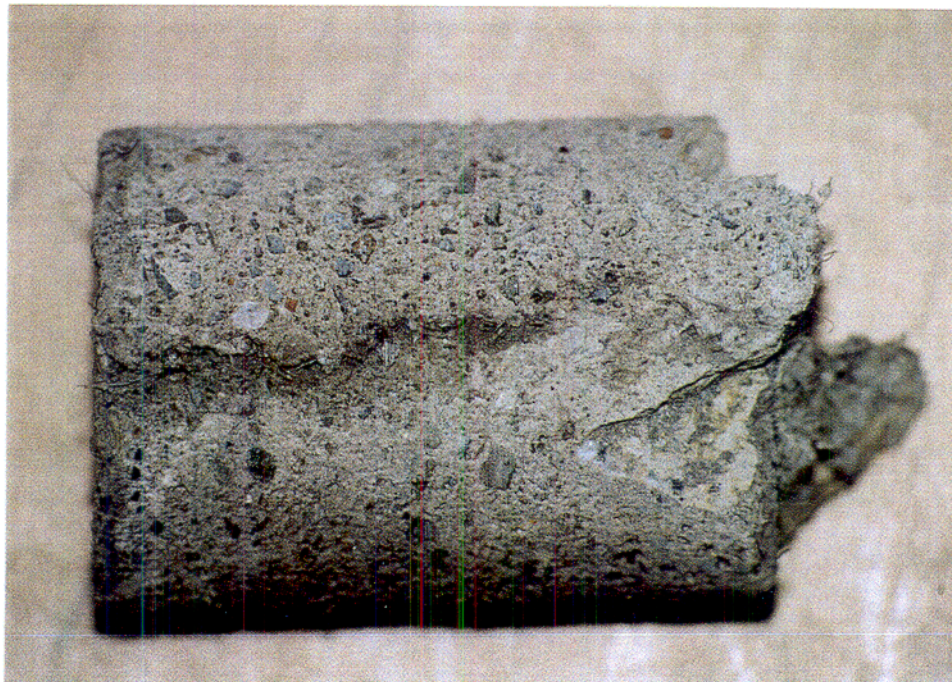
Some plastic shrinkage cracks were observed in the shotcrete immediately after application. The primary cause of these cracks was the high rate of evaporation before initial set. In November 1992, cores were taken through a number of these cracks; some were found to extend through the cap, and others terminated approximately halfway through the cap (Photos 11 and 12). Most of the plastic shrinkage cracks exhibited very narrow surface widths. It is uncertain, without monitoring, how much water from surface runoff will pass through these cracks. However, it has been suggested in literature that cracks with surface widths of less than 0.2 mm will prove to be water tight in most circumstances where there is no hydraulic gradient (i.e. no surface ponding). In addition, when water percolates through cracks, it dissolves calcium hydroxide salts from the cement matrix and chemically reacts with the flyash to form compounds possessing cement-like properties.

Photo 12 A core drilled in November 1992, with a crack terminated in the cover

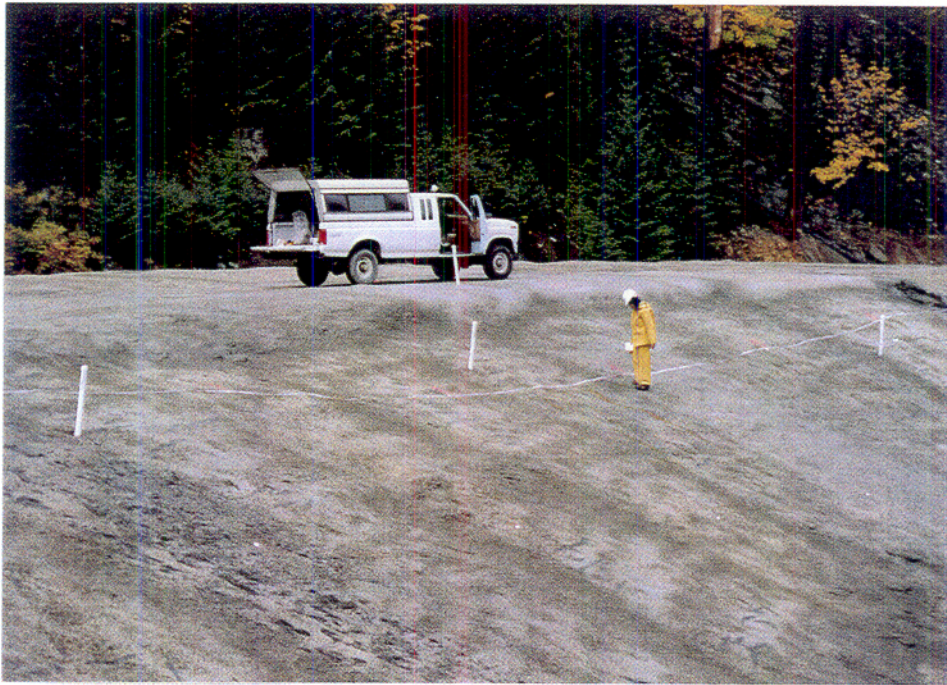
A visual assessment was carried out in September 1993, one year following placement of the cover (Photo 13), and the overall durability performance was good. There was no evidence of major cracking or movement in the cover. The shotcrete did not appear to have suffered any frost damage or erosion. Some minor cracks were observed in two small areas where the shotcrete was thinner than the 75 mm standard depth. Iron staining was observed on these areas as a result of water flow from the waste rock dump through the shotcrete panel (Photo 14). The source of this flow appears to be lateral movement of water through the dump. Similar

Photo 13 Inspection of test panel, September 1993

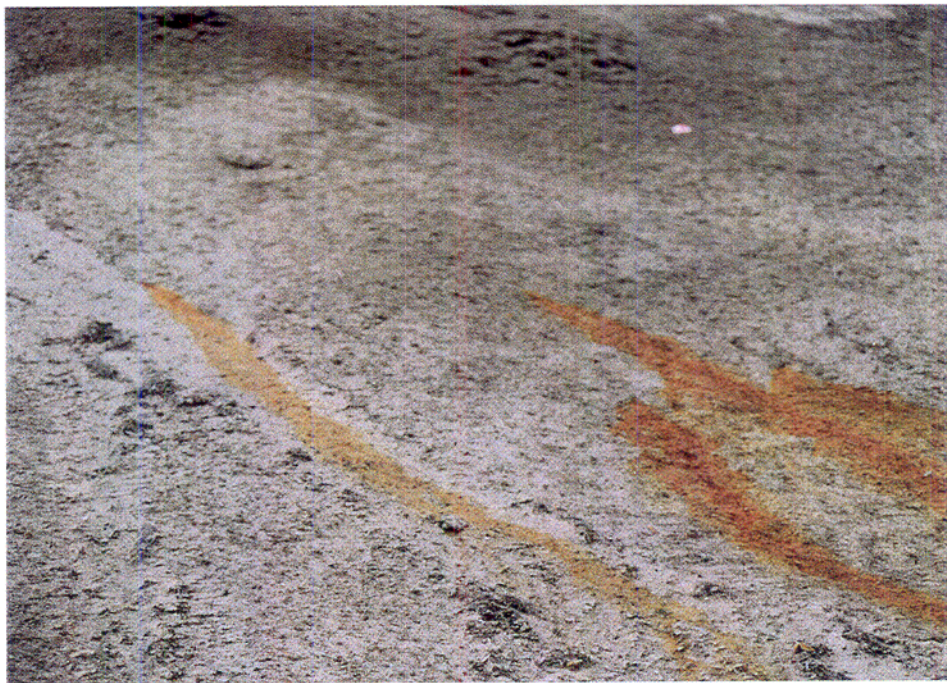
water movement has been observed in other non-covered areas of the waste rock dump. These observations provide pertinent data to assess the performance of the shotcrete, however implications of cover performance to the control of ARD are beyond the scope of this study.

Photo 14 Oxide staining was observed on some areas as a result of water flow from the waste rock dump through the shotcrete panel

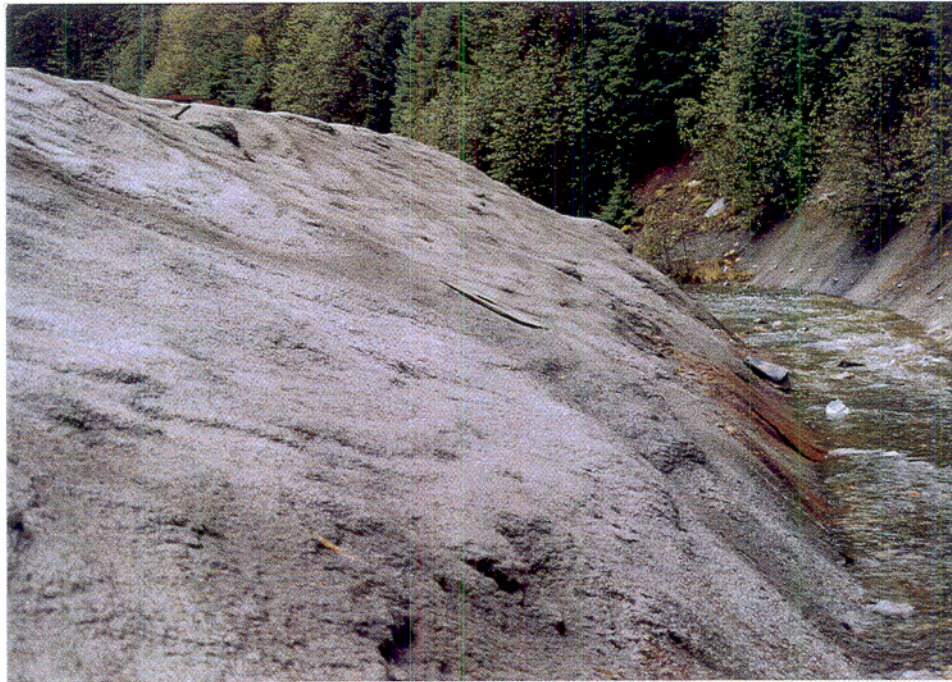
The shotcrete on the steep slope of the dump adjacent to the diversion ditch was in very good condition and there were no stains. There was some staining at the interface between the test panel and the diversion ditch (Photo 15).

Photo 15 The shotcrete on the side of the diversion ditch as inspected in 1993

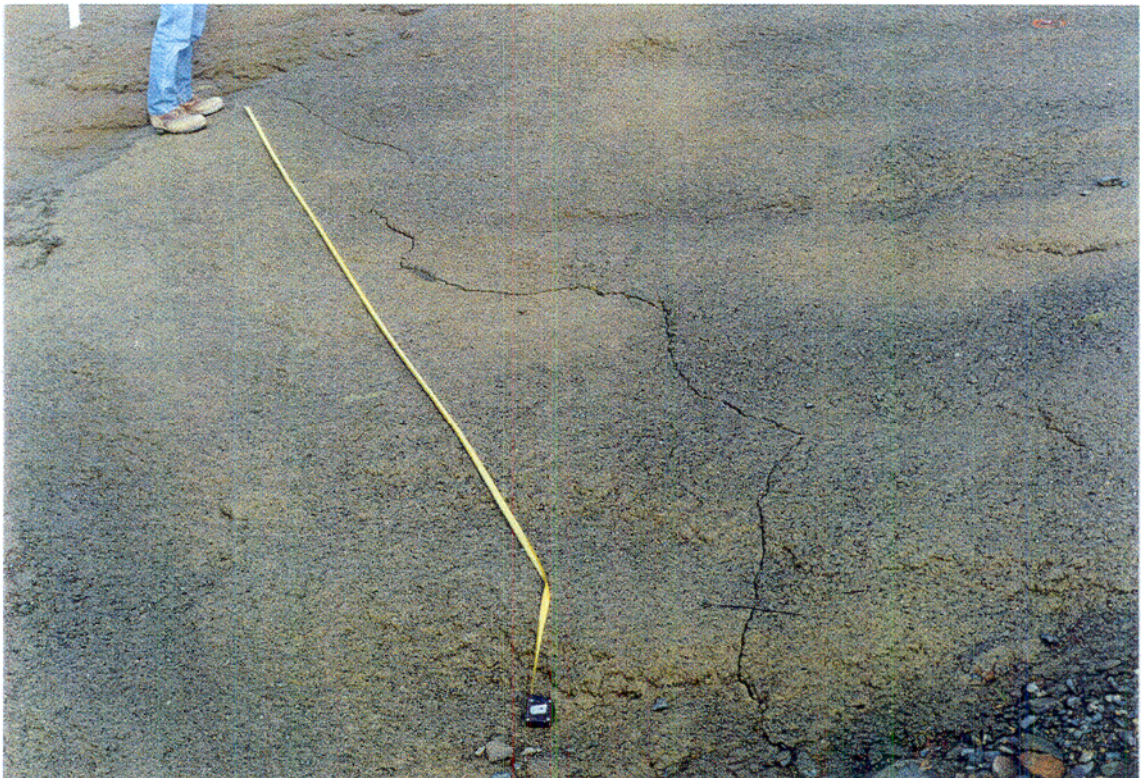
The cracks on the shotcrete cover were profiled during the 1995 field inspection (Figure 9). All of the cracks were located on the sloping portions of the test panel (Photo 16). Although the number and length of the cracks were slightly greater than in the previous inspection, iron stains were less visible. Silt had collected in a few of the cracks and some vegetation had established (Photo 17). Cracks sealed during the field drilling in 1992 showed no signs of re-opening. In the area of the tailings mix, short-length, interconnected cracks were predominant.

The larger cracks developed horizontally across the slope. It is believed that these cracks are a result of bending of the panel due to local settlement of the waste. The elevation surveys confirmed that the movement of the slope over the three year period was minimal. The compaction of the slope prior to the shotcrete application is believed to be very important in achieving this stability. Another factor which may be contributing to the cracking is the depth of the shotcrete. Cores taken from the shotcrete indicate that the cap was as thin as 50 mm in some areas, well below the design thickness of 75 mm. Additionally, the swinging motion of the robotic arm can cause uneven shotcrete placement, resulting in ridges in some portions of the test area. This factor may be improved with modifications to the application apparatus. Some of the cracks observed were located at the base of these ridges. The width of the cracks was less than 2 mm and did not show evidence of further opening over the monitoring period. The cracks can be sealed to prevent water from entering the waste material and sealing will prevent

Photo 16 A 6m long crack located at between grid 37 and 54, as observed during 1995 inspection

the cracks from enlarging due to growth of vegetation within the cracks. A delay of a couple of years between the application of the shotcrete and placement of an overburden cover may be advantageous as it allows for any minor settlement cracks to develop and be repaired prior to placement of the soil material.

Regular maintenance is only required if there are major cracks in the panel. At the time of the last assessment, there were only two cracks which required repairs.

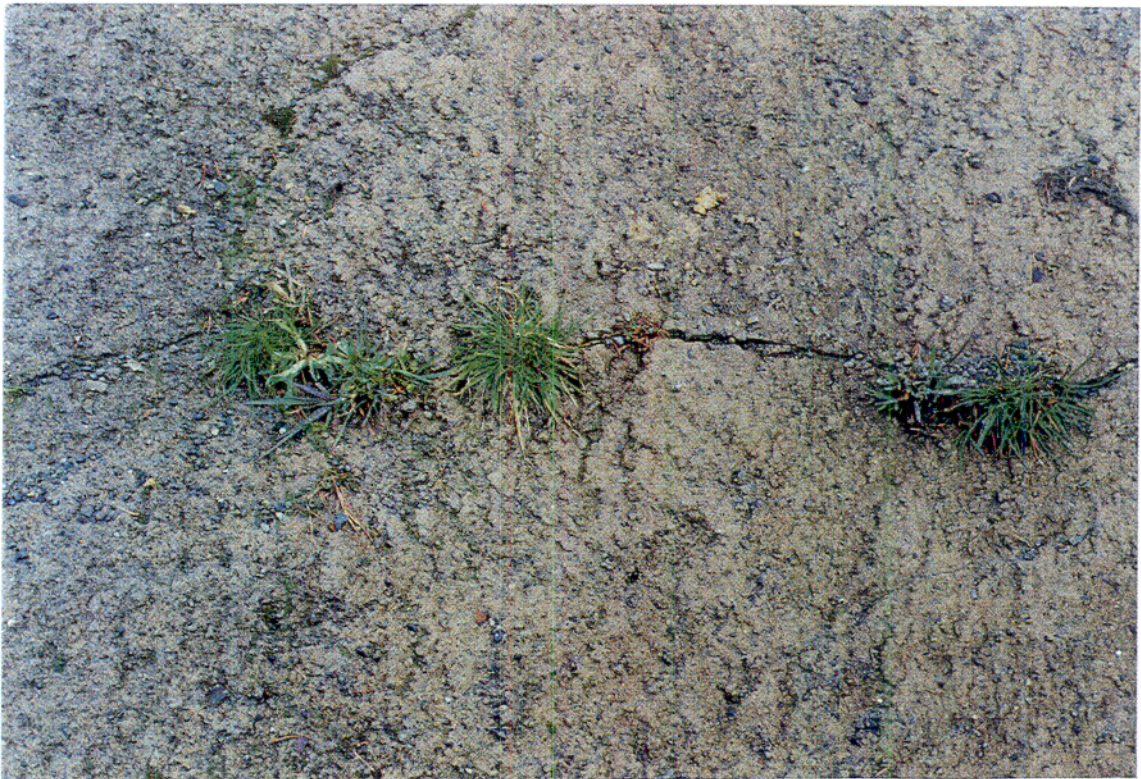
Photo 17 Vegetation and silt in few large cracks

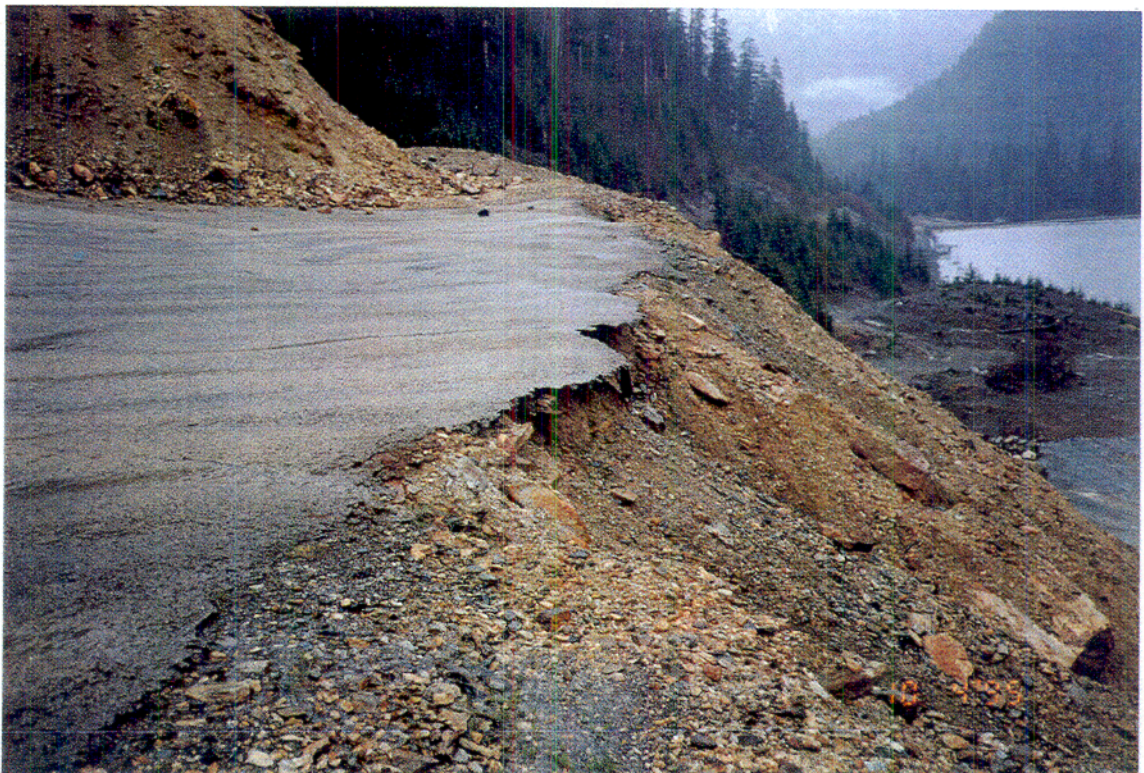
The lower portion of the test panel (on the bench) did show some slope movement. Since this part of the slope was an area of fill, the underlying material was very loose and the slope below the test panel was found to be unstable. Portions of the test panel on the bench produced a hollow sound when the surface was tapped. In comparison, a very solid sound was produced on the slope portion of the test panel. It is inferred that subsidence of underlying dump material may be responsible for the hollow sound, but this has not been confirmed. Subsequent to this inspection, the access road to this bench was closed to vehicle traffic.

Photo 18 The edge of the lower portion of the test panel showed signs of erosion
