# Rehabilitation Commitments for Pits and Waste Rock Stockpiles at Frances Creek Iron Ore Mine

Frances Creek Iron Ore Mine operated for just a few years to 1974, before being re-opened in 2007. The re-opening of the mine provided the opportunity to observe the natural evolution and revegetation of areas disturbed by previous mining, and a reclassification of the reactivity of the waste rock and pits walls, which led to a review of the mine's rehabilitation commitments. Minor geotechnical instability of pit walls is possible, associated with weathering of potentially acid forming rock in the pit walls. Sloughing and erosion of pit walls is also likely. Natural revegetation of pit wall benches occurs over time, dominated by native trees. There is potential acidification of pit water, where potentially acid forming rock is exposed in the pit walls, although this appears to neutralise over time. The angle of repose side slopes of waste rock stockpiles were observed to remain geotechnically stable over time, with only minor face erosion likely, and trees volunteered over time. However, significant face erosion occurs where stockpile top rainfall runoff is allowed to overtop the crest.

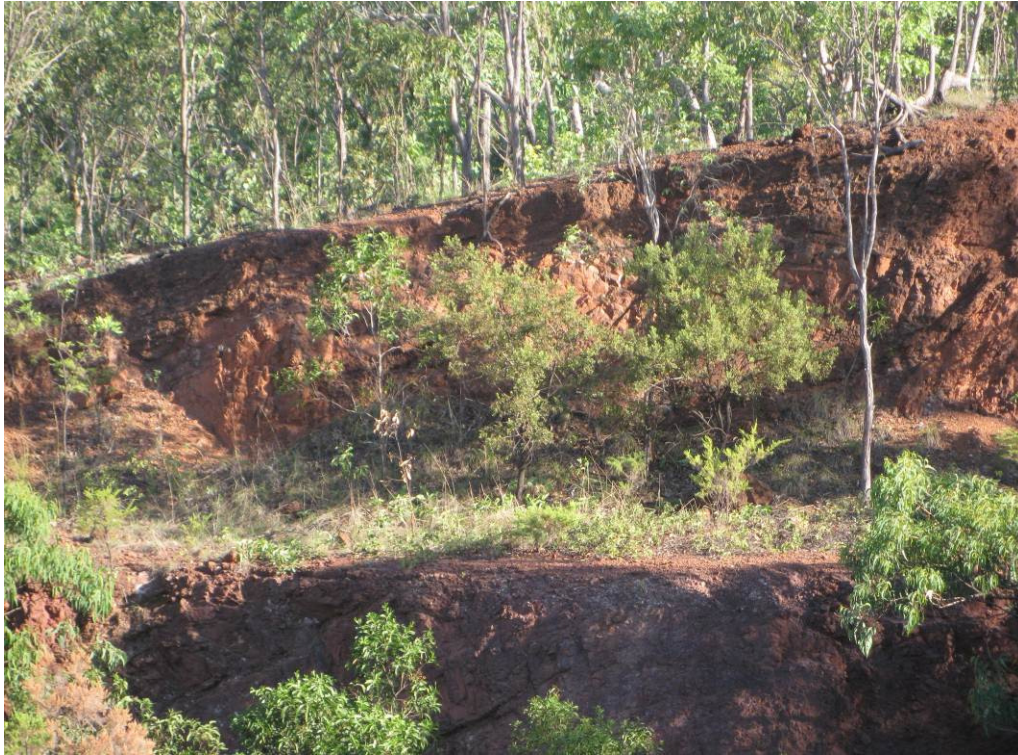
Figure 1. Observations of Thelma/Rosemary Pit 40 years after operations ceased.

Observations of unflattened, 40-year old pits at Frances Creek Mine revealed that minor geotechnical instability of steep pit walls is possible (e.g. Thelma/Rosemary Pit, associated with weathering of PAF rock), that sloughing and erosion of pit walls is likely, and that natural revegetation of benches occurs over time (see Figure 1). Intermediate pit slopes were typically cut at about  $60^\circ$  to the horizontal, are up to 10 m high, and are separated by benches typically 3 m wide. The steep pit walls mimic the steep natural escarpments fringing the site.

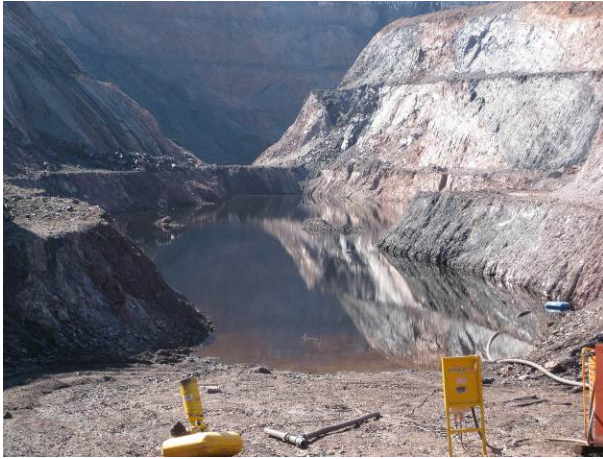
(a) Recent Thelma/Rosemary pit water at pH ~2.5

Figure 2. Acidification of pits due to exposure of PAF rock in walls.

Geochemically, the potential acidification of pit water has been realised where PAF material is exposed in the pit walls, e.g. the recent Thelma/Rosemary Pit with pit water pH  $\sim 2.5$ , and the 40-year old Thelma 2 Pit with pit water pH  $\sim 4$  (see Figure 2). The apparent increase in pit water pH with time suggests that as the exposed PAF material oxides it tends to coat with oxidation products, shutting down the reactivity and allowing the pH to recover.

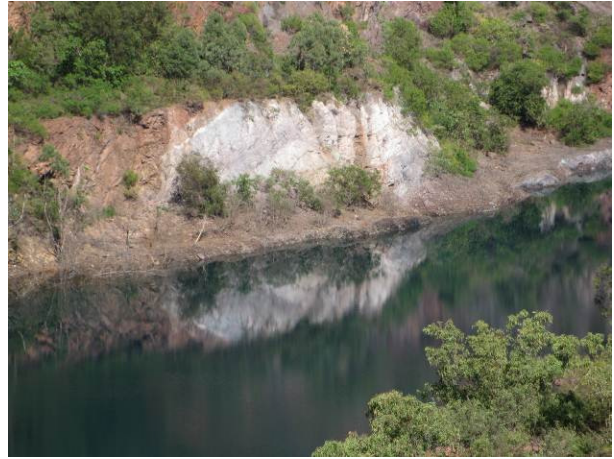
(b) 40-year old Thelma 2 pit water at pH ~4

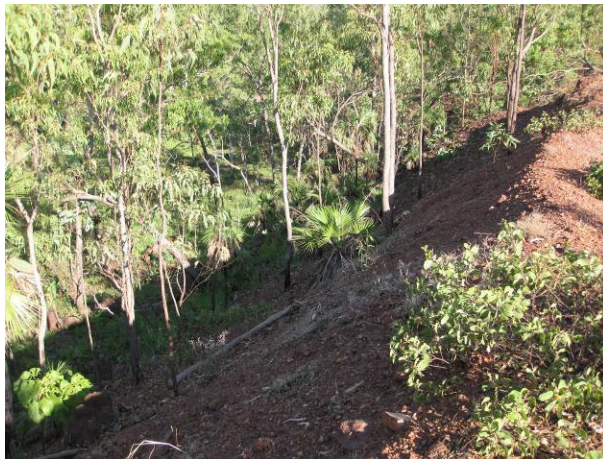
(a) Geotechnically stable 40-year old slope

Figure 3. Observations of waste rock stockpile slope faces.

Observations of waste rock stockpiles at Frances Creek Mine, which are up to 45 m high and are usually constructed in 15 m high lifts, reveal that 40-year old, angle of repose slopes have remained geotechnically stable. However, minor face erosion (rilling) of slopes (including recent slopes) comprising weathered waste rock is likely until or unless vegetation becomes established, and gullying occurs if the slope crest is overtopped by rainfall runoff at any stage (see Figure 3).

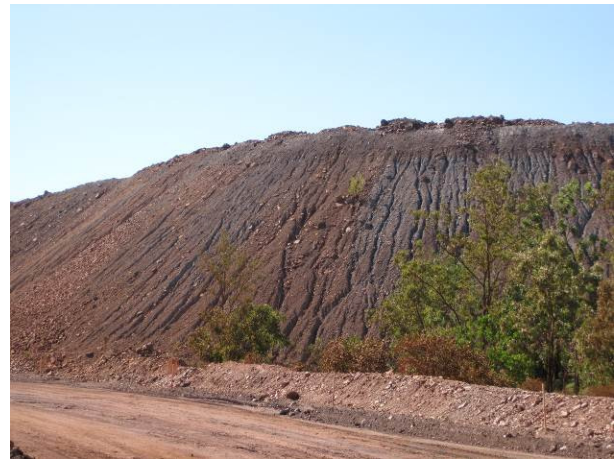
(b) Rilling of unvegetated face comprising weathered waste rock

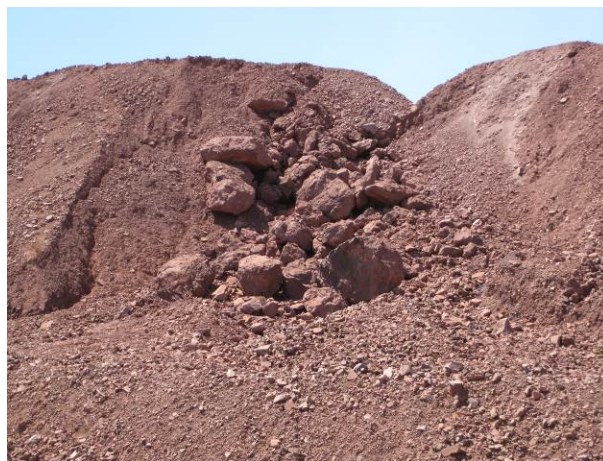
(c) Gullying due to overtopping (note that boulders were placed to control erosion)

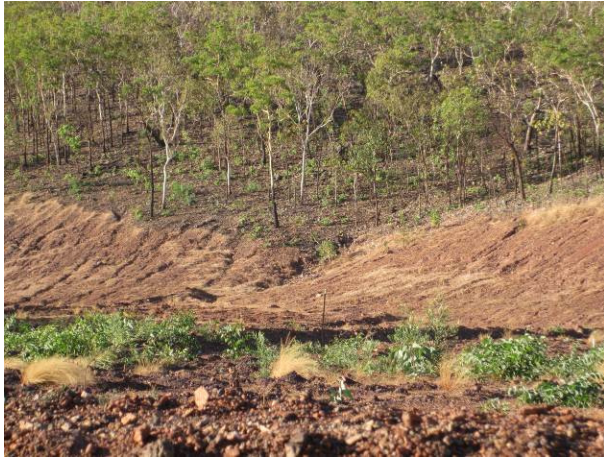
(a) Erosion of stripped natural slope

Figure 4. Observations of stripped, natural and fresh waste rock slope textures and erosion.

Observations at Frances Creek reveal how effective the natural rock cover is in resisting erosion compared with a stripped natural slope, and the comparable texture of natural and angle of repose, fresh waste rock stockpile slopes (see Figure 4). Figure 5 compares natural and 40-year old waste rock stockpile landforms at Frances Creek Mine, which are of comparable scale and shape.

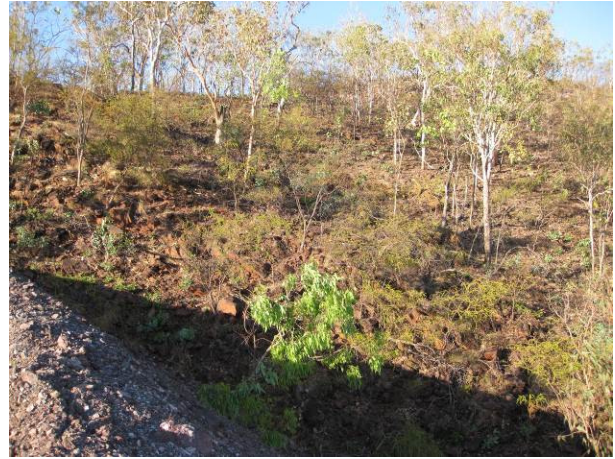
(b) Comparable natural and fresh waste rock textures

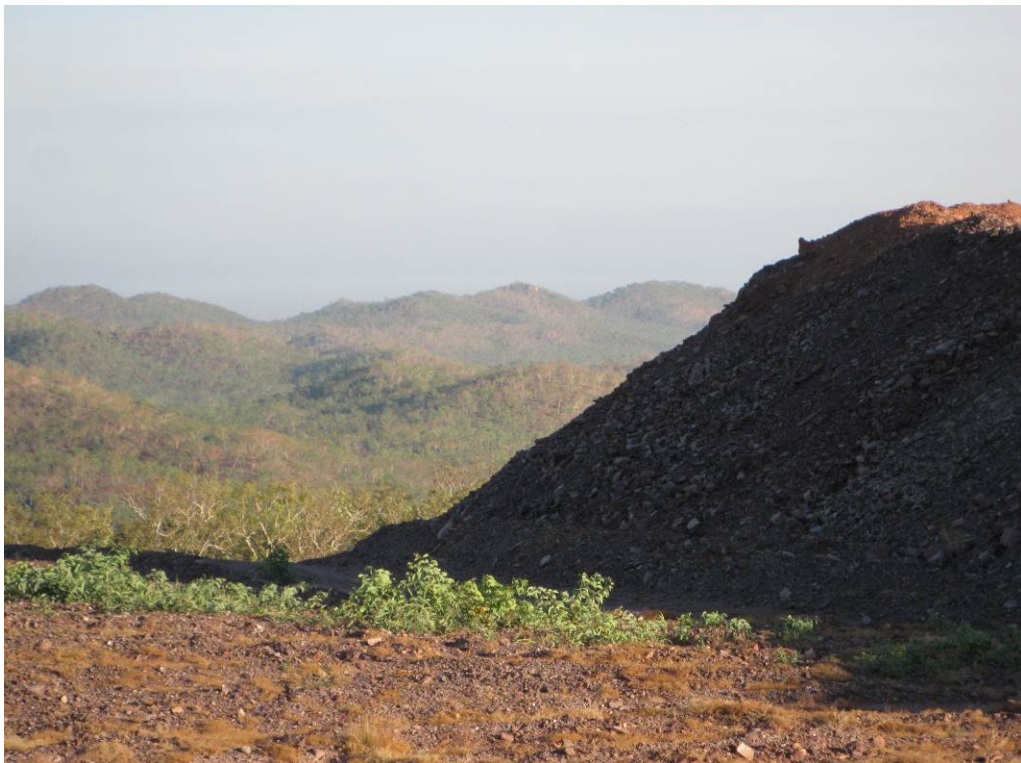
Figure 5. Natural (far-field) and 40-year old, waste rock stockpile (near-field to right) landforms.

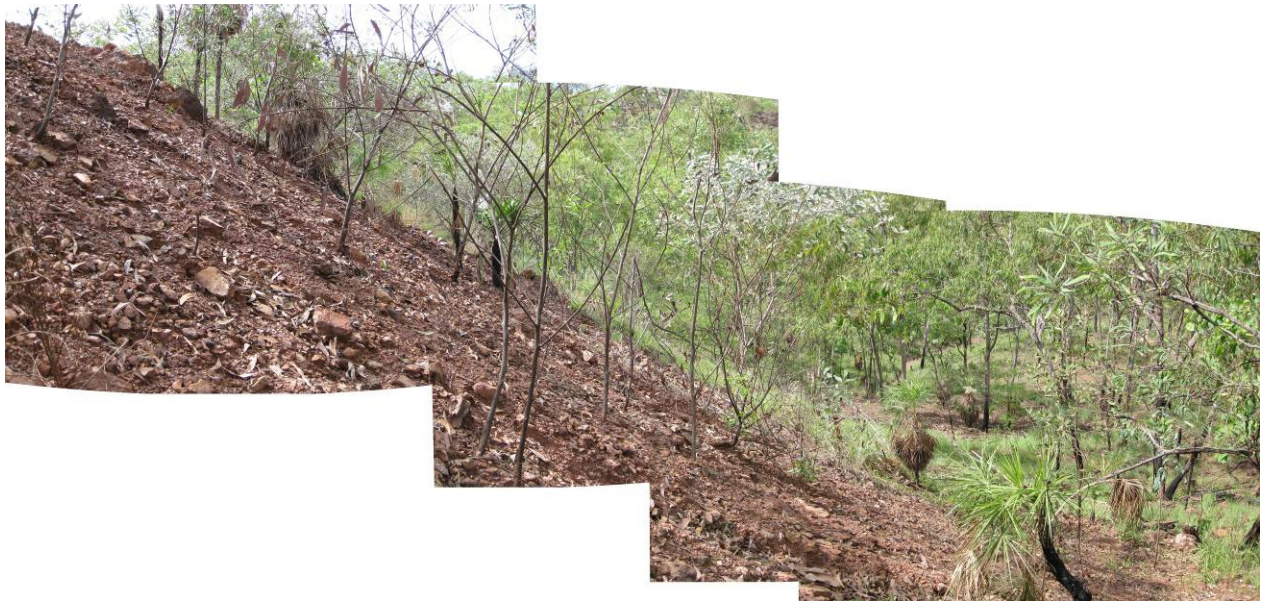
(a) Erosionally stable angle of repose waste rock stockpile slope

Figure 6. Erosional stability of angle of repose versus flattened waste rock stockpile slopes.

Since re-opening the mine in 2007, some waste rock stockpile slopes have been flattened to about  $8^{\circ}$  and revegetated, by way of rehabilitation. Observations show that this is counter-productive from an erosion

perspective, since slope flattening lengthens the slope length and smooths the surface, increasing rainfall runoff and reducing erosion resistance (see Figure 6).

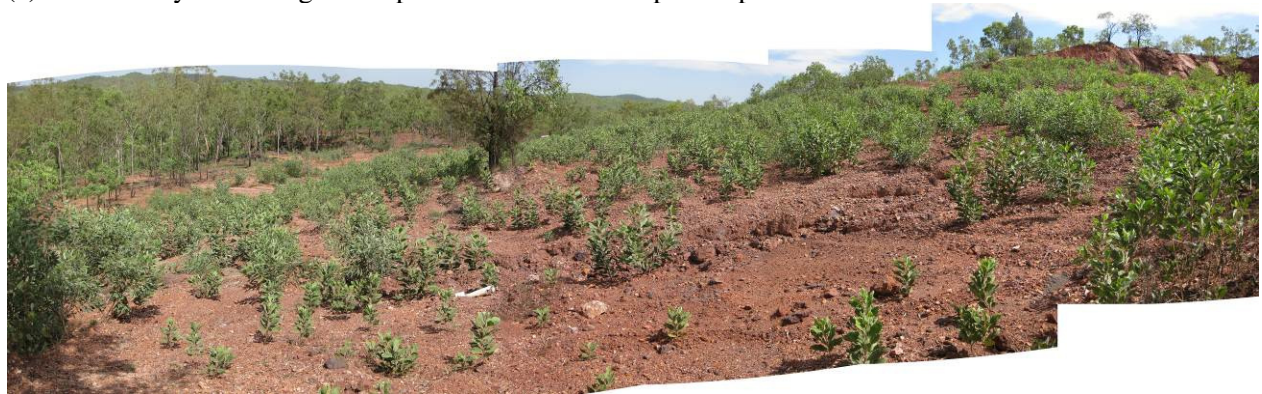
(b) Eroding, flattened (8°) waste rock stockpile slope

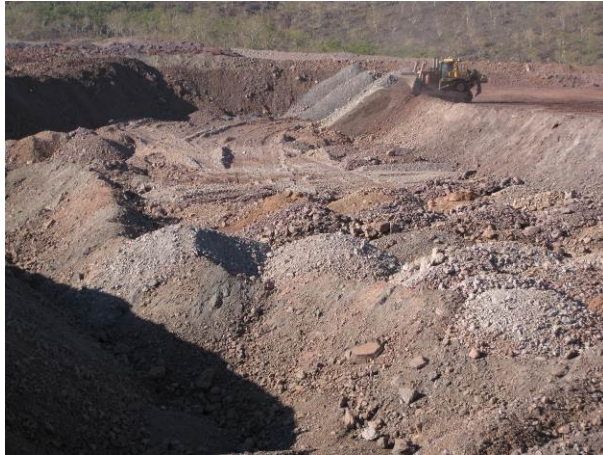
(a) Surface encapsulation of PAF

Figure 7. Encapsulating PAF waste rock.

Figure 7 shows the encapsulation of PAF waste rock by NAF waste rock on the sides and as a cap, in a surface stockpile, and PAF waste rock being dumped in-pit.

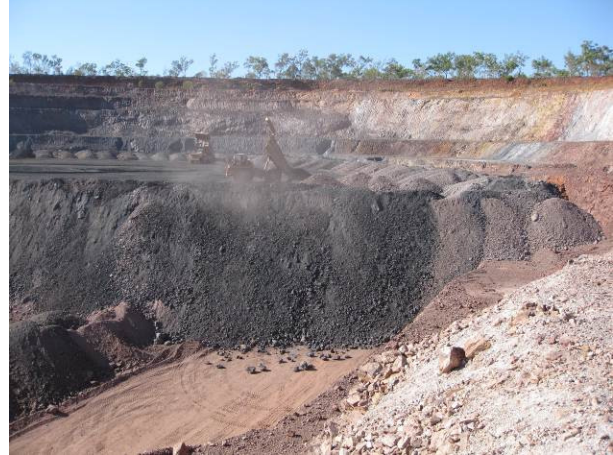
(b) In-pit encapsulation of PAF

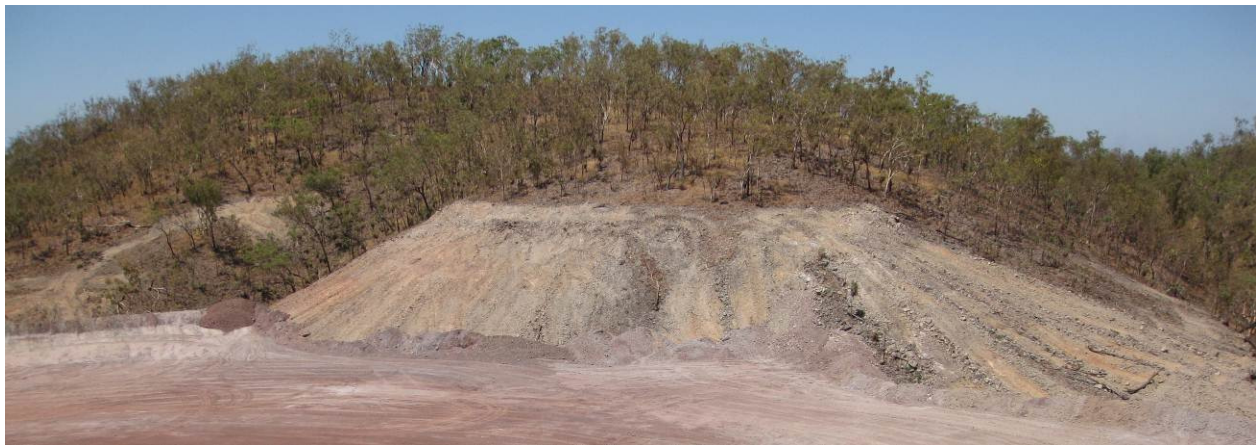
Figure 8. There may be little topsoil on natural hillslopes, and stripping will encourage erosion and infiltration.

- topsoil, where found in appreciable amounts on areas to be mined, should be stockpiled in <2 m high windrows (to preserve organic matter and seeds), noting that there may be little “topsoil” on natural hill slopes, and pre-stripping will encourage erosion and infiltration (see Figure 8);
- NAF, coarse-textured, durable rock should be stockpiled for use as rip rap; and
- NAF, weathered rock should be stockpiled for use in surface paddock dumping on final waste rock stockpile tops and benches.
