# Parys in Springtime: Hazard Management and Steps Towards Remediation of the UK's Most Polluted Acidic Mine Discharge

Paul L. Younger<sup>1</sup> and Hugh A.B. Potter<sup>2</sup>

## Abstract

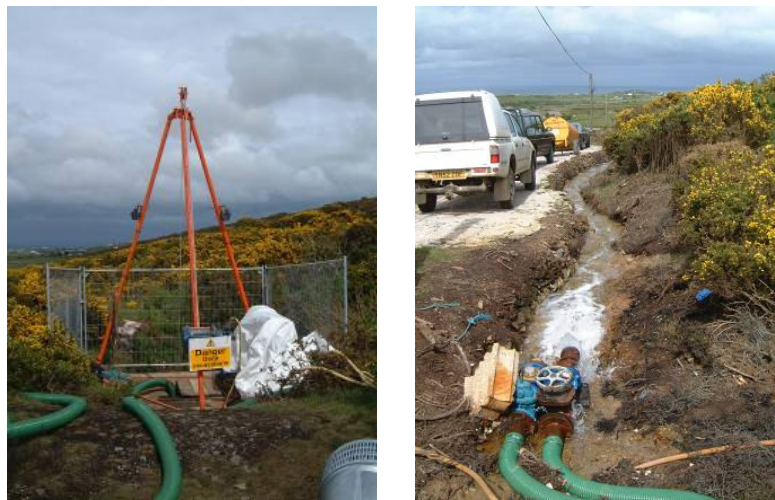
Figure 4. Pumping operations at Gardd Daniel Shaft in 2003.

In the event, the pumping operation at the shaft went smoothly (Figure 4) and no contingency measures were triggered.

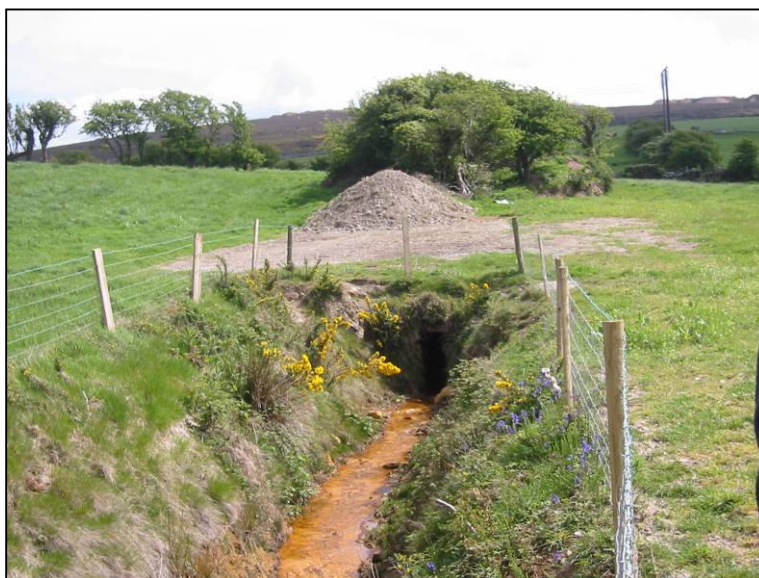
Figure 5. The Dyffryn Adda adit.

Following removal of the dam, the bulk of the pollution is discharged to the north via the Dyffryn Adda adit (Figure 5) into the Afon Goch Gogledd; however the Afon Goch De remains contaminated primarily due to run-off from the very extensive mine wastes and former precipitation ponds. In 2004, a scoping study reviewed available water quality and flow data to establish the metal loadings from the site. Results for key pollutants are given in Table 1 (unpublished report for Environment Agency). The scoping study concluded that active treatment was required for the main Dyffryn Adda adit discharge (Figure 5) which enters the Afon Goch Gogledd, and that further monitoring was needed to fully characterise the variation in flows and water quality. On the south side, the Afon Dulas now has the potential to support fish and so efforts should be made to control the input of metals from diffuse sources.

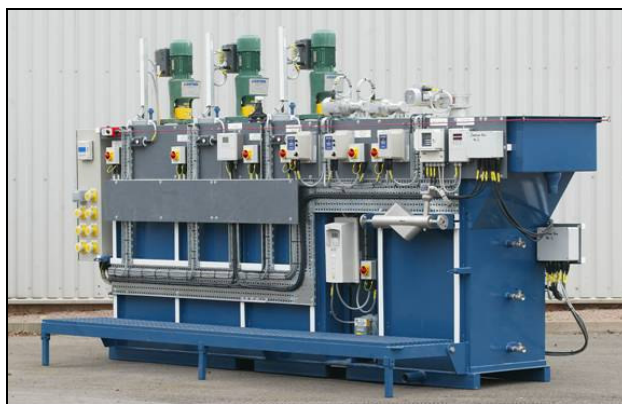
Figure 6. Mynydd Parys pilot active treatment plant.

In 2007, a number of potential treatment technologies were reviewed (lime dosing, sulphide precipitation) and a pilot-scale field trial was carried out to establish the feasibility of treating the mine water. Monitoring data do not show any significant change in water quality since the dewatering operation but this will be reviewed prior to detailed design of a full-scale plant. The technology tested was a high density sludge hydroxide system designed and operated by Siltbuster Ltd. A series of jar tests were carried out to establish dosing rates using either sodium hydroxide or lime, and air requirements. These were followed by running the pilot-plant using initially lime (and subsequently sodium hydroxide) plus a polymer flocculent for 3-4 weeks to assess metal-removal effectiveness. The pilot plant has a series of lamellar plates to remove solids. A consistent sludge was generated and subjected to a comprehensive characterisation process to determine whether it was inert, non-hazardous or hazardous waste for disposal.

The results showed that treatment should remove between 96 and 99% of the dissolved metals (Cd = 96.2%; Cu = 99.9%; Fe = 99.9%; Zn = 98.3%) except Mn (35.6%), and raised water from pH 3 to pH 7, with little difference in performance between lime and sodium hydroxide. The mine water contains very little carbon dioxide and so there is no requirement to install a de-gassing stage. The sludge generated was primarily iron hydroxide with small amounts of calcium, sulphate and carbonate compounds. A good high density sludge was formed and after filter pressing, the sludge should be at least 40% solids. At full scale, around 500 tonnes per year of dry solids would be generated. The sludge was characterised using Environment Agency guidance and found to be non-hazardous.
